POLITECNICO DI MILANO

The Role of Structural Homogeneity
in Seismically Active Historical Centers of Abruzzo

Castel del Monte, Castelvechio di Calvisio, Santo Stefano di Sessanio, Villa Santa Lucia degli Abruzzi

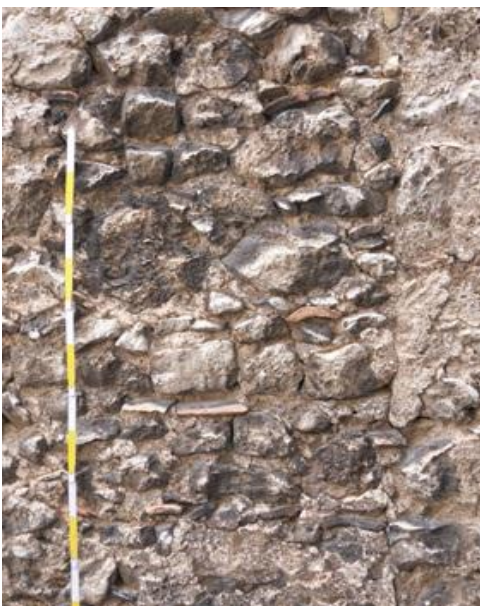
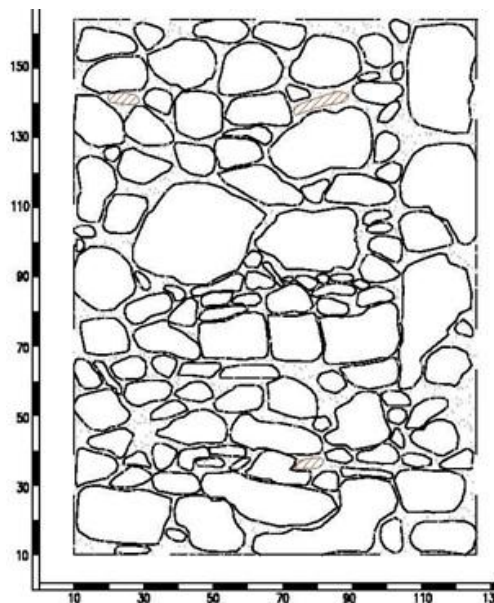
protect the masonry structure below. As seen in figure 5.11 and 5.12, the masonry typology one in this particular structure was once covered in plaster. However this plaster has almost been completely

decayed and therefore the masonry typology below is almost completely revealed. Due to the amount of visible decay both of the masonry stones as well as the

mortar, it can be determined that this plaster covering has been absent for a substantial amount of time. This particular example of masonry typology one is unique due to the large quantity of brick pieces among the more substantial masonry stones. However as is to be expected for masonry typology one, there are no distinctive horizontal or vertical structural systems within the masonry, which is what categorizes the masonry as the lowest quality present in Villa Santa Lucia degli Abruzzi. However it is important to note that this masonry has survived several seismic events in its lifetime and can be considered structurally sufficient.

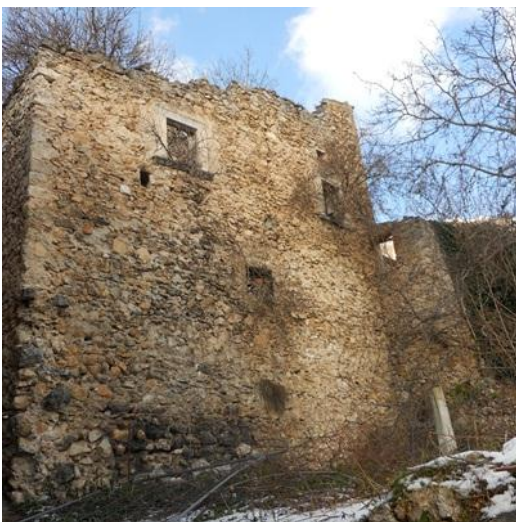
Figure 5.13 Aggregate VSL 025

example is found in aggregate VSL 025. This aggregate is located within the historical center and is currently of private use and is uninhabited. As seen in figure 5.13, there was once a plaster covering to protect the masonry structure beneath, however it is almost completely decayed away due to weathering and human traffic. This implies that an intervention of the structure has not occurred within the recent past, since the initial construction of the

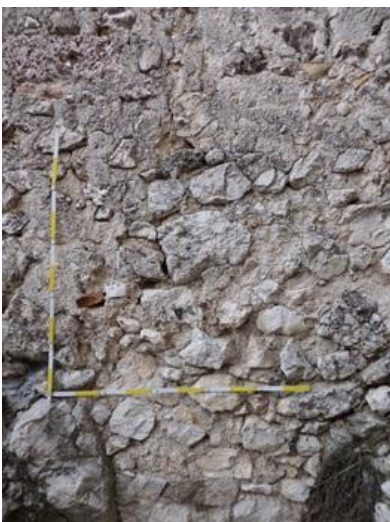
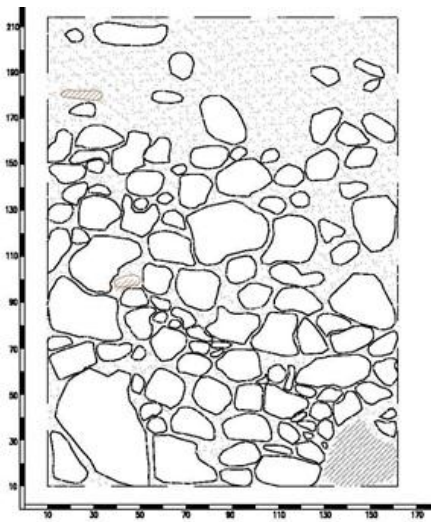
there is no significant presence of either a horizontal or vertical structural system within the masonry. However it is important to note that the masonry stones are of high quality, coming from the surrounding area, and the

overall masonry system is structurally sound and in general does not render the building vulnerable. This particular masonry typology however is the lowest quality present in Villa Santa Lucia degli Abruzzi. The masonry, analyzed in figures 5.14 and 5.15 is characterized by a combination of both large and small stone. Observational analysis also reveals a large amount of mortar which helps to stabilize the masonry in the case of a seismic event.

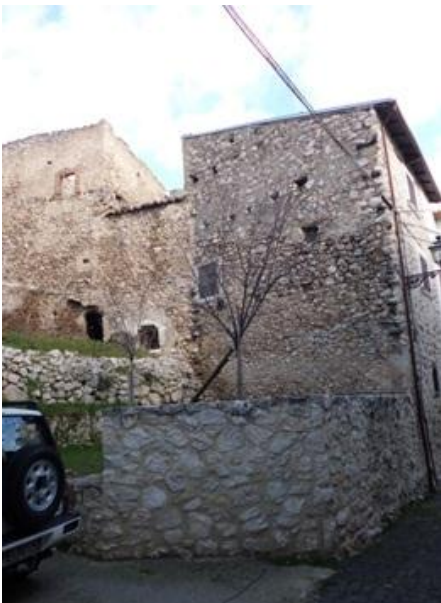
Figure 5.20 VSL 006 Ruins

The first example of a ruin within the historical center of Villa Santa Lucia degli Abruzzi is located in aggregate VSL 006. This particular aggregate lacks in structural homogeneity regarding

the four primary structural elements that will be discussed in the section 5.7. In addition, the aggregate is very irregular in both plan and elevation. The ruined building in question is characterized by being composed of masonry typology one, the weakest of the masonry typologies present in Villa Santa Lucia degli Abruzzi. Unfortunately due to security measures in place, it was impossible to complete a more complete observational analysis of the ruins. However the mode of failure does not appear to imply a failure in the strength of the masonry elements. It is important to note that this conclusion is solely conjecture and would need to be verified through additional extensive analysis done both on-site and in a laboratory.

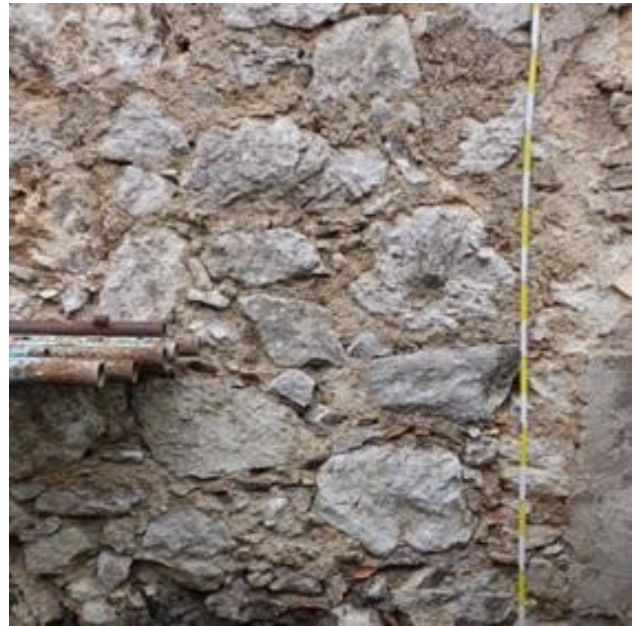
Figure 5.23 Masonry Typology 1 Ruins

Stones than typically seen in masonry typology two samples. It is important to note that the masonry structure shows extensive decay and lacks any evidence of a plaster covering. As seen in figures 5.24

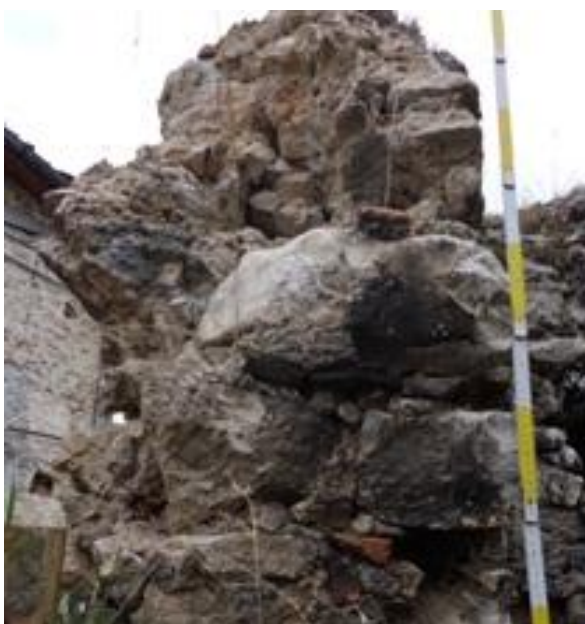
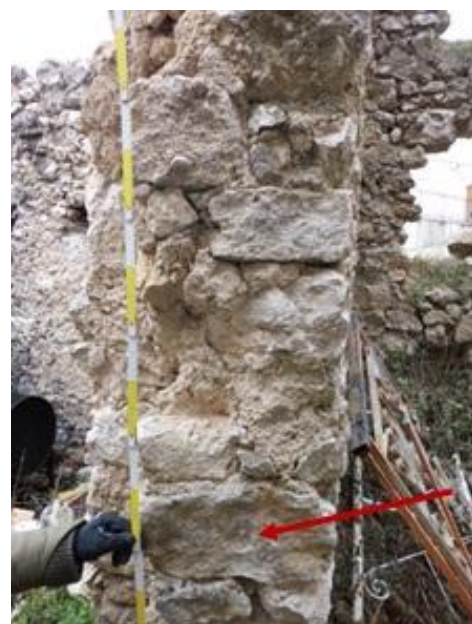
and 5.25, there are two masonry sections exposed for observational analysis. Assuming these sections are a portion of the building in ruins, it can be said that the brickwork has been assembled, in both cases, with a certain effectiveness. Despite the size of the sections under examination, it can be deduced that the masonry is comprised of two leaves, partially clamped with the presence of larger stones, holding the two leaves together. Approximately every 70 centimeters, we find one of these stones, as is indicated by the red arrow in figure 5.25. It is also important the presence of limestone wedges. The mortar within the sections is also in good condition and of good consistency. There were no voids found in either section. Observational analysis can conclude that the masonry quality was not a major factor in the initial collapse of this particular structure. This is a conclusion based solely on observational analysis and would need to be verified through additional analysis.

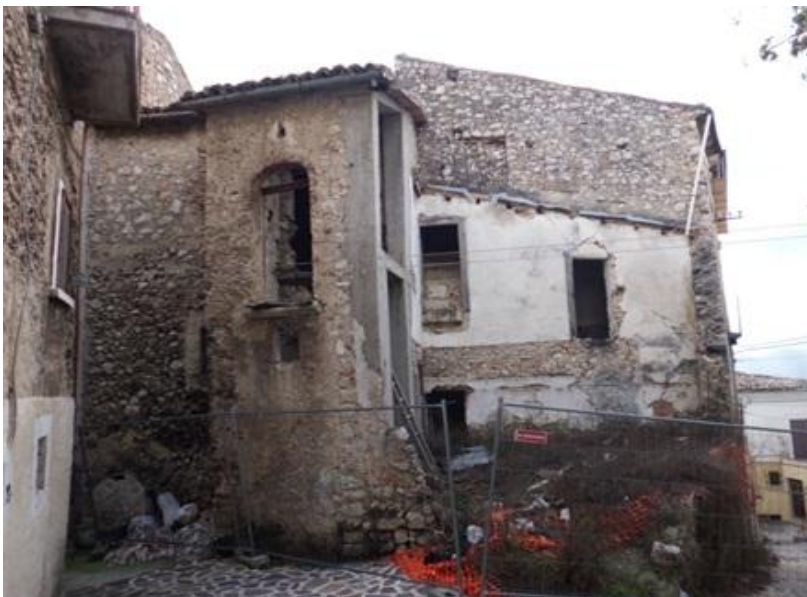
Figure 5.26 Aggregate VSL 015 Ruins

aggregate is extremely irregular regarding plan and has been considered to be homogeneous regarding the four primary structural factors except in the section of the aggregate where the ruins are located. The masonry typology of the ruins is categorized as masonry typology one. Due to

the inaccessibility of the site due to security reasons, observational analysis was extremely limited. Therefore concluding a potential cause of collapse is impossible. Further analysis both on-site and in a laboratory is required to verify the cause or causes of collapse.

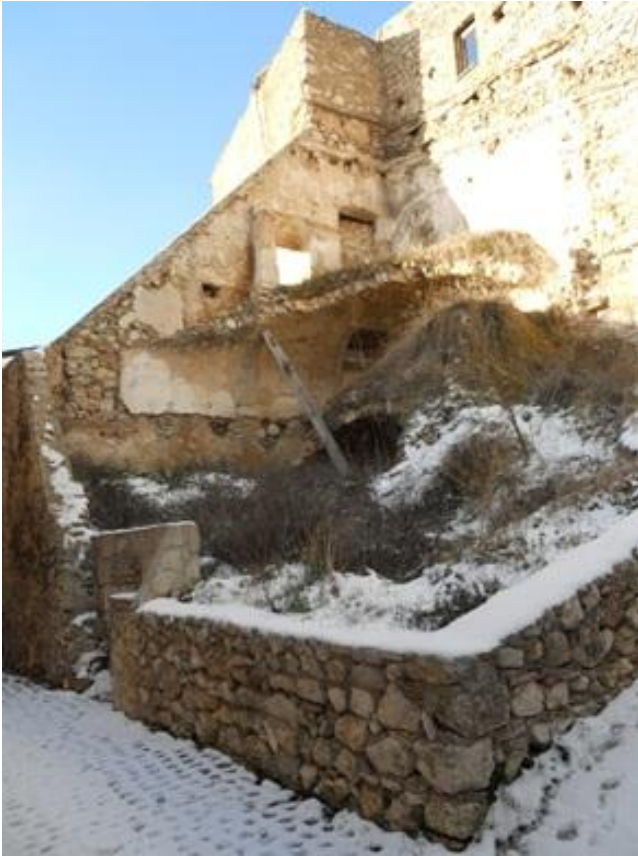
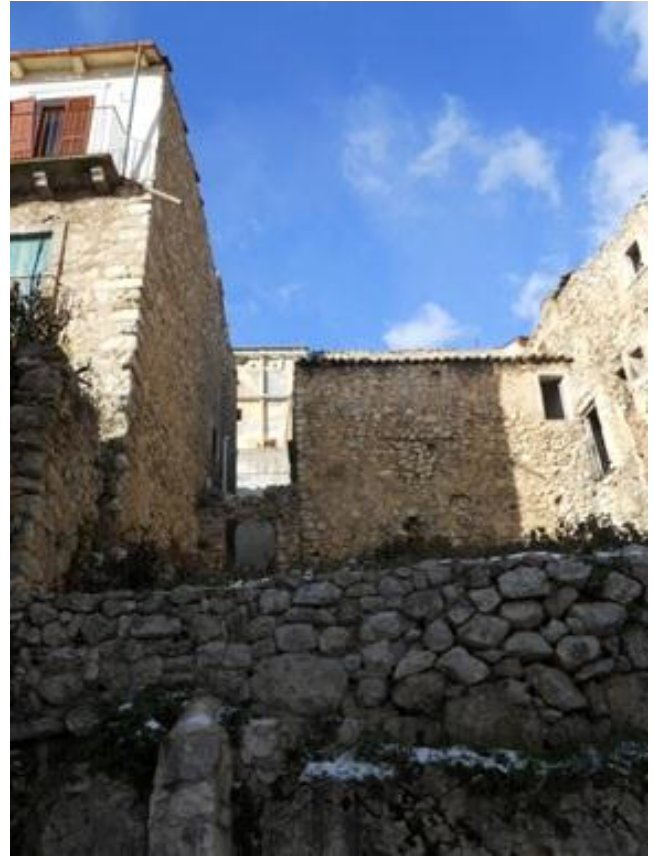
Figure 5.27 Aggregate VSL 020-A Ruins

The fourth example of ruins within the village comes from aggregate VSL 020-A. This particular is fairly regular in both plan and elevation. The entire aggregate is plaster covered except

for the ruins which are categorized as masonry typology one regarding the structural masonry. This is lowest quality masonry present in Villa Santa Lucia degli Abruzzi. The collapse of the structure seems to be isolated from the adjacent structures and suggests this structure was built after the initial construction of the village. In addition, the collapse mechanisms present appear to be connected to

masonry structure present. It is important that this conclusion is based solely on observational analysis and must be verified with further analysis and investigations.

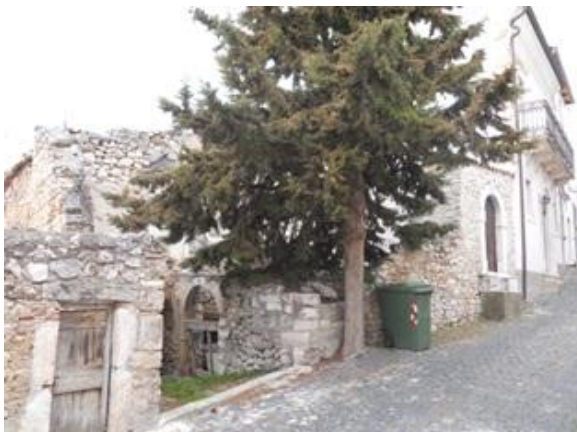
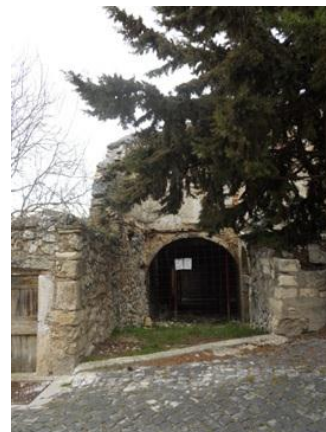
Figure 5.29 Aggregate VSL 025 Ruins

The aggregate is located within the center of the village and is extremely irregular in plan, specifically where the ruins are located within the aggregate. However the aggregate is fairly regular regarding the four major structural factors analyzed. This particular structure in question is composed of masonry typology two. Observational analysis as well as the high quality of masonry implies that the initial collapse was not related to the masonry. However this can only be considered conjecture, due to inability to further investigate the ruins. Further analysis both on-site and in a laboratory are required to verify these conclusions.

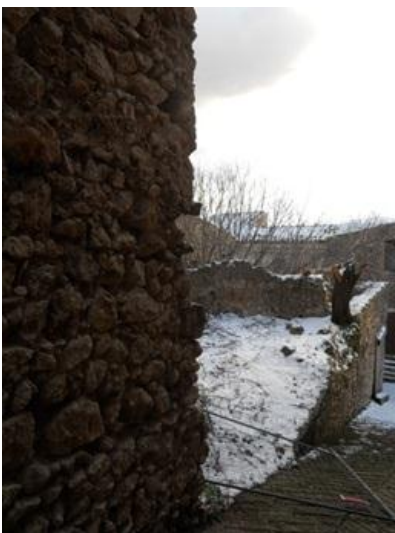
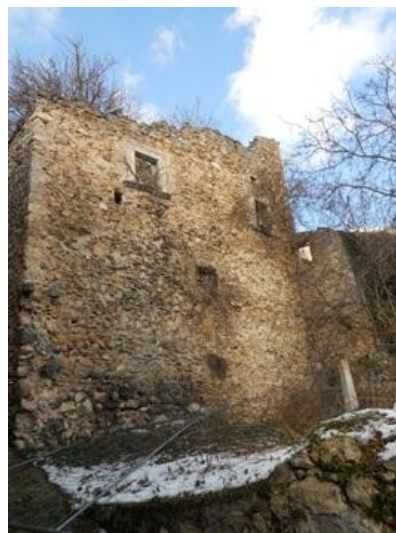
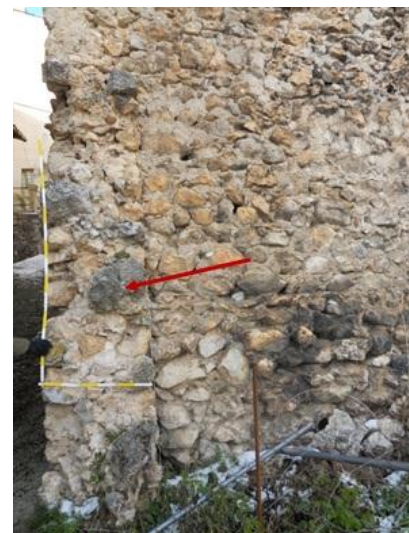
Figure 5.31 Aggregate VSL 110

major structural factors. It is also important to note that the majority of the buildings within the aggregate are in ruins. In addition, the structure has been categorized as masonry typology one. Due to the access to the site as well as the presence of an exposed masonry section, the observational analysis in this particular case is more detailed than other examples of ruins within Villa Santa Lucia degli Abruzzi. Assuming that the section, seen in figure 5.33, is a portion of the building in ruins, it can be said that the brickwork has been assembled with a certain effectiveness. Despite the size of the section under examination, it can be deduced that the masonry is comprised of two leaves partially clamped by larger stones. One of these stones is pointed out by the red arrow in figure 5.33.

The masonry structure consists of stones of both medium and large size, implying a higher quality masonry. It is also important to note the presence of very porous limestone wedges. The mortar within the section is also in good condition, with light gray coloration and firm consistency. The aggregates within the mortar in the section are larger than those present in the mortar visible on the surface of the masonry wall. There were no voids present in the sample. It can therefore be presumed that the masonry quality was not a major structural factor in the collapse of the structure. Again, as in the previous examples, all of these conclusions are based solely on observational analysis and would therefore need to be verified through further analysis.

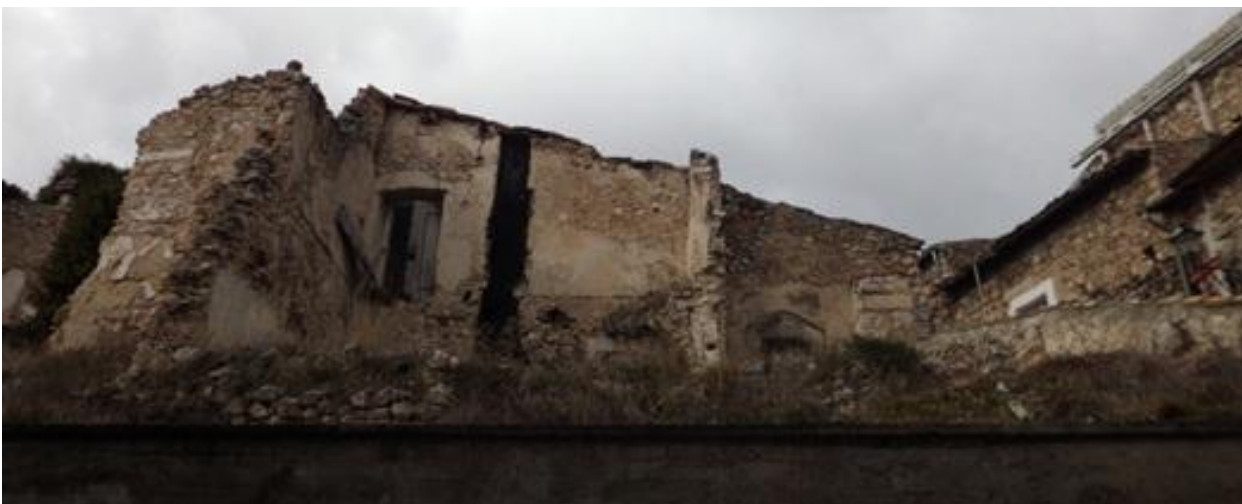
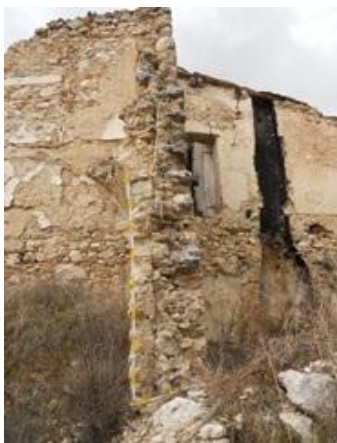
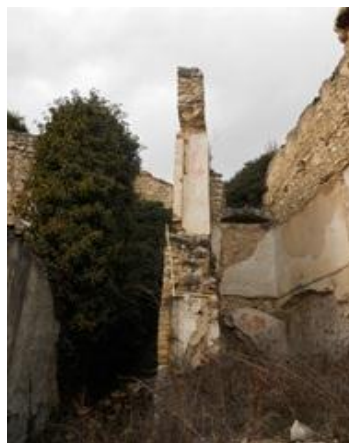
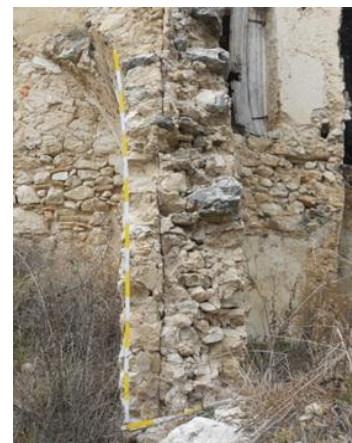
Figure 5.34 Aggregate Y Ruins

exposed and accessible masonry section, detailed observational analysis was possible. Assuming that the wall section is a portion of the building in ruins, it has been noted that the masonry is composed of three leaves: two outer masonry leaves and an internal filling layer. The outer two leaves are composed of limestone of both medium and large sizes. There is also a presence of small stones and lime mortar to support the larger stones. It is also important to note the presence of very porous limestone wedges. Within the section, the mortar is in good condition, with light gray-brown color and is well compacted. The aggregates in the mortar are larger in the section than they appear on the surface of the masonry wall. There are no voids present within the section. Based on this analysis of masonry of the section and the definitions given in the table of NTC C8A2.1 and 14.01.08, the masonry can be categorized in masonry typology one, the weakest of those present in Villa Santa Lucia degli Abruzzi. The above analysis and well as the mode of collapse apparent in the figures above indicates that the masonry may have played a major role in the collapse of the structure in question. However this conclusion is based solely on observational analysis and would need further analysis in order to verify these assessments.

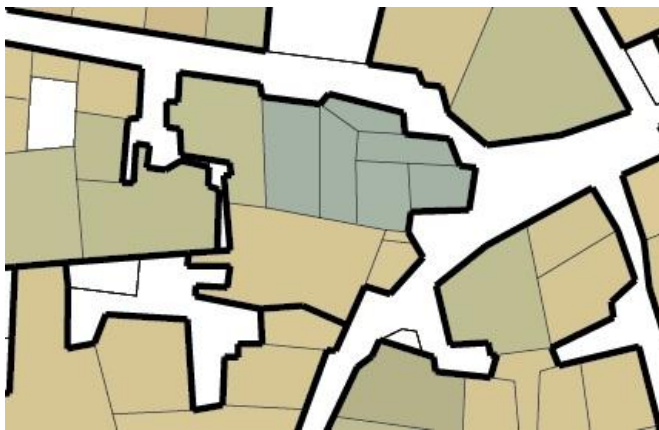
Figure 5.40 Collective Homogeneity Analysis

The first example of collective structural homogeneity of Villa Santa Lucia degli Abruzzi is found within the center of the village. The example is the entirety of aggregate VSL 010. The aggregate is composed of nine structures, all of which are privately owned and one that is currently inhabited. In addition, the aggregate is irregular in plan. The aggregate is fairly regular in elevation as seen in figure 5.43. There is no case within the aggregate where two adjacent structures differ in height by more than a single story. All of the buildings within the aggregate are typical aggregate houses. The structural factor that makes this aggregate a negative example of structural homogeneity is the orientation of the buildings to the elevation curves. As is seen in figure 5.42, the Northern

the aggregate to function as two separate units in the case of a seismic event. This can lead to several potential collapse mechanisms such as torsion within the individual aggregate, hammering between the structures and out of plane wall overturning as well. In order to minimize these effects, extensive connections

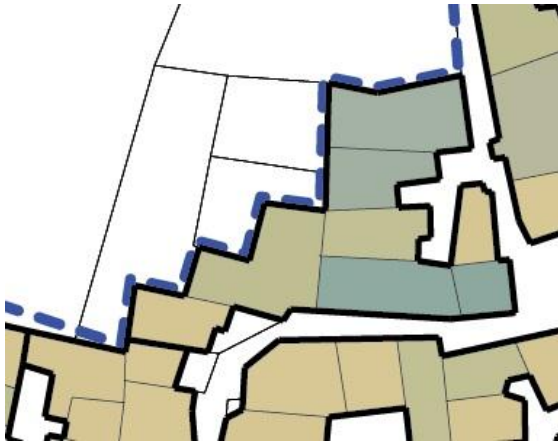
Figure 5.47 Collective Homogeneity Analysis

houses. However their orientation to the elevation curves vary throughout the aggregate. Unlike in the previous example, the aggregates oriented perpendicular to the elevation curves are not grouped together as a single unit, but instead are placed throughout the aggregate. This increases the likeliness of several collapse mechanisms, which can occur in

several locations in the aggregate. These potential collapse mechanisms include torsion, out of wall overturning and hammering. These potential damages are also magnified by the lack of homogeneity

in both the building heights and masonry typologies present. The building heights within the aggregate are variable and in some occasions adjacent structures differ in height by more than two stories. Finally one third of the aggregate is revealed to be masonry typology one while the remainder of the buildings within the aggregate are indistinguishable due to a plaster cover. The location of this revealed section implies additions to the original structure that occurred after the initial construction of the village, however this is solely conjecture. Overall this particular aggregate is extremely inhomogeneous and therefore very vulnerable in the case of a seismic event. Therefore this aggregate will be further analyzed and evaluated in section 5.15; the vulnerability conclusion.

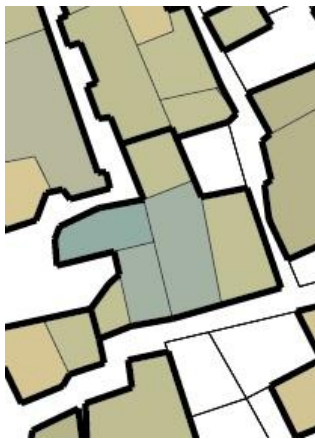
Figure 5.54 Homogeneity

privately owned and currently uninhabited. In addition, two of the six structures have been deemed uninhabitable after the post 2009 L’Aquila earthquake assessment of the village. The aggregate is irregular in plan as well as in elevation. As seen in the Collective homogeneity analysis, in figure 5.54, the aggregate has a fairly homogeneous central core with several extremities that differ structurally from that core. All of the units within the aggregate are typical aggregate houses, however this core is

oriented perpendicular to the elevation curves while the remainder of the aggregate is oriented parallel to the elevation curves. This extremely important to note because this creates fulcrum points

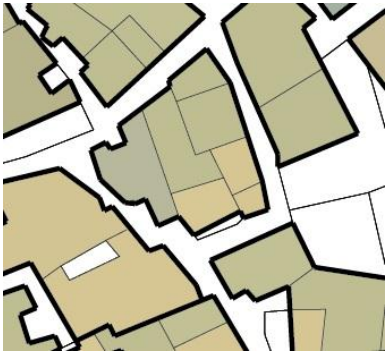
5.61 Collective Homogeneity

aggregate. In the six structures there are three masonry typologies present. These include masonry typology, masonry typology two and structures whose structure cannot be distinguished due to a plaster cover. The presence of a plaster covering on a select few units implies a recent renovation of the aggregate that was not completed on the entire aggregate or structures added to the

aggregate after the initial construction of the village. This lack of homogeneous does not allow the aggregate to function as a single unit in the case of a seismic event and therefore increases the

possibility of several potential collapse mechanisms such as hammering. These mechanisms can be minimized through the addition of permanent structural interventions that aid in connecting the separate masonry typologies through the use of tie rods or similar interventions.

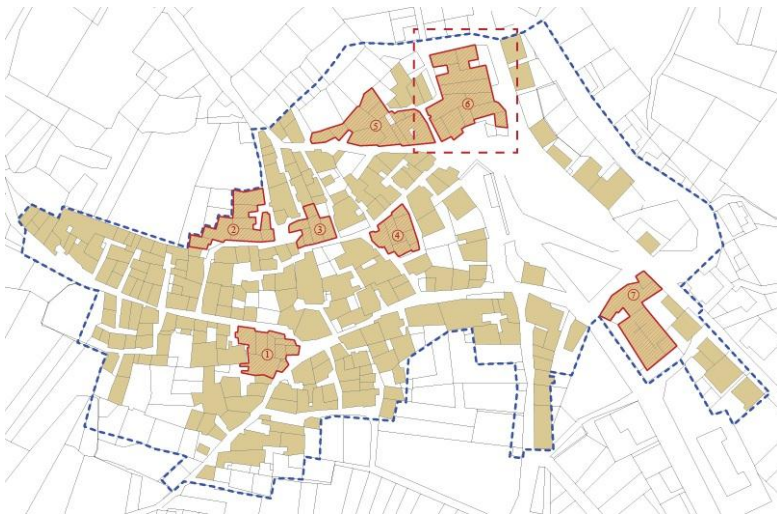
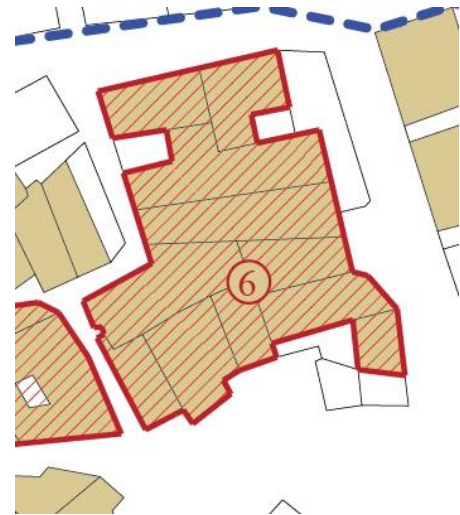
Figure 5.73 Aggregate within Villa Santa Lucia degli Abruzzi

them are currently inhabited and two have been categorized as uninhabited following the post seismic damage assessment. The aggregate is irregular in both plan and elevation. It is also one of the more negative examples to be presented in this section. All of the units within the aggregate have been categorized as typical aggregate houses. However these houses differ in their orientation to the elevation curves. The aggregate is separated into two sections. The

Southern most five aggregates are oriented perpendicular to the elevation curves. The remainder of the aggregates, in the Central and Northern sections of the aggregate, are oriented parallel to the elevation curves. This is extremely important because of the potential collapse mechanisms related to

differing orientations in a single aggregate. Regarding building heights, the aggregate is fairly homogeneous, however there is one case where adjacent structures differ in height by more than two stories. The connection point between these two structures is therefore extremely vulnerable to collapse and should be substantially reinforced in order to avoid damages. This is especially the case because of the high number of inhabited units within the aggregate. Finally the masonry typology consists of either masonry typology one or plaster covered structures. Due to the plaster covering on many of the structures, it is impossible to determine their masonry structure and therefore their potential vulnerability due to the masonry typologies. However it is important to note that a plaster covering generally implies recent renovations or interventions, which were therefore not completed on the entire aggregate. This can lead to an increased lack of homogeneity within the aggregate, leading to further potential collapse mechanisms.

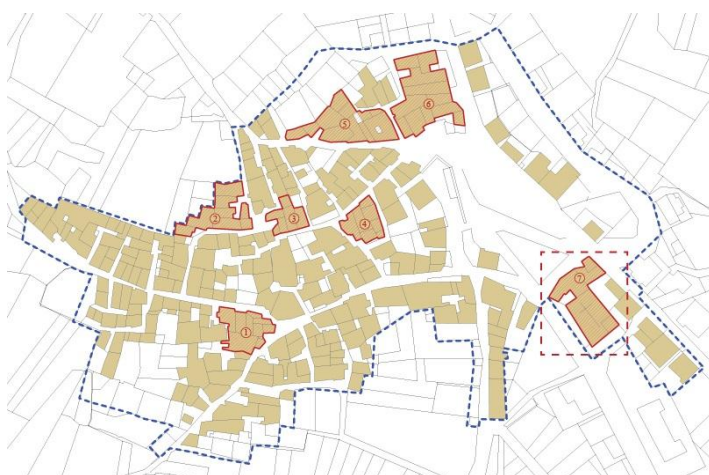
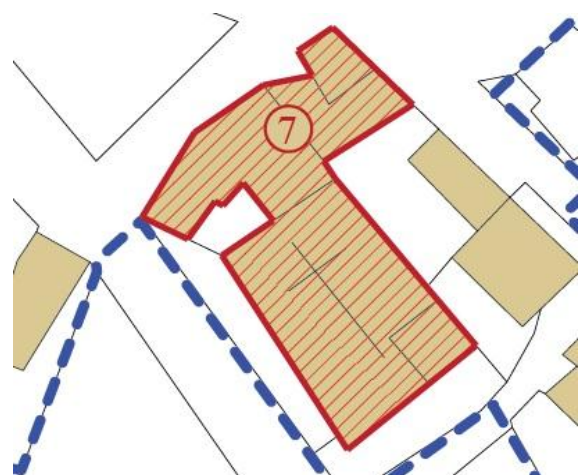
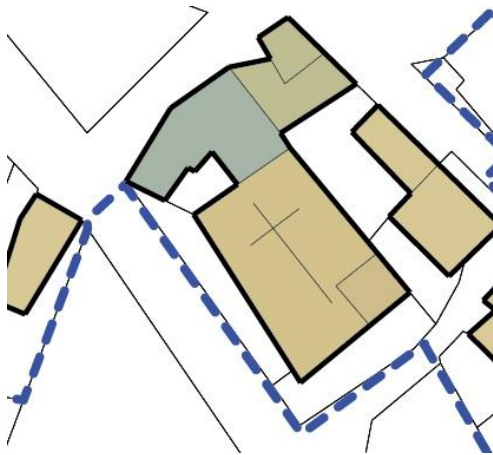
Figure 5.82 *Collective Homogeneity*

The seventh and final negative example of collective structural homogeneity within Villa Santa Lucia degli Abruzzi is located in aggregate VSL 012. This aggregate is located in the very core of the historical center and is extremely important due to the presence of the only church of the village. The aggregate is composed of five structures. One of these units is of public use and all of them are currently uninhabited. As seen in the collective homogeneity analysis, seen in figure 5.82,

the aggregate is split into three separate sections and therefore lacks collective homogeneity within

the aggregate. Three of the four buildings have been categorized as being typical aggregate houses.

The remaining structure is a church or religious structure.

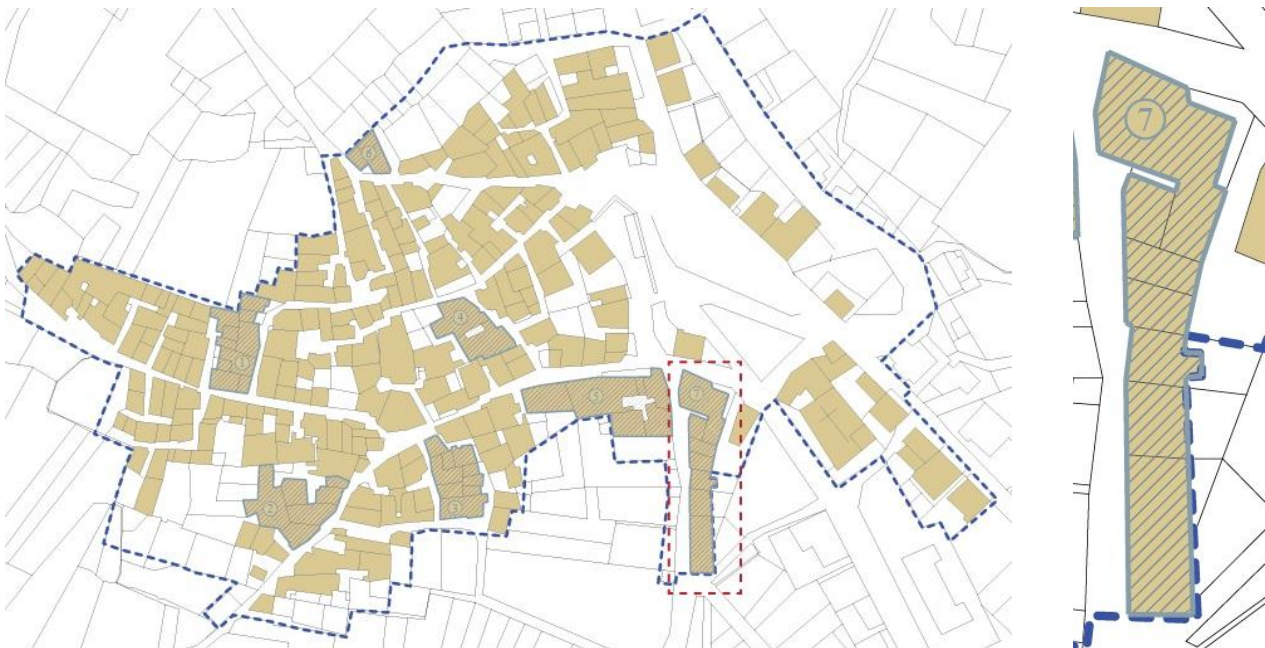
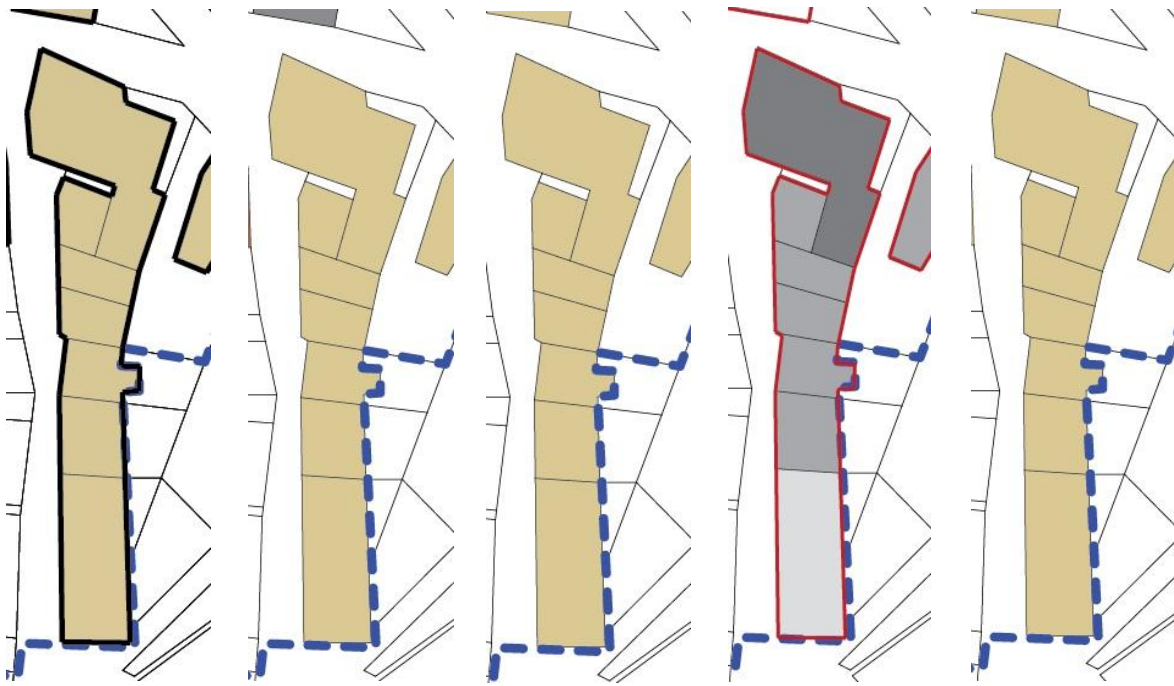
Figure 5.87 Aggregate within Villa Santa Lucia degli Abruzzi

This particular aggregate is composed of seven units, all of which are privately owned, one of which has been deemed uninhabitable and one that is currently inhabited. The aggregate is extremely regular in both plan and elevation. It is important to note that this aggregate appears to have been constructed at the same time as the original village although that must be verified. As seen in the collective homogeneity analysis in figure 5.89, the aggregate is one of the most homogeneous of the aggregates within the village. All of the units within the aggregate have been categorized as typical aggregate houses. In addition all of the structures within the aggregate are oriented parallel to the elevation curves. This characteristic of the aggregate is crucial considering the amount of potential

collapse mechanisms that are related to irregularity of orientation to the elevation curves in a single aggregate. The main point of irregularity within the aggregate is from the building heights. The building height's follow the topography, but in no case do adjacent units differ in height by more than a single story. Finally the entire aggregate, regarding the masonry typology, is plaster covered. While it is impossible to properly determine the vulnerability of the structure regarding the masonry typology due to this plaster cover, it is important to note that all of the units within the aggregate have the cover. This implies a recent restorative effort that took all of the buildings within the aggregate into account, which is essential when attempting to maintain structural homogeneity within an aggregate. Overall this aggregate is a good model for future restorative efforts to be performed within the village that hope to keep structural homogeneity a primary goal

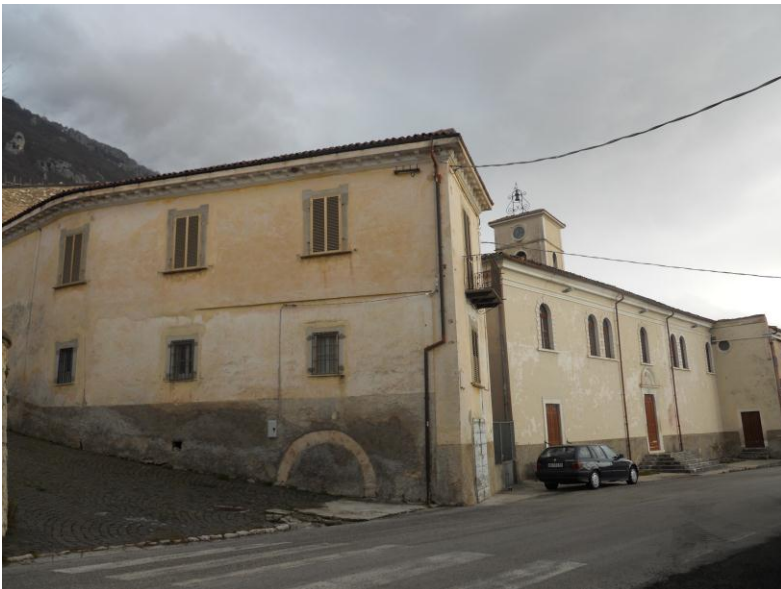
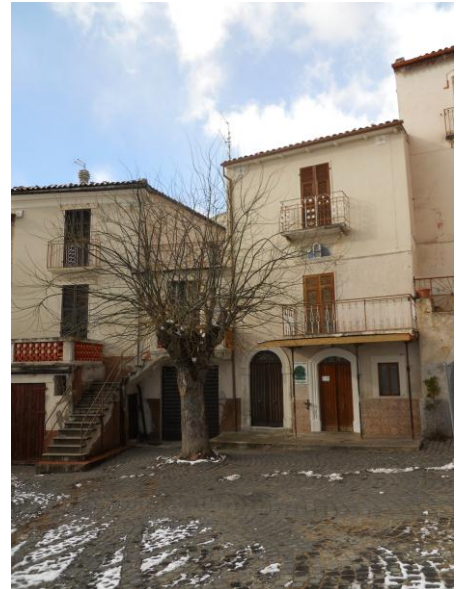
Figure 5.96 Positive Openings

There are two positive examples of openings to be discussed that are found in Villa Santa Lucia degli Abruzzi. These examples are found in the church aggregate and the aggregate VSL 003.

In both of these cases, the openings are properly placed apart and are aligned into vertical columns which minimize the area of influence of the openings on the masonry structure. These are the ideal placements of openings within a structure in order to minimize the negative effects of punctures.

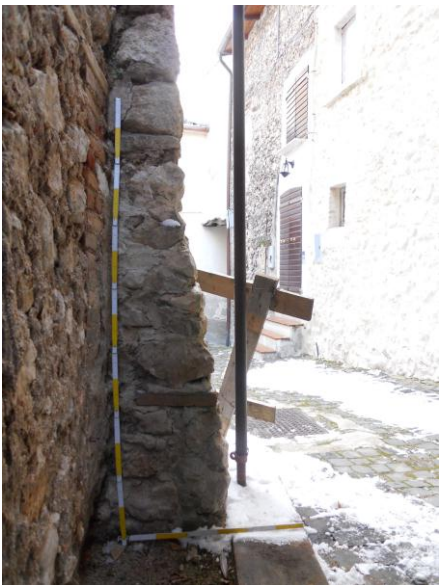
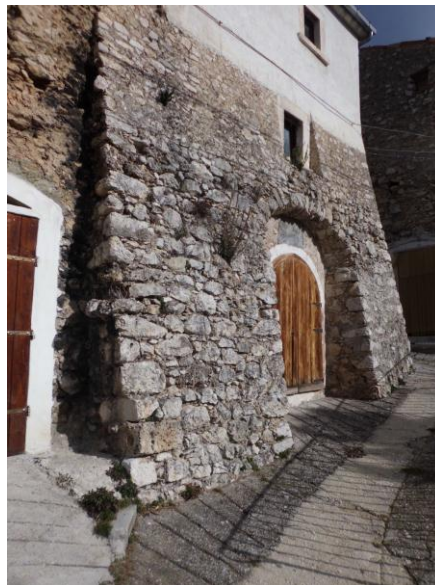
within the village with buttresses in place, approximately 21 buildings. As seen in figures 5.98 and 5.99, there are two different typologies of buttresses present within Villa Santa Lucia degli Abruzzi. The first typology is a partial buttress that only partially covers the height of the wall being supported. Typically this typology of buttress was not present in the original construction, but

instead was added later due to the need for additional structural support. The second typology however, the complete buttress, spans the height of the wall being supported. The example, as seen in figure 5.99, is located in the heart of the historical center and was therefore presumably a part of the original construction of the village. This is typically the case for complete buttresses. It is also important to note that due to the size of the buttress structure and the narrow streets within the historical center of Villa Santa Lucia degli Abruzzi, in many conditions, the addition of a complete buttress is impossible after the initial construction. In this case, either tie rods can be utilized or partial buttresses, if the space allows for such a structural addition.

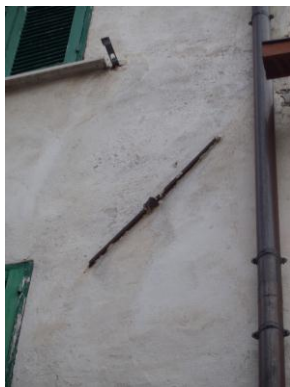
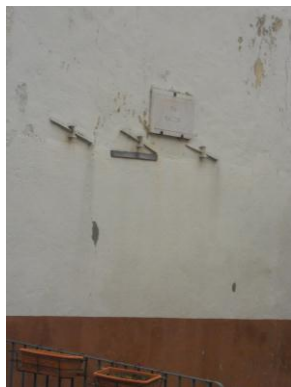
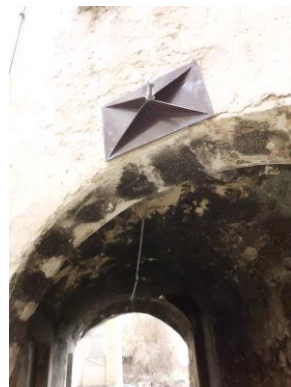
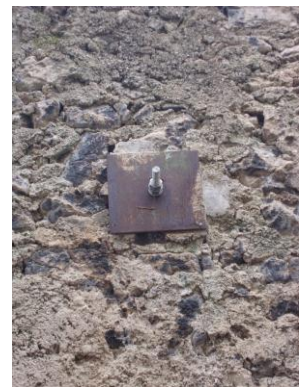
tie rods, the first being a bar tie rods, as seen in figure 5.100 and 5.101. The second category is plate tie rods, as seen in figures 5.102 and 5.103. In general, plate tie rods can be considered less damaging to the surface of the structure, while bar tie rods have a tendency to puncture the surface, although this is only the case in rare occasions. Tie rods are extremely efficient strengthening tools in seismic areas, however their placement must be considered thoroughly. In general, both the placement and implementation of tie rods, within Villa Santa Lucia degli Abruzzi as well as other villages within the Baronia collective, are efficient. There is a clear history of construction knowledge specific to masonry within seismically active historical centers.

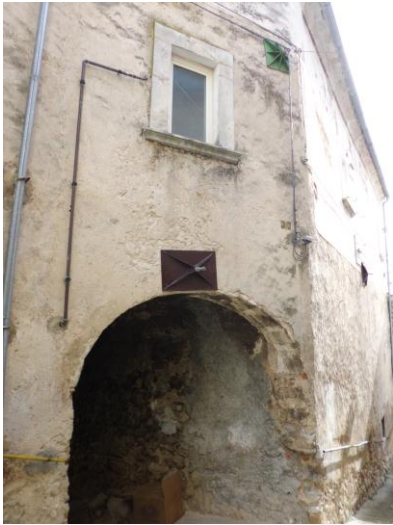
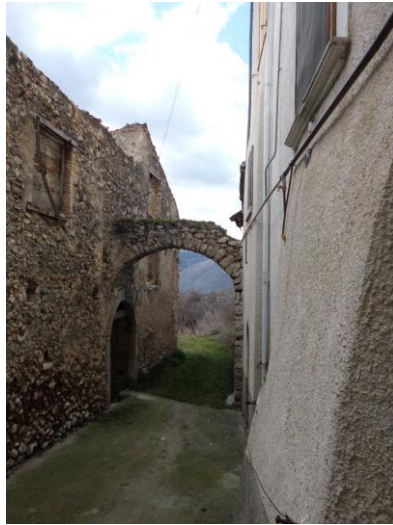
separating two adjacent structures in the case of a seismic event. This separation can deter the occurrence of the hammering between the two structures. It is important to note that high density “sporti” can create minor structural damages to the attached façade, or collapse on

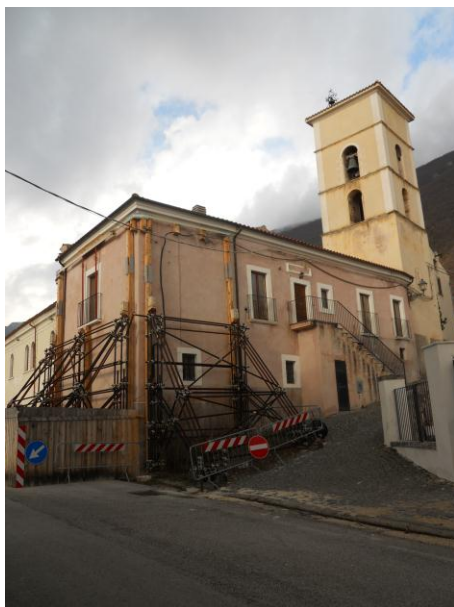
Figure 5.106 Wall Prop Intervention

The first typology of temporary structural interventions to be discussed, present in Villa Santa Lucia degli Abruzzi, is that of the traditional prop intervention, which is an extremely common temporary intervention, specifically in the region of Abruzzo. The first and only example of this typology to be discussed is located in aggregate VSL 012. The example to be discussed is located on the only church within the village. Traditional prop interventions aim at preventing one of the most common potential collapse mechanisms; out of plane wall overturning. This particular collapse

mechanism is common in churches due to their typically irregular facades and building heights within a single aggregate. This particular example is fairly efficient, with the aim of better supporting two of the façade walls. However the intervention touches the façade at only four separate points, although the wooden beams allow for better distribution of the stress.

traditional prop intervention is a good example for temporary structural interventions. It is important to note that this intervention should be seen as only a temporary intervention and permanent interventions should be implemented as soon as possible in order to prevent further damage or collapses.

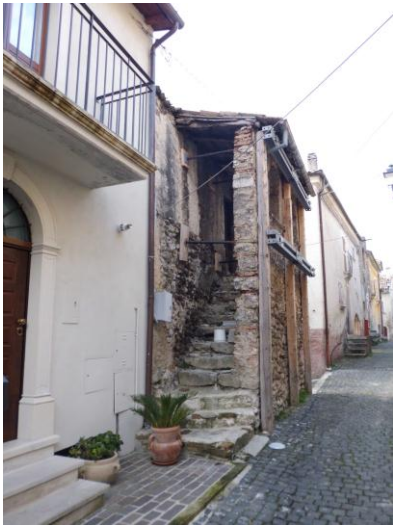
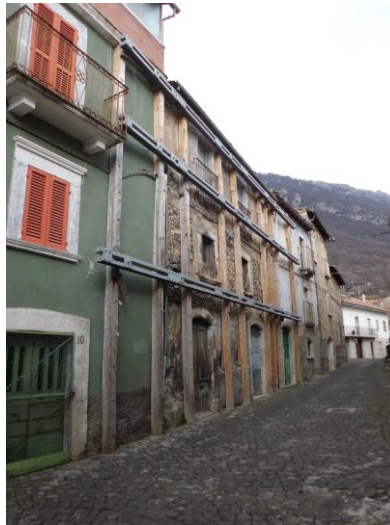
of temporary intervention are located in aggregates VSL 002 and VSL 013-B. Both of these examples are located within the core of the historical center of the village. In both cases, steel and wood compose the intervention.

Similar to the traditional wall prop intervention, this typology of intervention aids in minimizing the effects of the collapse mechanisms of out of plane wall overturning. This typology however is typically placed on the façade of the structure facing the narrow street way and never on the sides. Due to the use of steel instead of wood, the intervention has the propensity to last longer, however these temporary interventions will still eventually need to be replaced with permanent structural interventions that prohibit the possible collapse mechanisms of the façade. In both cases, the interventions present are of high quality and have little effect on the existing structural dynamics of the surface due to distribution of the stresses put on the façade by the connections to the intervention. These can both be considered to be efficient temporary structural interventions, however these conjectures would have to be verified through further analysis on-site.

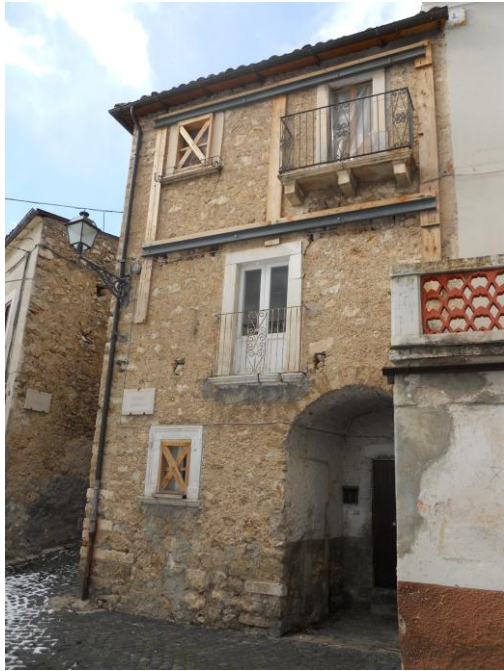
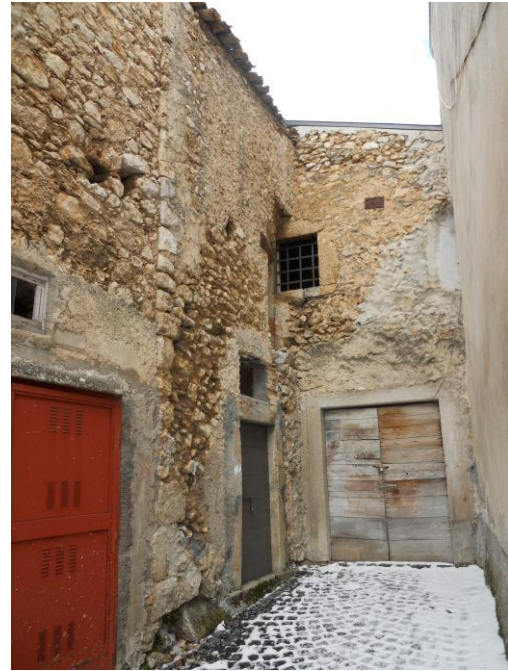
Figure 5.109 Aggregate VSL 004

The first example of one of the more vulnerable aggregates is found in the heart of the historic center, near the San Marco church, specifically in aggregate VSL 004. This example, as all

regarding its collective homogeneity. As seen in the models above, the aggregate is extremely irregular regarding the building heights and masonry typology composition. There were also damages in the aggregate after the 2009 L'Aquila seismic event and not all of the structures within the aggregate have permanent structural interventions in place. As seen in both figures 5.109 and 5.110, there is also irregularity in both additions to the structures as well as openings. Openings have been placed too close to structural elements such as the roof or corners. This is especially the case in figure 5.110, where an opening is located directly in the corner, compromising the structural integrity of both structural involved. Also additions, such as balconies have been added as cantilevers to the original structure which is extremely vulnerable to collapse in the case of a seismic event due to the uneven mass distribution. It is also important to note the extreme changes of the aggregate over time, with elements of different masonry composition, has contributed to the determination of this particular aggregate as a high priority level. Regarding a future for this aggregate, there are several restoration options available. First and foremost, additional permanent and temporary structural interventions need to be added to better control the reactions between the irregular units within the aggregate. These interventions should specifically be placed in vulnerable areas such as fulcrum point and where there are vulnerable openings. In addition, any damages sustained during the most recent seismic event of 2009 need to be thoroughly analyzed and resolved to better protect the inhabitants of the aggregate.

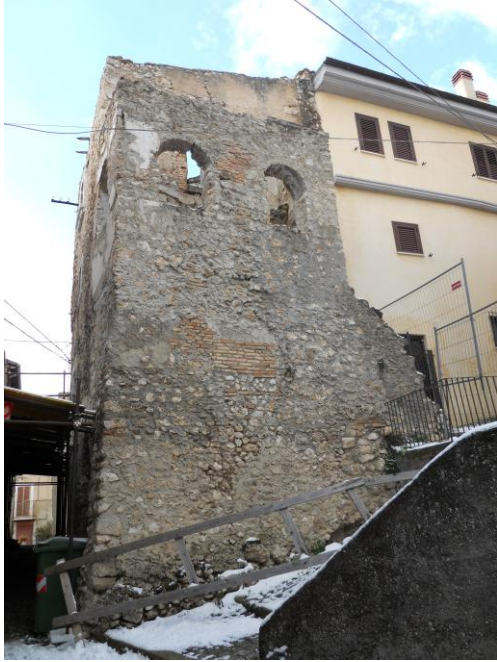
Figure 5.113 Aggregate VSL 020-B

The second example of a high priority structure is found in the historical center, specifically in aggregate VSL 020-B. This example has been previously discussed as one of the negative examples within Villa Santa Lucia. This aggregate has been chosen for several reasons, the first of which is that one of the eight structures within the aggregate is currently inhabited. In addition, as previously mentioned, the aggregate has been considered to be negative regarding its overall collective homogeneity. This particular aggregate is extremely irregular in both masonry typology composition and the building heights of the individual units within the aggregate. The aggregate is also irregular in

place. As seen in figure 5.113, several masonry restorations have taken place that failed to respect the existing masonry composition. Regarding a future for this aggregate, there are several restoration options available. Additional permanent and temporary structural interventions need to be added to better control the reactions between the irregular units within the aggregate. These interventions should specifically be placed in vulnerable areas such as fulcrum points between two attached structures of different heights. In addition, any damages sustained during the most recent seismic event of 2009 need to be thoroughly analyzed and resolved to better protect the inhabitants of the aggregate. Also previously ruined buildings need to be better controlled to avoid more damages.

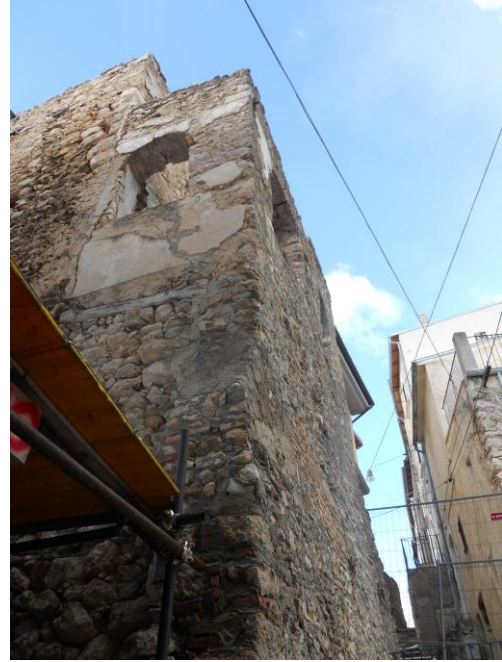
Figure 5.114 Aggregate VSL 020-B

both plan and elevation. There were also damages in the aggregate after the 2009 L'Aquila seismic event and not all of the structures within the aggregate have permanent structural interventions in
