**A PROPOSAL FOR THE RESTORATION AND THE
REUSE OF THE DISMISSED POWER PLANT OF EDİRNE,
TURKEY**

ÖZGE NOYAN matt. 764300

(M.Sc. Thesis)

July 2013

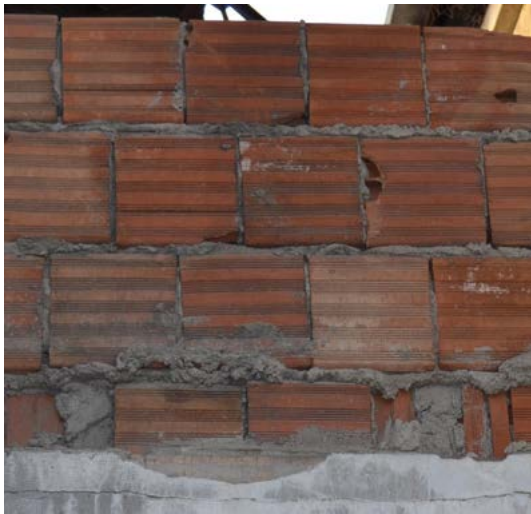
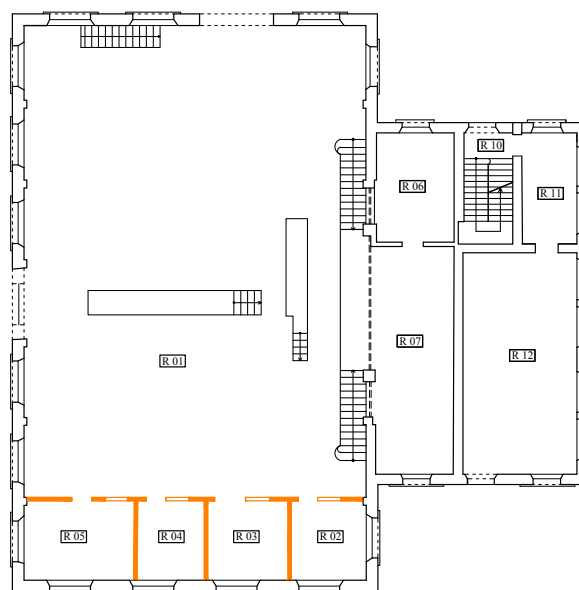
GROUND FLOOR

LOCATION: The room R02, R03, R04 and R05 are constructed with the hollow bricks.

DESCRIPTION: The hollow red brick wall was constructed later. It is a different type of brick. The four rooms were built with perforated brick. It is not a bearing wall. It was built for partition wall. The dimension of the hollow brick; stretcher is 29 cm, header is 19 cm and height is 13,5 cm.

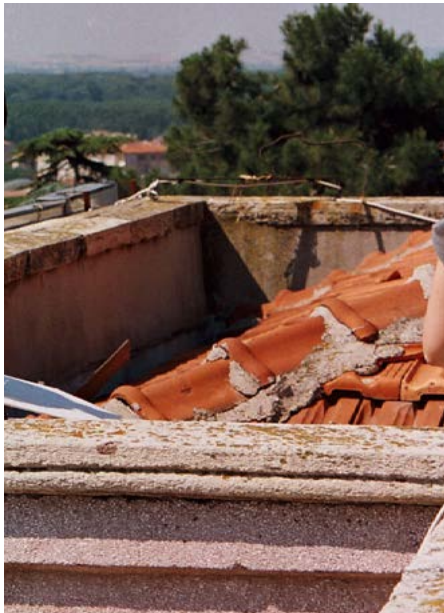
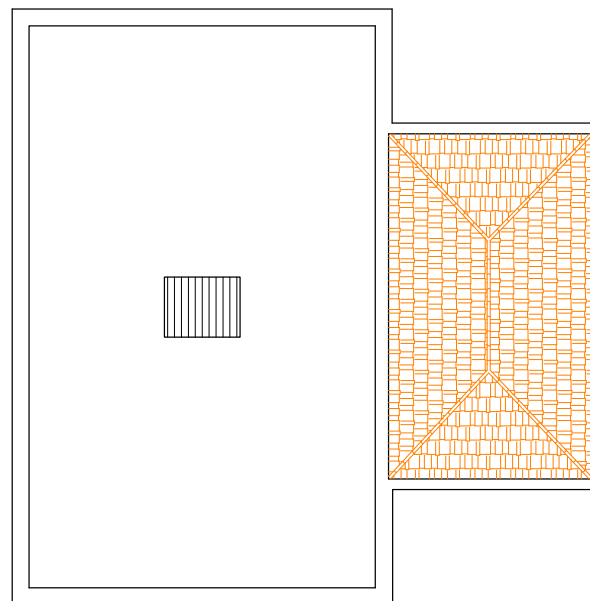
ROOF PLAN

LOCATION: The roof tiles are on the top of the building which is located to northwest direction is constructed by red brick roof tiles.

DESCRIPTION: The gable roof and the ridge are red tile brick. The tile starts from the ridge to finished gutter. It is Marseille type brick. The dimension of roof tile is 23 cm x 41 cm.

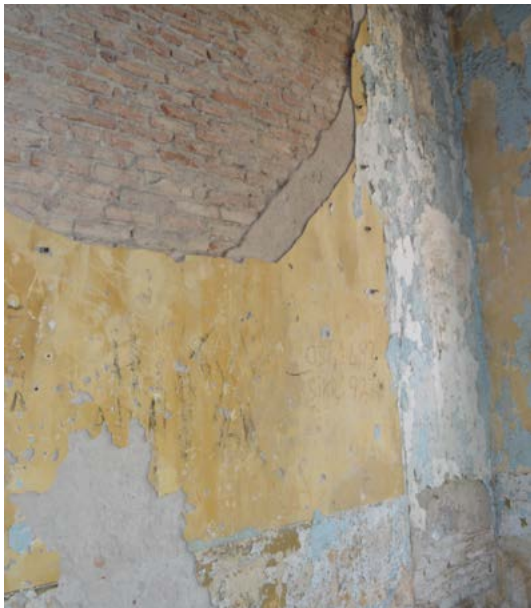
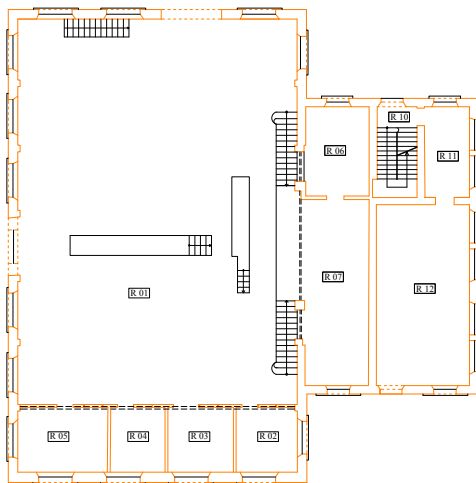
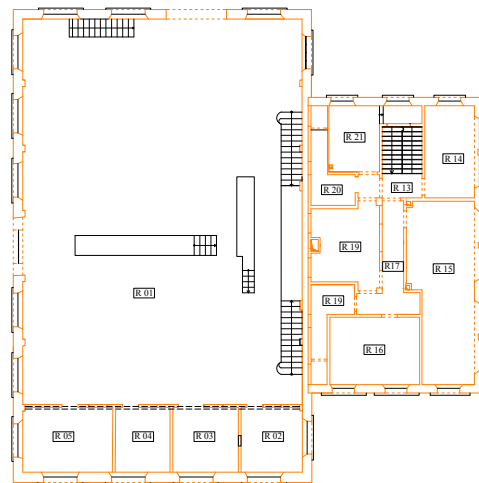
LOCATION: Paints are visible to the interior and exterior facade of the building with different colour.

DESCRIPTION: Interior and exterior original colour of the building is yellow. However, some part is paint white, blue, green and grey. Generally, bellow the window was paint with grey colour.

The roughcast plaster ,which is located exterior facade, is paint bordeaux.

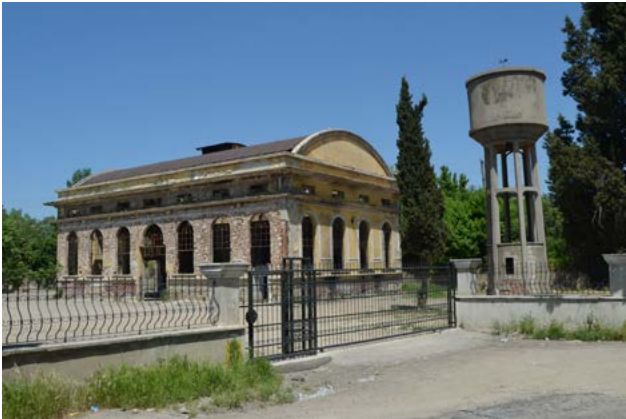
Picture 4.1

The access to the garden is only possible through the garden gate at the southeast of the lot. The gate opening width is 8.70 meter and the height of the garden wall is 2.25 meter. The garden concrete wall is up to 1.10 meter from the ground. After 110 cm fence is covered with concrete, the 90 cm iron fence has been settled on the concrete wall. (see *Picture 4.1*)

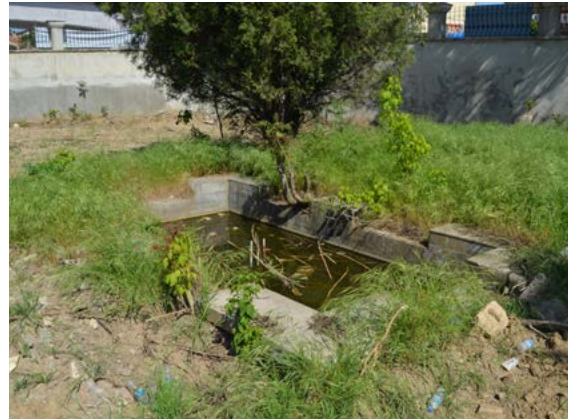
Picture 4.2 Pool

In the garden, the Power Plant is located at the northeast of the lot. A water reservoir constructed in concrete is located at the southeast of the lot. Next to the water reservoir, there is a small pool. Originally, water was obtained from this pool, and stored in the reservoir. (see *Picture 4.2*)

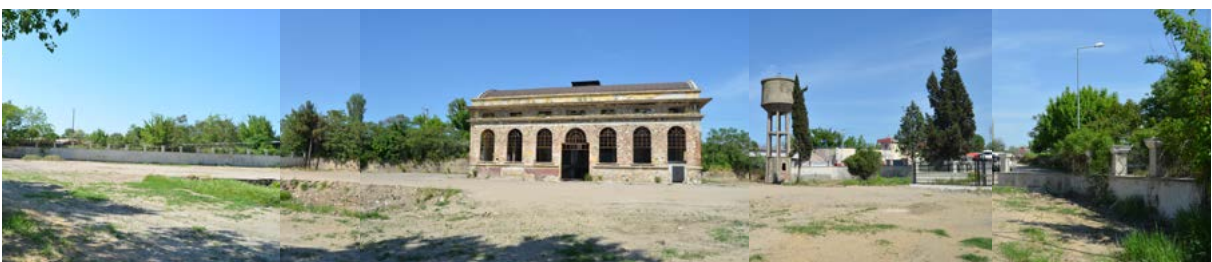
Picture 4.3

According to the Edirne Protection District Board, the garden of the Power Plant and the surrounding area are registered as the Tatarhaniler Cemetery. Some tombstones which have been excavated in the garden are still visible next to the Power Plant. (see *Picture 4.3*)

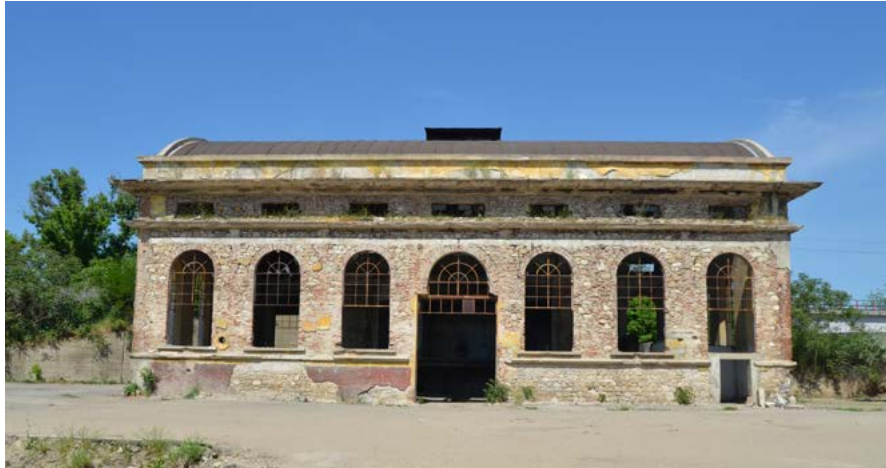
Picture 4.4

In the facade, there are six rounded arch windows (180 x 380 cm): three on each side of the central door. Above the arched windows there are rectangular windows (150 x 50 cm) above the rectangular windows, the another eaves returns throughout the building. The roof is vaulted. The ventilation on the roof is in the central axis. (see Picture 4.4)

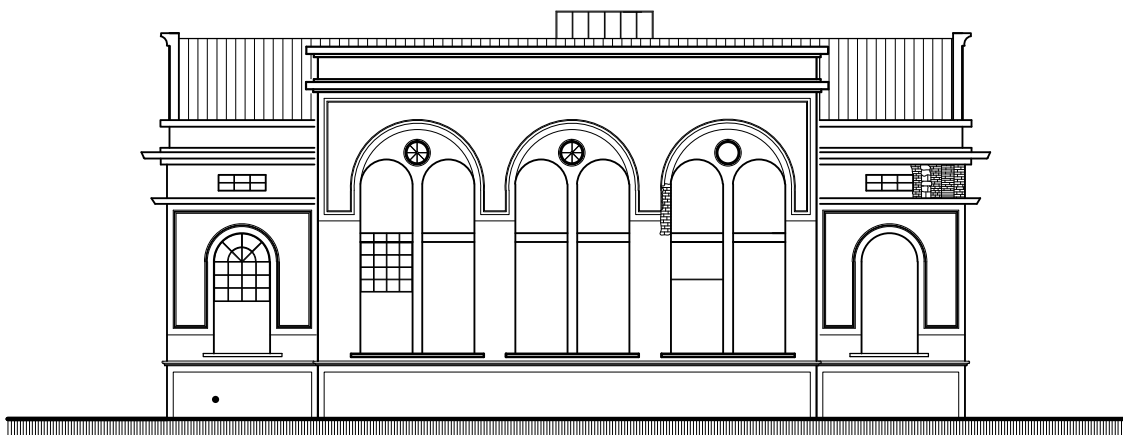
Drawing 4.1

The Atelier Building facade has two rounded-arch windows and two rectangular windows on the each side of the facade. The roof is barrel vault. (see *Drawing 4.1 and Picture 4.6*) Water out pipe appears on the right side of the facade. (see *Picture 4.7*)

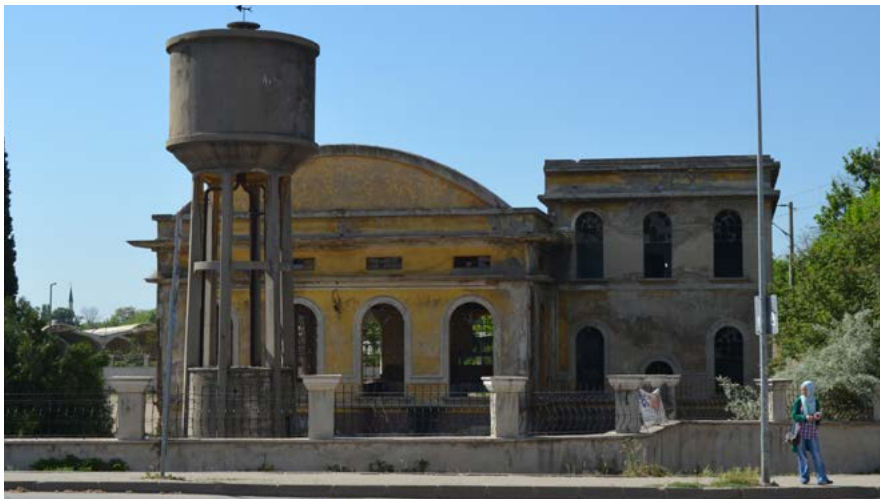
Picture 4.8

The Atelier Building, as the other facades, has four rounded-arch windows (180 x 380 cm) and above the cornice rounded-arch windows after the has rectangular windows (150 x 50 cm) and above the rectangular window the eaves returns throughout the building. This eaves are used as gutter. Above the eaves, there is the vaulted roof. Both Atelier and Administration Buildings' arched windows are surrounded by frame. (see Picture 4.8)

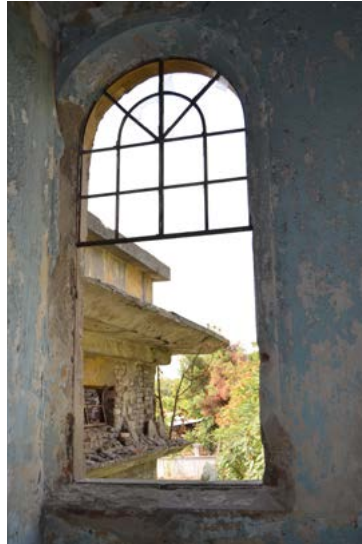
Picture 4.8

While the doors' frame, windows' frame and balusters of staircases had been removed, some doors and windows border and staircases were damaged. (*see Picture 4.7, 4.8, 4.9, 4.10*)

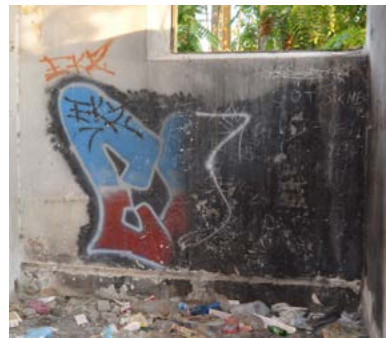
Picture 4.11

Some walls have graffiti because of vandals. (see Picture 4.11) Fire is a major cause of damage. Vandals can intentionally or accidentally set the building on fire and burn it. It can cause lack of materials.(see Picture 4.12)

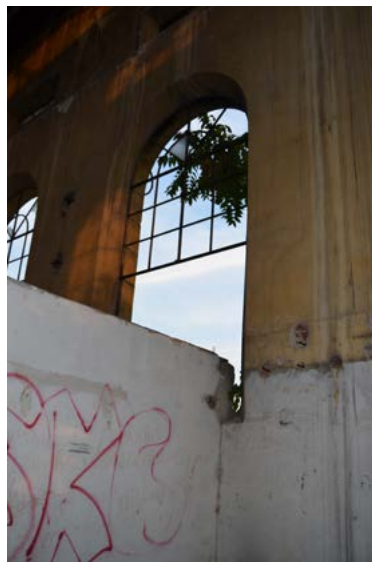
Picture 4.14

R02, R03, R04 and R05 rooms were constructed later. However, the rooms have been constructed inconvenience way. (see Picture 4.14)

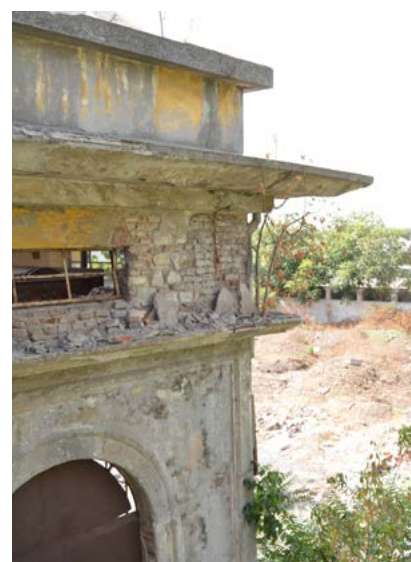
Picture 4.15

Vegetations are visible near the facade of the building and some plants have grown on the gutter. Roots of plants can go deep into the existing holes causing further cracks and water penetration. (*see Picture 4.15*)

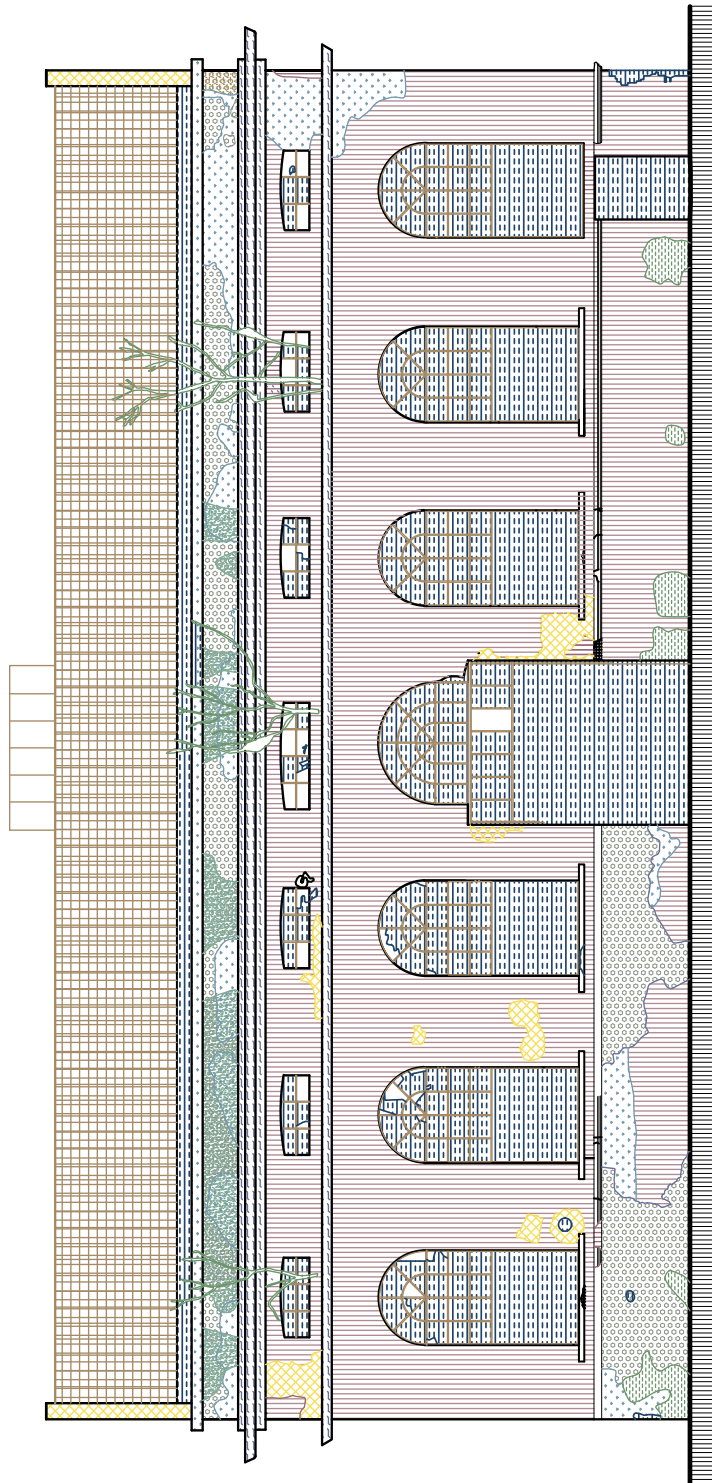
Loss of Materials: Materials that were at the construction of building but disappear with the affect of nature. All the South-west elevation plasters also the cornices of the windows were disappeared. Some plasters at the North-east elevation was damaged.
