RESTORATION OF ARISTIDES DE SOUSA MENDES HOUSE CABANAS DE VIRIATO, PORTUGAL

Master of Science Thesis from:
Carolina Luísa de Sá e Brito matt. 767291

(MASTER OF SCIENCE THESIS)

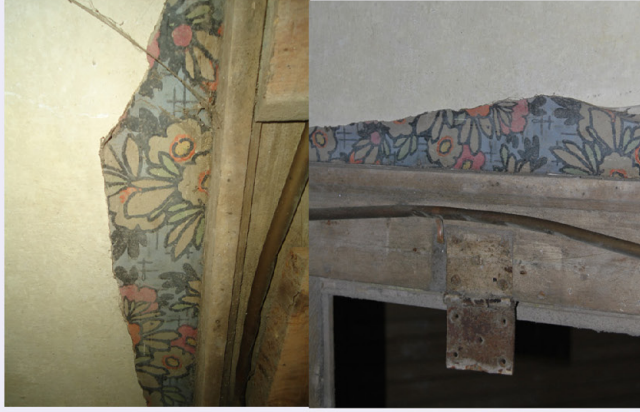
View from the two remaining pieces of the wallpaper left in the house.

The Wallpaper was part of the finishing layer of the Interior Walls. It was part of the decoration, changing the colours and patterns according with the decoration of the room. Today there is only two pieces remaining on R05 on the Ground Floor.

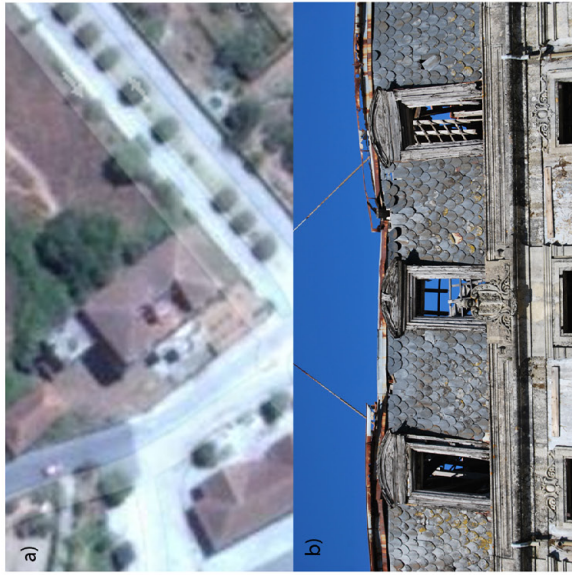
Figures: a) Top view from the roof. b) View from the ground-floor of the collapsed area.

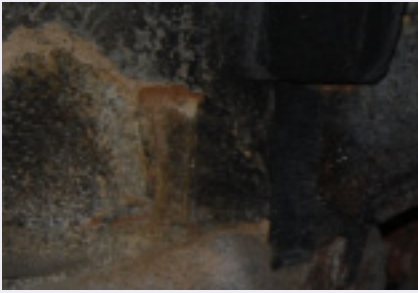
<p style="text-align: center;">ASHES DEPOSIT</p>

<p>Present on the oven's room, it is characterized by a superficial deposit of ashes on the walls, giving its black appearance.</p>
<p style="text-align: center;">MATERIAL DEPOSIT</p>
