Damage analysis of “Gazi Mihal Bey” case study bath structure:

Collapsed analysis of “Gazi Mihal Bey” case study bath structure:

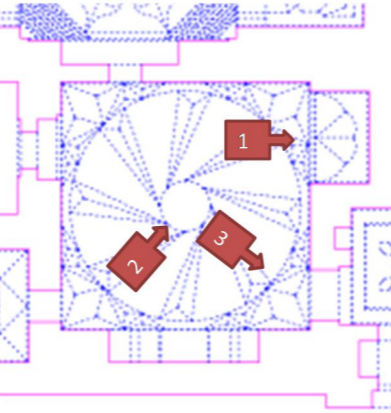
There is a consistency of masonry structure. The masonry stone pattern inside of the masonry cell is well constructed. Brick material is used for constructing the transition elements and the dome.	Fig: 1,2

Inside of "cell A" there are few cracks in front of the masonry wall surface. However the crack is shown in figure 1,2; is started from wall surface and continued to the dome structure.

In the Plane A B C		In detail cell "A"; squared stones with bricks were used. Leaves of the masonry were good bonded. Rows between stones were constructed regularly.	Fig: All

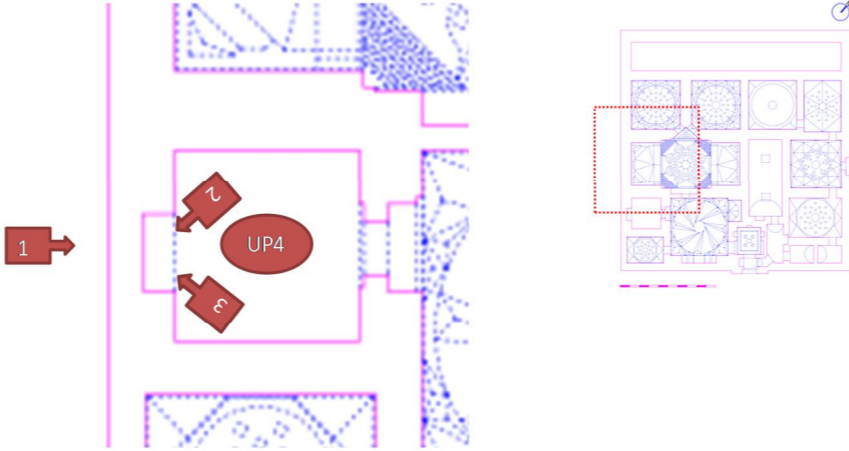
There is a consistency of the wall structure. Brick constructed as tie beams were used on the surface of the walls. Timber tie beams sockets are present inside of the wall construction. The domes and transitional elements were built with brick tiles. There is lighting holes on the top of the domes.	Fig: 1

In figure 1: The outside masonry of the "cell C" is deteriorated. Parts of the outer layer of the masonry is collapsed. In figure 2,3: Part of the wall of the masonry was broken down by users. The broke passage was given an idea of the wall section. Empty timber sockets, diatone stones are seen in these sections. In figure 4: Cracks on the domes are seen. Top of the dome the opening was damaged and some parts were collapsed.

Out of Plane A B C		In detail cell "C"; squared stones with bricks were used. Leaves of the masonry were good bonded. Rows between stones and bricks were constructed regularly.	Fig: 1,2,3

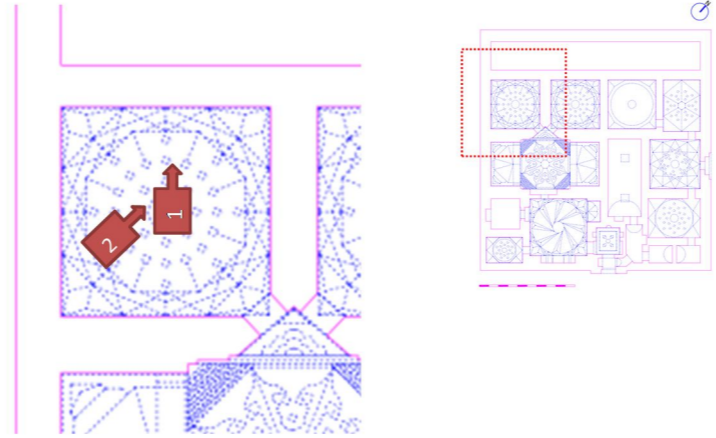
In figure 1,2: A crack start from the opening between the water tank area and the cell and it continues to the dome.
		Out of Plane A B C		Fig: All

In the Plane A B C	In detail cell "E"; squared stones with bricks were used. Leaves of the masonry were good bonded and rows between them were constructed regularly.

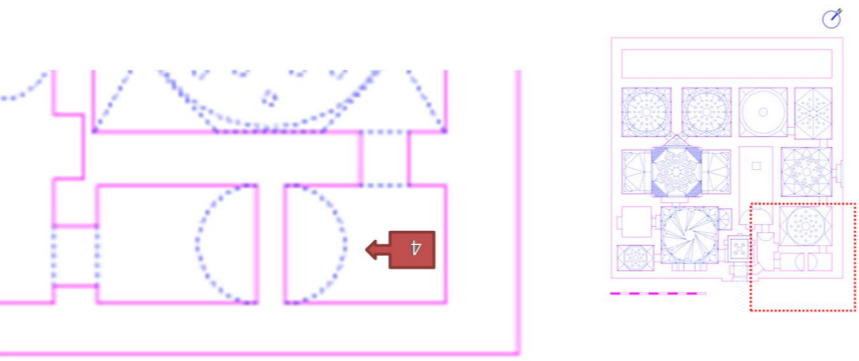
In the Plane A B C	In detail cell "K"; bricks were used. Stones were used as beams. Leaves of the masonry were good bonded and rows between them were constructed regularly.

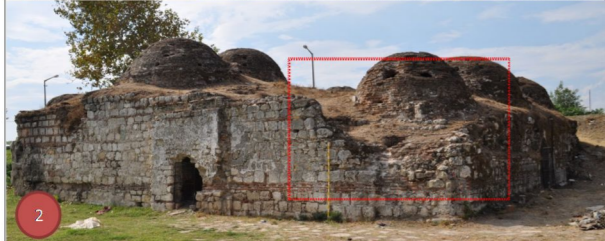
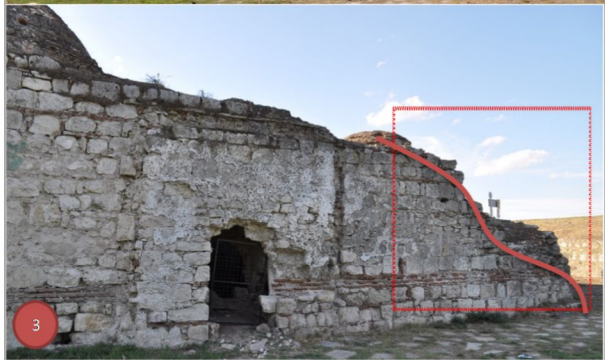
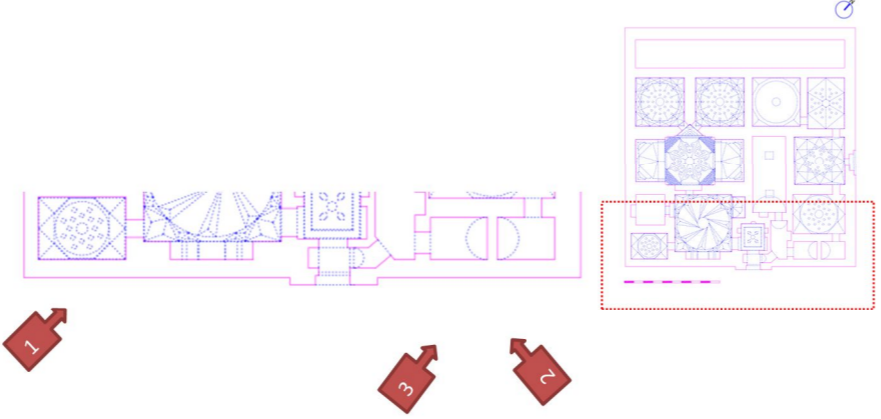
Table 7.36: Damage analysis of “Gazi Mihal Bey” case study bath structure, “Cell B, A, K” elevation

Vertical A B C	Qualitative methods of for evaluation is rated, "B" in vertical, "C" out of plane and "B" in plane actions. In detail cell "B,A,K" Elevation; squared stones with bricks were used. Leaves of the masonry were good bonded and rows between them were constructed regularly. However there is a deterioration on the elevatoin of the bath.	Fig: All

In figure 1: The structure was affected from the vertical actors. Corner of the wall is collapsed and after the previous consolidation works is repairs. It is easily seen on the picture form the different use of material. In figure 2,3: The other corner of the bath is collapsed in the same angle with the opposite corner. however it is not repaired.

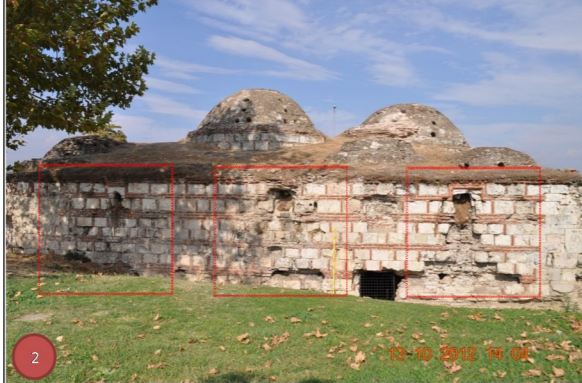
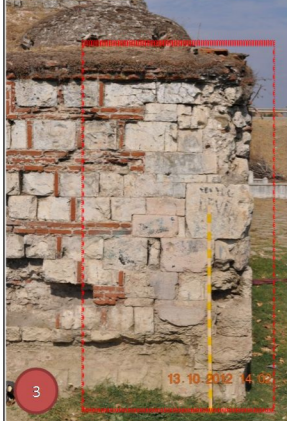
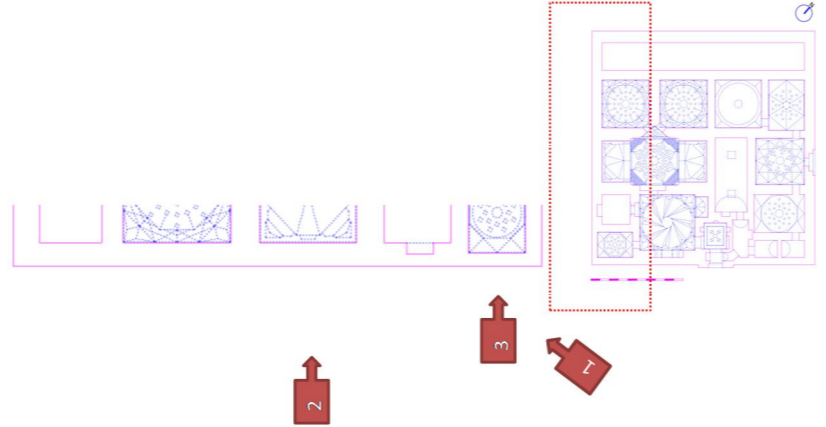
Table 7.37: Damage analysis of “Gazi Mihal Bey” case study bath structure, “Cell E, D, C, B” elevation

Vertical A B C	Qualitative methods of for evaluation is rated, "B" in vertical, "C" out of plane and "B" in plane actions. In detail cell "E, D, C, B" elevation; squared stones with bricks were used. Leaves of the masonry were good bonded and rows between them were constructed regularly. However there is a deterioration on the elevatoin of the bath.	Fig: All

In figure 1, 2, 3: On the elevaton of the structre, there is a deterioraton of the out layer of the masonry wall. Some parts of the wall were collapsed. The consistency of the brick layer is broken down. In figure 3: The collapsed corner of the masonry is seen. It was probably repaired in the previous consolidation works.

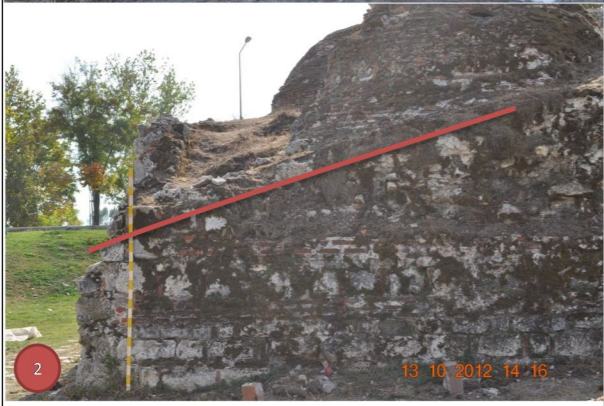
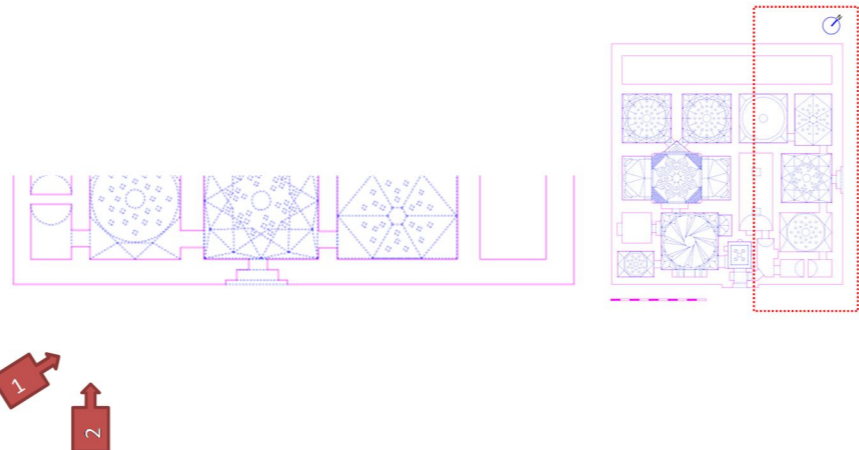
Table 7.38: Damage analysis of “Gazi Mihal Bey” case study bath structure, “Cell K, J, I, H” elevation

Vertical A B C	Qualitative methods of for evaluation is rated, "B" in vertical, "C" out of plane and "B" in plane actions. In detail cell "K, J, I, H" elevation; squared stones with bricks were used. Leaves of the masonry were good bonded and rows between them were constructed regularly. However there is a deterioration and vegetation on the elevatoin of the bath.	Fig: All

In figure 1, 2: There is a deterioration of the elevation. Vegetation is covered whole elevation. The corner of the structure was collapsed.
