Damage analysis of “Ke an” case study bath structure:  
 Table 7.47: Damage analysis of “Ke an” case study bath structure, “Cell A”

Table 7.48: Damage analysis of “Ke an” case study bath structure, “Cell B”

Table 7.49: Damage analysis of “Ke an” case study bath structure, “Cell C”

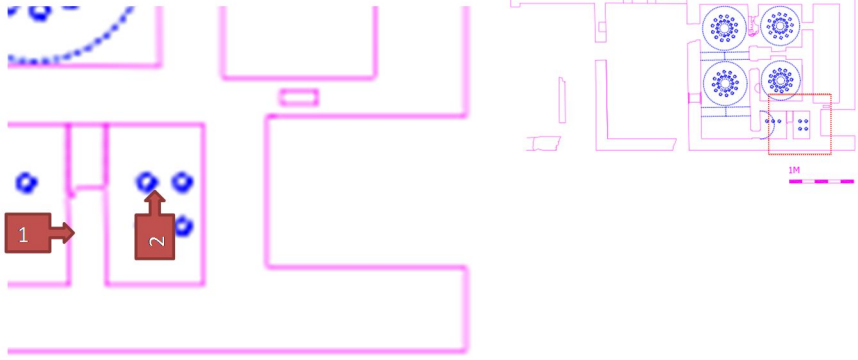
Vertical A B C	Qualitative methods of for evaluation is rated, "B" in vertical, "C" out of plane and "C" in plane actions.	Fig: 1	Fig: All		Between the masonry walls there is a consistency of the structure. However the partition wall and the structure do not any connecton. There is a deterioration of stone wall construction. The masonry walls of the structure is too wide. The dome and the transitional elements made up of brick material.	Fig: 1	Fig: 2	In figure 1: The masonry wall structure was partly collapsed. However it is not a load bearing wall of the structure. It is a partition wall. The arch and jamb of the walls are made up of brick material. In figure 2: The stone slab structure is partly collapsed. And it will affect the stability of the masonry walls.

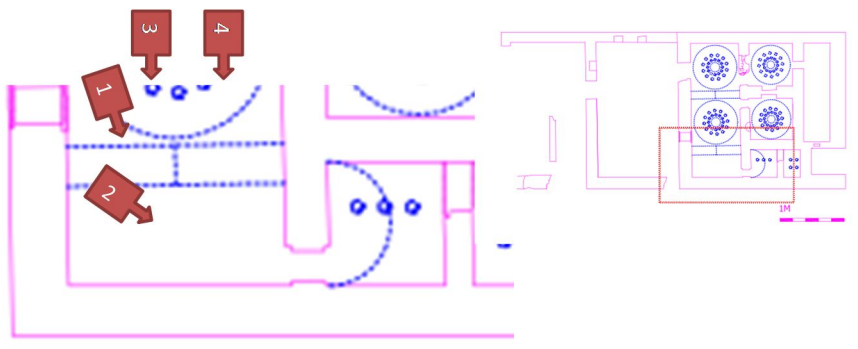
<p>Between the masonry walls there is a consistency of the structure. However the partition wall and the structure do not any connecton. There is a deterioration of stone wall construction. The masonry walls of the structure is too wide. The dome and the transitional elements made up of brick material.</p>	<p>Fig: 1</p>

<p>In figure 1: There is a crack between the wall and the vault. Interior walls of the masonry wall there are empty sockets for the piping system. In front of the wall the stone slab was broken down. The empty sockets and the broken slab affects the stability of the wall.</p>

<p>In the Plane</p> <p>A</p> <p>B</p> <p>(C)</p>									<p>In detail cell "B"; irregular shape and longitudinal stones were used. Leaves of the masonry were bonded with diatones. Rows between stones were constructed irregularly. But there is an intension to horizontal linearity.</p>

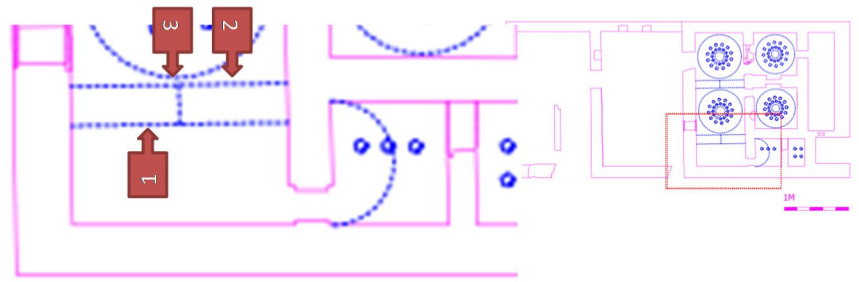
<p>Between the masonry walls there is a consistency of the structure. There is a deterioration of stone wall construction. The masonry walls of the structure is too wide. The dome and the transitional elements made up of brick material. Pointed arches are used in this structure.</p>	<p>Fig: 1,3</p>

<p>In figure 1: There is a crack on the top of arch element. This crack is started from the point arch to the perimeter of the dome. This crack is very tiny. On the masonry walls there are two big cracks which are probaby made by users. In figure 2: The crack is same in figure 1. On the top of the dome there is damages on the middle lantern part. In figure 3: On the elevaton of the wall there are cracks and empty sockets for the piping system. On the stone floor there are some parts is broken down.</p>

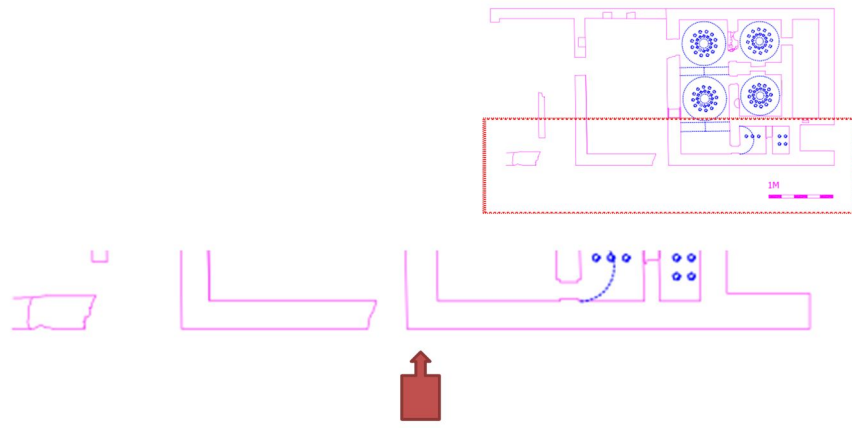
Table 7.51: Damage analysis of “Ke an” case study bath structure, “Cell C, B, E” elevation

Between the masonry walls there is a consistency of the structure. There is a deterioration of stone wall construction. The masonry walls of the structure is too wide. The dome and the transitional elements made up of brick material. Pointed arches are used in this structure.

In figure 1: There is a deterioration on the structure. Part of the vault structure was collapsed. The "C, B, A" elevation of the structure was deteriorated and the joints of the stones were delaminated.
