**POLITECNICO DI MILANO**

ABC **PhD** DOCTORAL PROGRAMME  
in ARCHITECTURE, BUILT ENVIRONMENT  
and CONSTRUCTION ENGINEERING

# SEISMIC VULNERABILITY OF CHURCHES: A TERRITORIAL KNOWLEDGE APPROACH

**Gessica  
Sferrazza Papa**

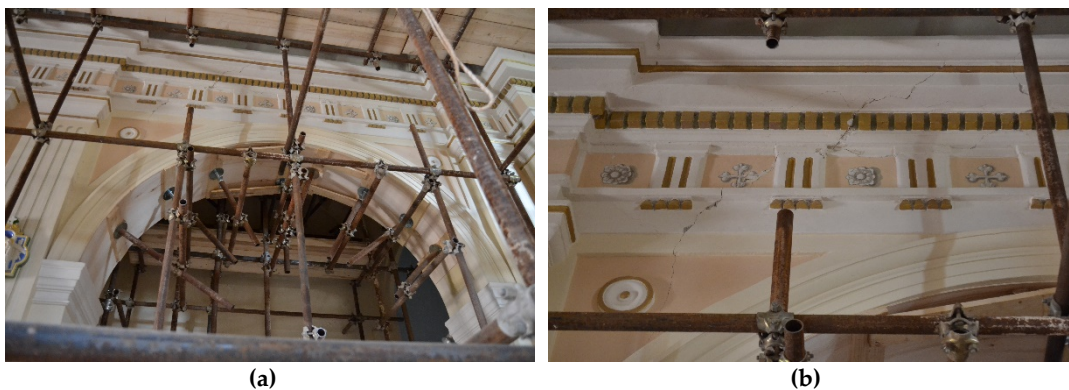
- *Vaults.* This structural and architectural element suffered damage both in the case of thin brick shells and in the case of ‘voussoir’ vault (see previous Figure 3- 5).
- *Colonnade.* When the church has more than one nave, the colonnade responds to the longitudinal loads; such response usually generates shear cracks at the level of the entablature when this element exists between the column and the vault level(Figure 3- 8).

**Figure 3- 8** Shear cracks in the entablature as longitudinal response of the colonnade: **a.** crack in the entablature of the colonnade; **b.** detail of the shear crack.

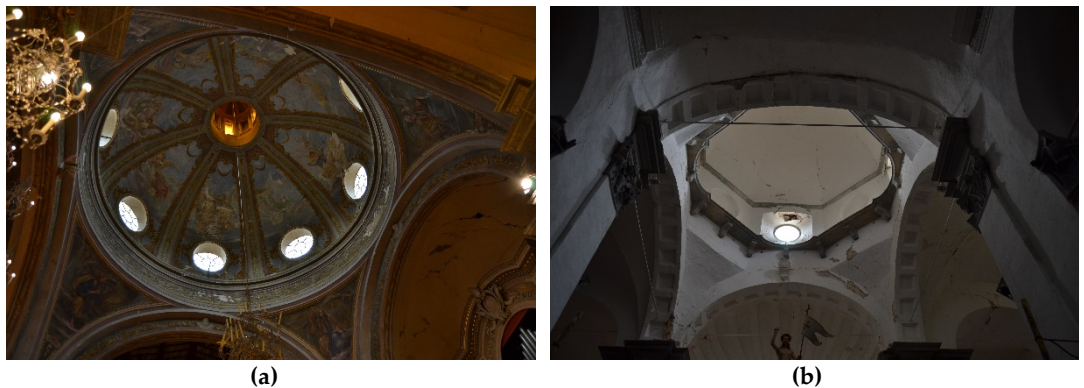
- *Dome.* Some shear cracks are found in the churches that present this architectural element, in particular in proximity of the openings (Figure 3- 10).

**Figure 3- 10** Shear cracks in the domes: **a.** Santa Maria Nuova in Tolentino; **b.** Santa Maria del Glorioso in San Severino Marche.

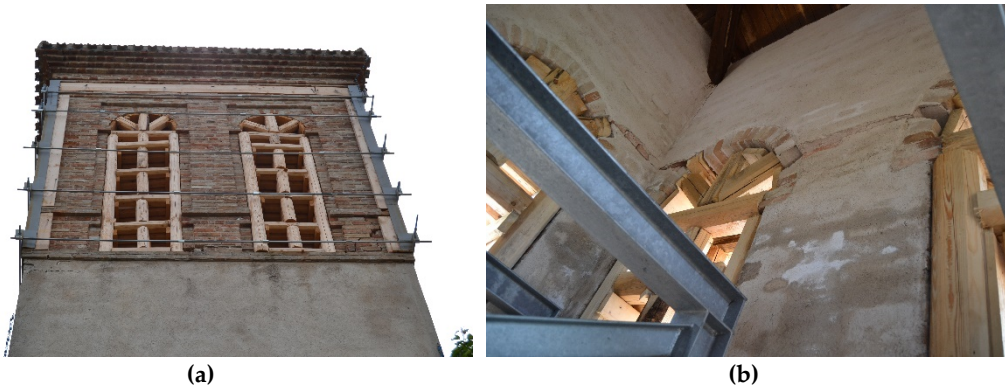
- *Bell towers.* The most common damage reported for this macro-element is due to torsional effects of the upper part (belfry), that depending on the slenderness of the pillars was more or less evident (Figure 3- 11).

**Figure 3- 11** Bell tower torsion of the upper part of the belfry of the bell tower of San Lorenzo in Dignano.

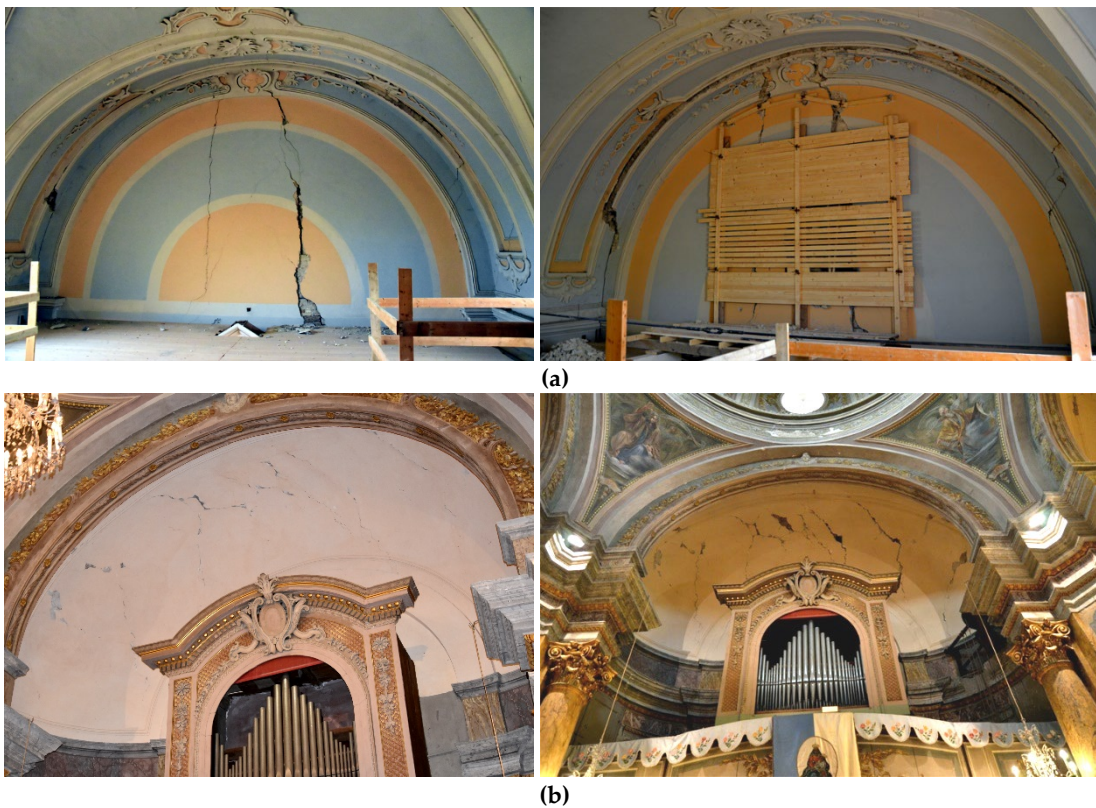
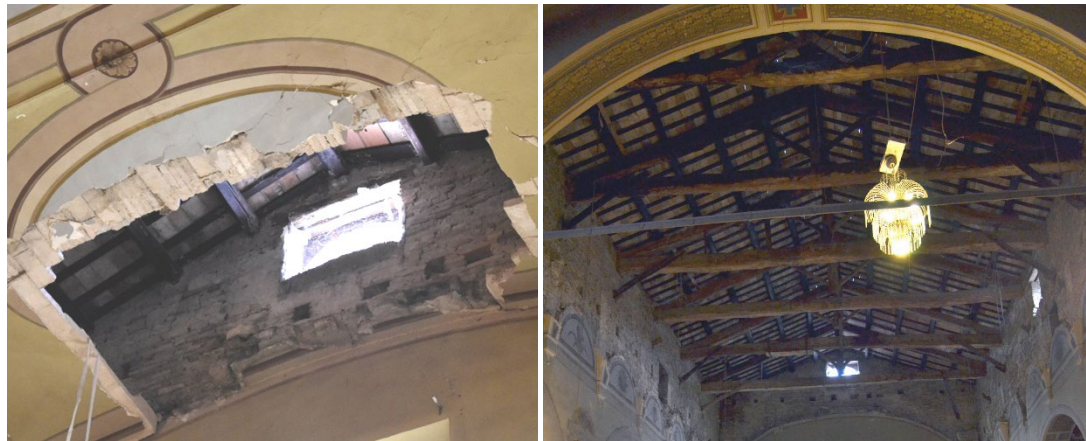
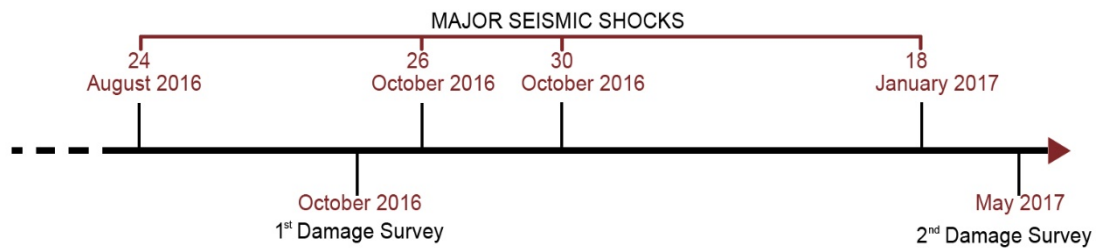
Moreover, some of the churches were visited twice, once after the first event of August 2016, but before the major shocks of October 26 and October 30, and once in spring 2017. This double survey gave the possibility to observe the evolution of damage in some of the churches of the sample. This was the case of San Francesco, Santa Maria Nuova, and SS Crocifisso in Tolentino (Figure 3- 12).

**Figure 3- 12** Evolution of the damage in the churches visited twice: on the left before the shocks occurred on October and on the right after the four shocks: **a.** damage on the interior side of the façade at the second order of San Francesco church; **b.** damage on one of the vaults which cover the niches of Santa Maria Nuova church; **c.** damage on the vault of the nave of SS Crocifisso church; **d.** timeline which clarifies when the surveys were performed together with the major seismic events (Parisi et al. 2018).

In the second case, the presence of a steel hoop, confining the drum, seemed to have influenced the damage. This reinforcement was intended to protect the top elements, but the damage occurred in the inferior vaults, which were more difficult to protect with limited interventions. Cracks were located in the four semi-circular vaults holding the drum and the dome. No serious damage was reported for these last two elements for the entire earthquake sequence. On the contrary, damage to the vaults increased with the following events, bringing one of them to the collapse limit (Figure 3- 12b). Further studies are required to better explain what occurred.

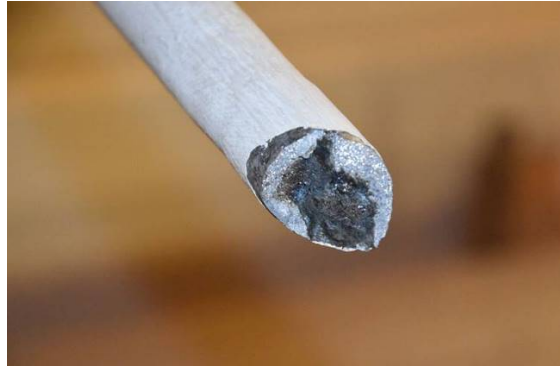
In the first case, the tie rods that had been positioned at the level of the impost of the arches and vault provided an effective contribution in stiffening the system and retaining the walls and vault. This is demonstrated by the rupture of the central tie that occurred in August 2016 and by the subsequent ruptures of two more ties with the two main shocks that arrived in October (Figure 3- 13).Immediately they were integrated with an emergency action.

**Figure 3- 13** Broken tie rod in August 2016 (Parisi et al. 2018)

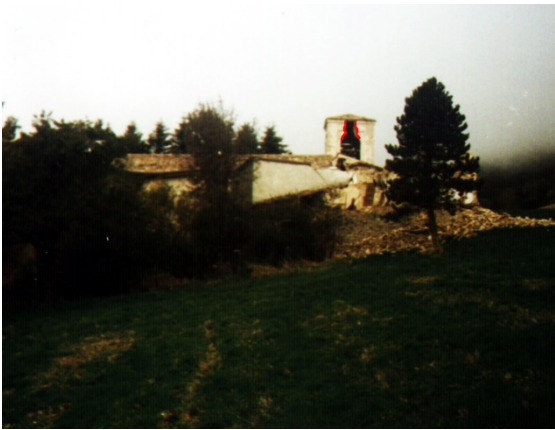
(a)

After this series of shocks, the church was severely damaged. The bell tower lost some parts of the belfry and some shear cracks appeared along the height (Figure 3- 20a). The upper part of the façade in contact with the concrete roof collapsed. Shear cracks appeared in the plane of the façade in the central part between the rose window and the portal (Figure 3- 20b). The lateral wall of the nave showed a separation of leaves with the collapse of a portion of wall, close to the concrete roof (Figure 3- 20c). The buttresses were damaged, losing the upper portion (Figure 3- 20d). In the background of Figure 3- 20b (red oval), some undamaged buttresses exhibit a different texture, especially at the borders of their depth, motivating the hypothesis of a rebuilding phase at some time. It was assumed that the damage followed the path of the later addition.

**Figure 3- 20** The 1997 Umbria-Marche earthquake damage: **a.** collapse of the upper part of the belfry; **c.** collapse of the external leaf of the lateral wall of the nave; **b.** shear crack in the plane of the façade and some collapsed portions of the upper part of the façade and the gable; **d.** collapse of the upper portion of the buttresses (Sferrazza Papa and Silva 2018).

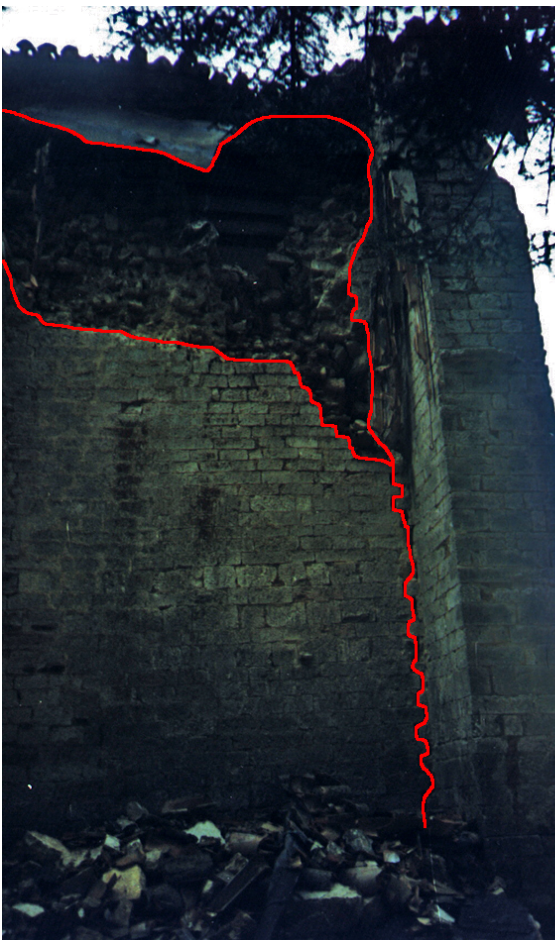
(c)

20d) is probably due the performed rebuilding at a different time, while the lateral walls (Figure 3- 20c) suffered disintegration of the external leaf. These types of damage were not obtained in the analyses because they are due to local characteristics difficult to include in a global model.

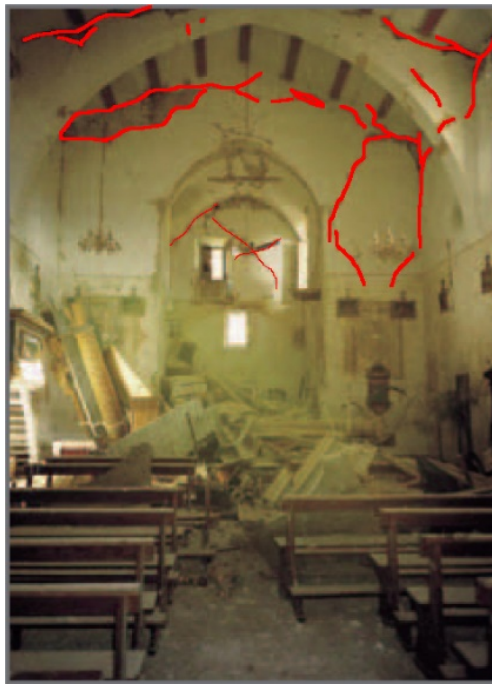
(a)

The interior of the church was also damaged. The stiffness of the concrete roof may have caused the shear cracks in the transversal arches (Figure 3- 21a) and the collapsed upper portion of the longitudinal wall is also visible inside (Figure 3- 21b).

**Figure 3- 21** Post-1997 earthquake damage of the interior of the church: **a.** View of the triumphal arches towards the apse area. Diffuse shear cracks and pounding damage. **b.** Inside view of St. Salvatore church. Partial collapse of the wall and of part of the internal leaf of the wall of the main façade at the tympanum level (Sferrazza Papa and Silva 2018).

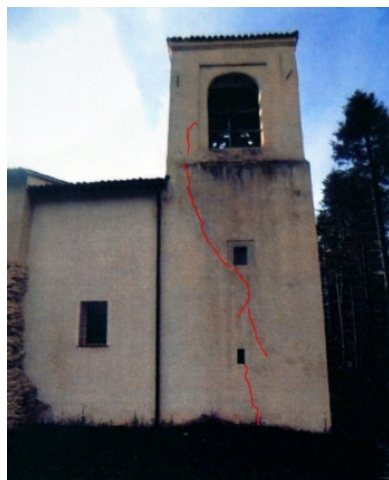
(a)

The on-site visit and survey performed in spring 2017 provided the opportunity to collect some photographical documentation that could help explain the damage. The church was less damaged than after the 1997 event. This time, no leaf separating effects were noticed. Some shear cracks were pointed out in the bell tower (Figure 3- 24a, Figure 3- 24b). The presence of the tie rods worked efficiently: indeed, this portion of the tower reacted with a box-like behavior, providing a contrast to the torsional action and causing cracks at the base of the terminal part of the bell tower. Other shear cracks were observed in the façade, probably retracing the discontinuity of the masonry due to the post-1997 earthquake repairing works (Figure 3- 24d). In the upper portion of the façade, in correspondence of the timber beams of the roof a light damage is visible, probably due to their pounding on the façade wall (Figure 3- 24c, Figure 3- 24d). The same occurred inside the church where the timber roof beams enter the arches of the nave (Figure 3- 24e). Finally, a crack at the base of the south wall of the nave was observed (Figure 3- 24f).

**Figure 3- 24** The 2016 Central Italy earthquake damage: **a.** shear cracks on the bell tower along the height; **b.** shear cracks that trace the same path of the damage reported after the 1997 earthquake (Sferrazza Papa and Silva 2018); **c.** Pounding effect of the beam in the façade wall (Sferrazza Papa and Silva 2018); **d.** Crack in the right upper corner in correspondence of the transversal walls of the nave and light damage in the plane of the façade (Sferrazza Papa and Silva 2018); **e.** Cracks in the arches in correspondence of the timber beams of the roof and in the triumphal arch close to the bell tower (Sferrazza Papa et al. 2019); **f.** Crack at the base of the south wall of the nave (Sferrazza Papa et al. 2019).

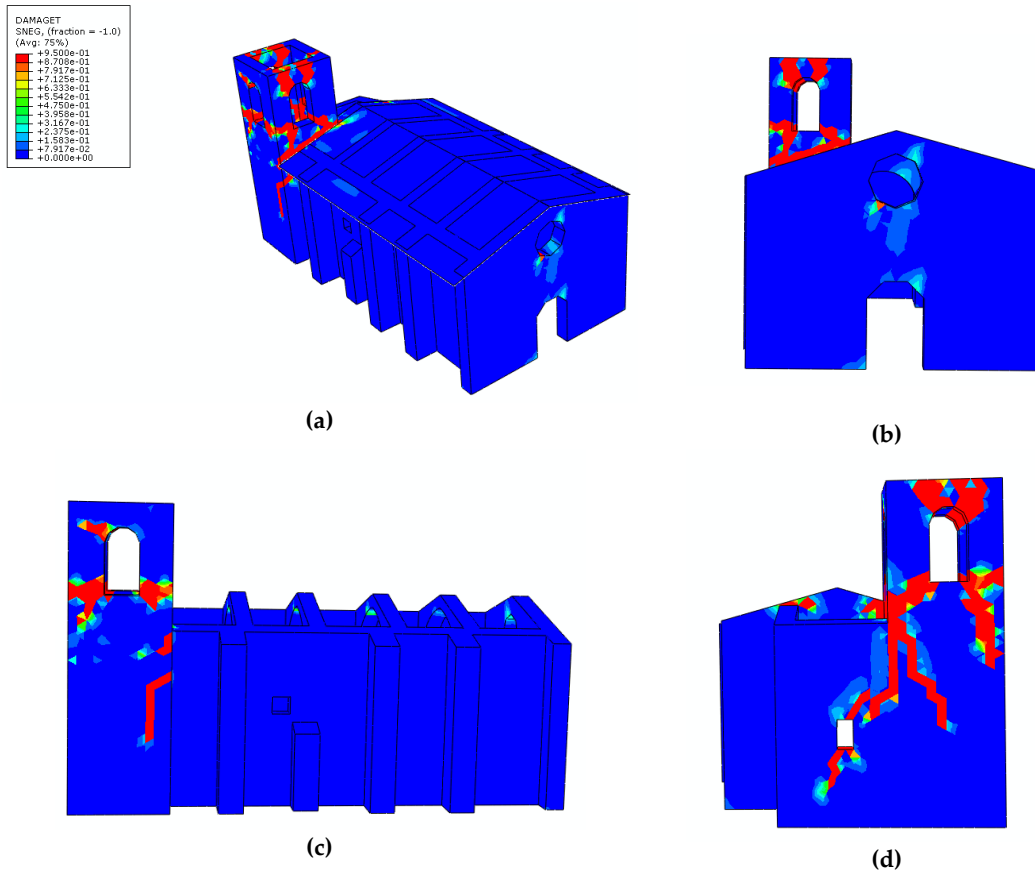
The results of the analyses are reported in terms of damage maps of the computed tensile damage  $d_t$ . The September (1997) shock was applied to the 1997 configuration and the damage of the triumphal arch (Figure 3- 33a), the façade (Figure 3- 33b), the bell tower (Figure 3- 33c), and the apse (Figure 3- 33d) was obtained. No damage in the buttresses and lateral walls emerged from the analyses. The damage in the buttresses (Figure 3-

**Figure 3- 33** Results of the seismic analyses applying the earthquake which occurred on September 27, 1997: **a.** North west view; **b.** West view; **c.** North view; **d.** East view.

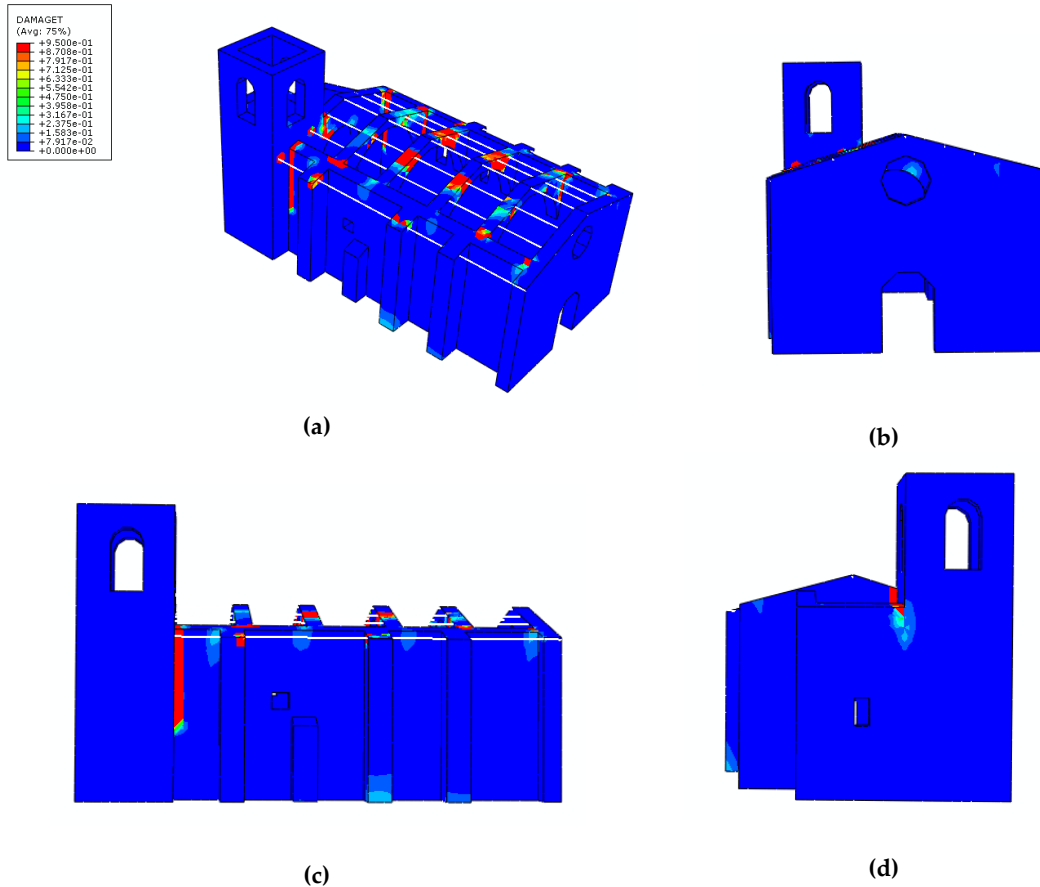
The accelerogram selected for the 2016 Central Italy event was applied to the 2016 configuration. Figure Figure 3- 34a shows the damage at the base of the longitudinal nave in the interior side of the south wall and in the arches, where the timber beams of the roof enter the masonry. It also shows a local damage in the façade at the intersection with the transversal walls of the nave, without showing any damage in the rest of the façade (Figure 3- 34b). The damage between the bell tower and the rest of the structure of the church in the east and north side (vertical crack) was also observed (Figure 3- 34c; Figure 3- 34d).

**Figure 3- 34** Results of the dynamic analyses for the 2016 configuration applying the occurred earthquake (October 30, 2016): **a.** North west view; **b.** West view; **c.** North view; **d.** East view.

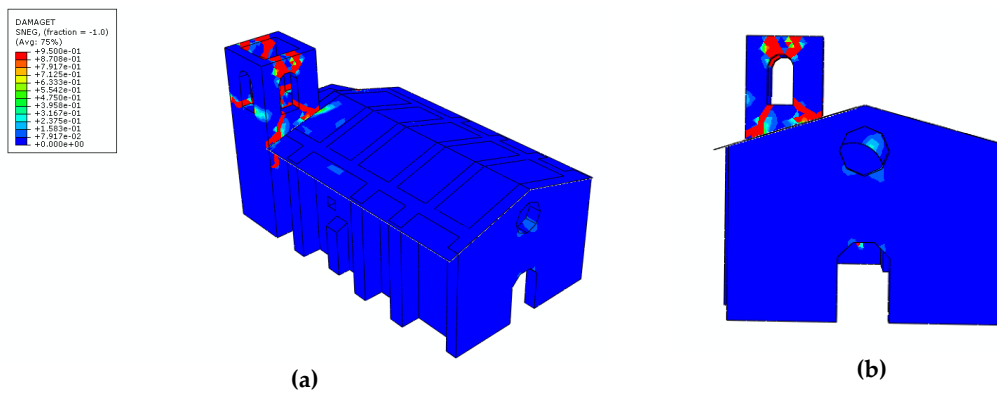
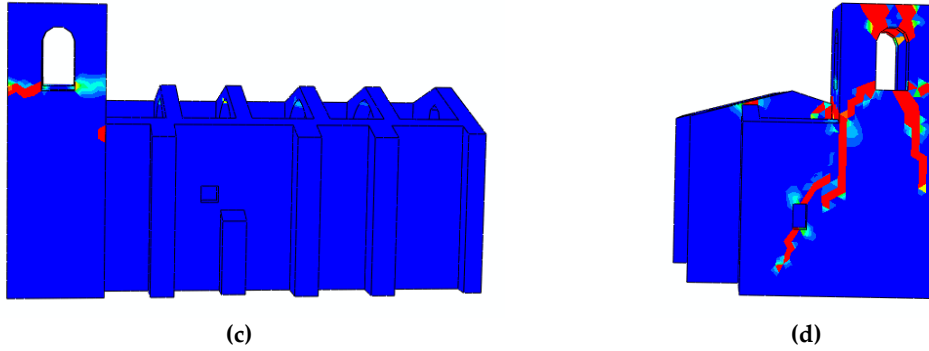
**Figure 3- 35** Results of the seismic analyses for the 1997 configuration applying the October 30, 2016 earthquake: **a.** North west view; **b.** West view; **c.** North view; **d.** East view.

From the comparison of Figure 3- 35 and Figure 3- 36 with Figure 3- 33 and Figure 3- 34, the damage pattern appears independent from the characteristics of the seismic events. At this point, some considerations on the influence of the roof type can be expressed: on the one hand, the concrete roof guarantees the box-like behavior, but it caused a damage principally concentrated on the façade and on the bell tower (Figure 3- 33a;Figure 3- 33b); on the other hand, the timber roof produced local damage, concentrated on the arches and on the intersection between the transversal walls and the façade (Figure 3- 33;Figure

3- 35;Figure 3- 34;Figure 3- 36). Moreover, an independent structural response of the bell tower was observed in the 2016 configuration. In this case, the timber roof is not capable to tie together the structure of the church and of the bell tower, causing less damage in the apse and bell tower, but producing a pounding effect in the part of connection between the apse and the bell tower, and between the lateral wall of the nave and the bell tower.

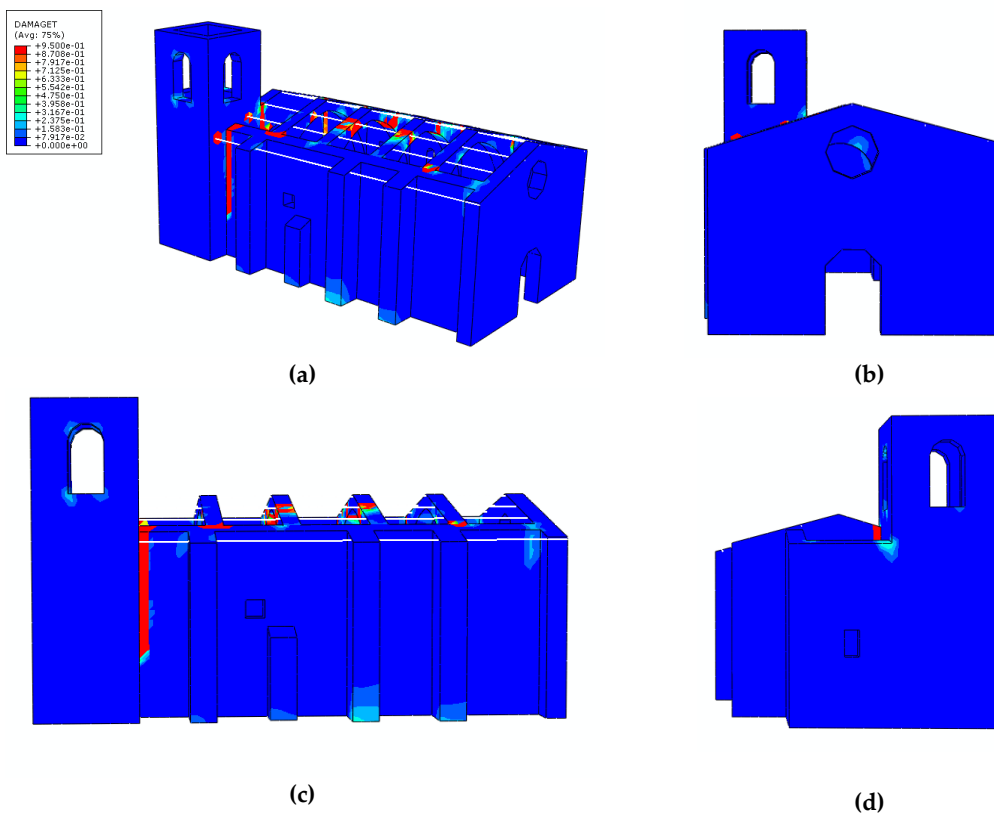
**Figure 3- 36** Results of the seismic analyses for the 2016 configuration applying the September 27,1997 earthquake: **a.** North west view; **b.** West view; **c.** North view; **d.** East view.

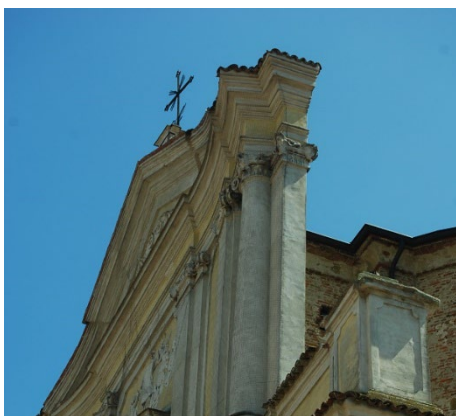
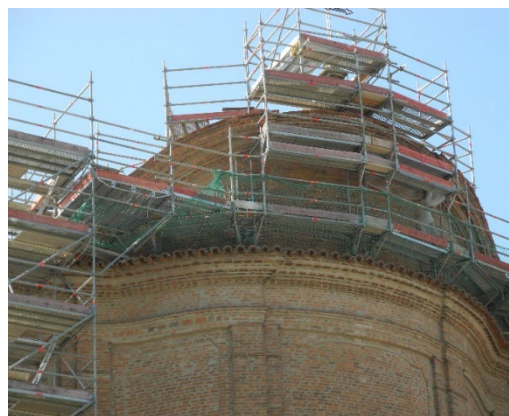
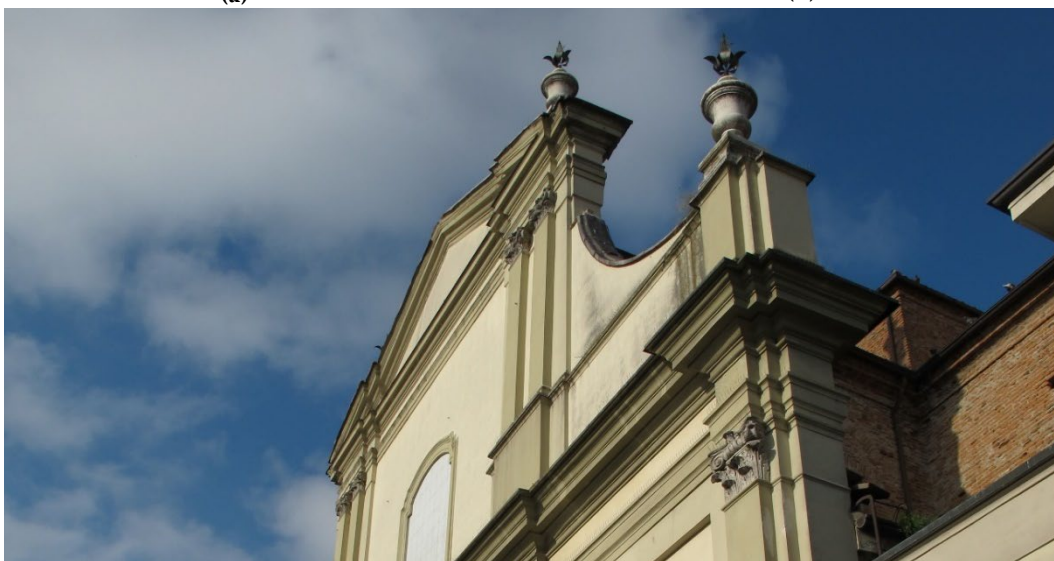
**Figure 4- 7** Example of soaring gable from the church sample (Superintendence of Brescia 2018).

- *The façade gable* was one of the most damaged macro-elements, being highly overhanging from the roof level, a typical characteristic for most of the churches in the sample;

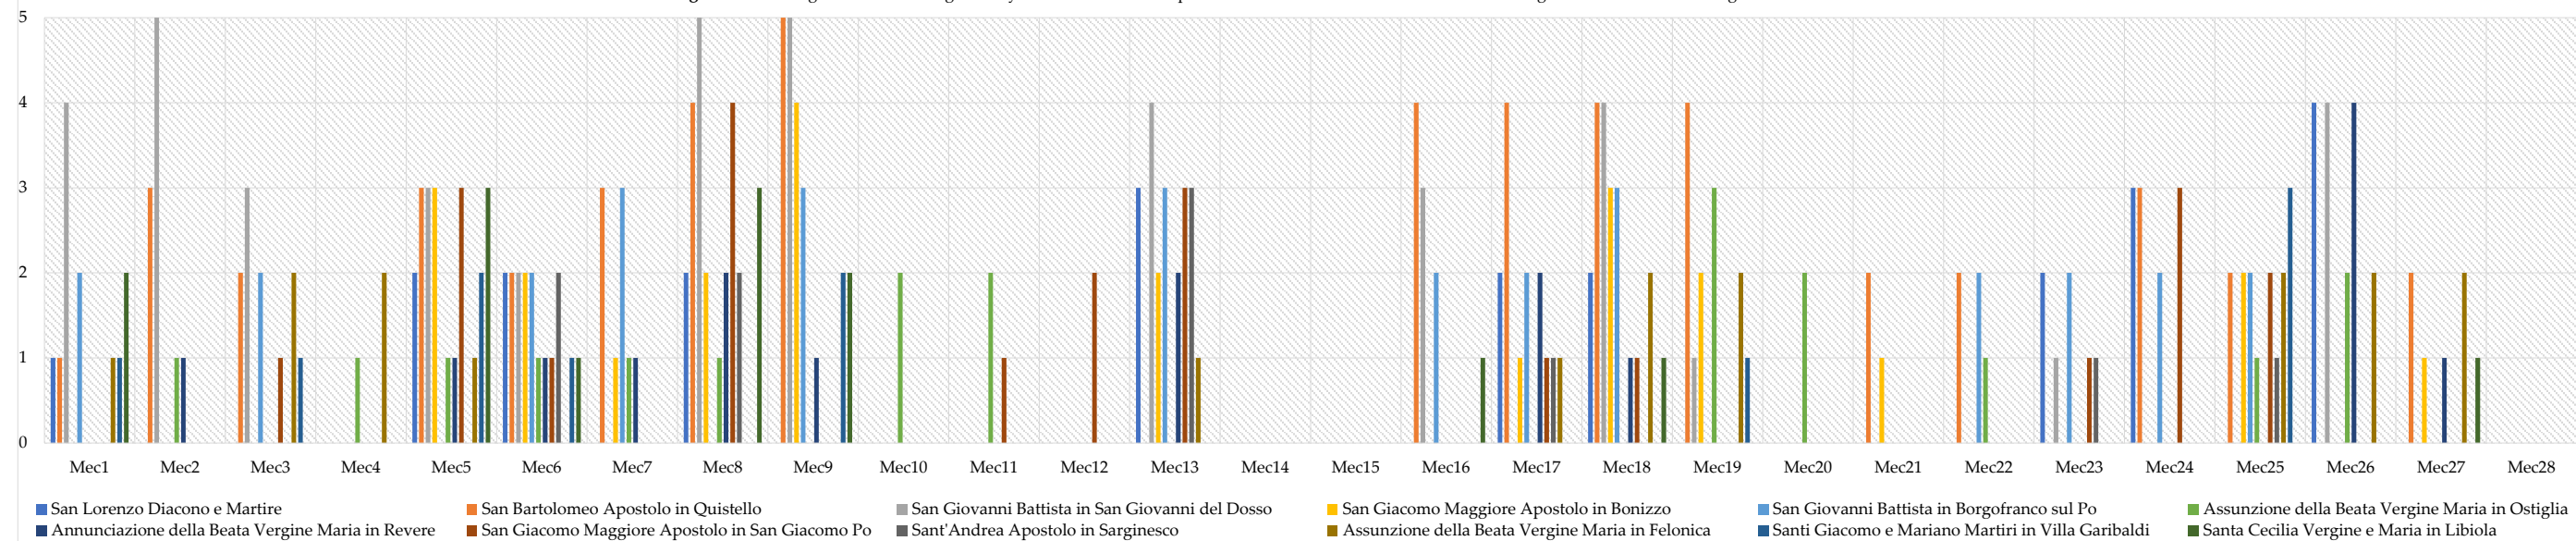
Figure 4- 10 reports the damage surveyed in the church sample after the two major shocks of the 2012 Pianura Padana Emiliana earthquake, distributed between the possible 28 mechanisms. The sources for the reported damage are the damage survey forms filled after the shock occurred on May 29. The surveyed damage is the result of the damage accumulation after the two major shocks.

Figure 4- 10 Histogram on the damage surveyed on the church sample and distribution of macro-elements. A damage level from 1 to 5 is assigned for each active mechanism.

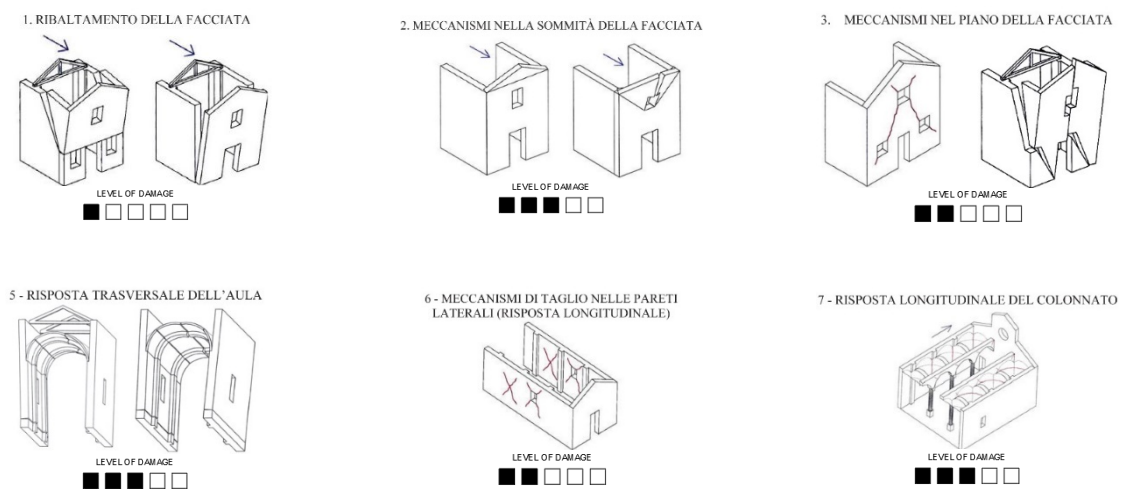
After the shock of May 29, the church was surveyed, Figure 4- 17 shows the mechanisms that developed. The damage is mostly concentrated on the façade, the system of vaults, and the colonnade. This is an interesting aspect if considered in relation with the configuration pointed out in the description of the case study (Section 4.3) and, more in general, with the construction characteristics of this geographical area (Section 4.2.1).

**Figure 4- 17** The occurred damage, distinguished per mechanism, after the two major shocks on May 2012. Mechanism 1: overturning of the façade; Mechanism 2: mechanisms of the upper part of the façade; Mechanism 3: in-plane mechanisms of the façade; Mechanism 5: longitudinal response of the lateral wall, in plane; Mechanism 6: Shear cracks in the walls; Mechanism 7: longitudinal response of the colonnade; Mechanism 8: crack in the vaults of the principal nave; Mechanism 9: cracks in the vaults of the lateral naves; Mechanism 16: Overturning of the apse; Mechanism 17: shear cracks in the presbytery or apse; Mechanism 18: cracks in the vaults of the apse; Mechanism 19: roof elements in the principal nave; Mechanism 21: roof element in the apse; Mechanism 22: overturning of the chapels; Mechanism 24: crack in the chapels; Mechanism 25: Crack in the part of interaction with irregularities; Mechanism 27: Cracks in the bell tower.

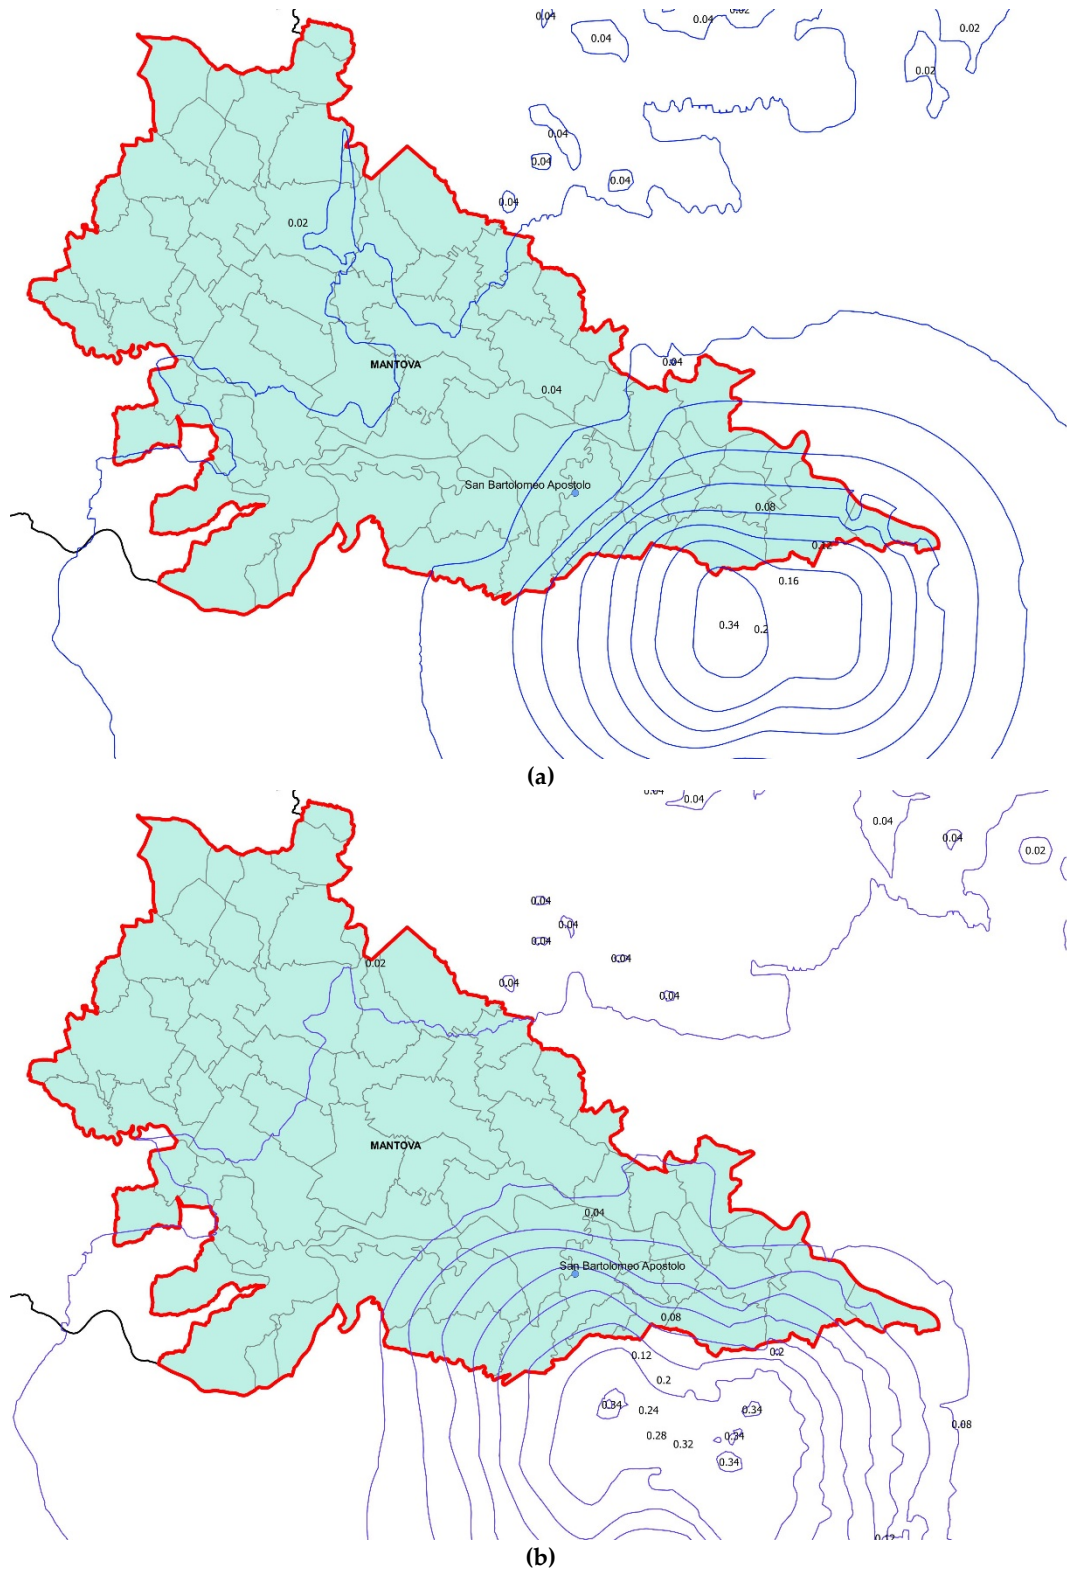
Such damage can be explained not only in relation with the construction characteristics of the church, that is the vulnerability associated with the building, but also at territorial level considering the PGA reached in the area with the two seismic events (Figure 4- 18). The two strong shocks hit the church in a short time lapse. According to the map, generated overlaying the position of the church with the PGA isocurves, in the absence of onsite registrations, San Bartolomeo stays in the 0.02 g area for the first shock (Figure 4- 18a) and 0.08 g for the second (Figure 4- 18b). The relatively short time between one

seismic event and the other, which prevented repairing or just provisional interventions, and the increase values of PGA in the two events contribute to explain the progression of damage, as observed in the case of the vault adjacent to the façade.

**Figure 4- 18** The church and the PGA isocurve: a. on May 20; b. on May 29.

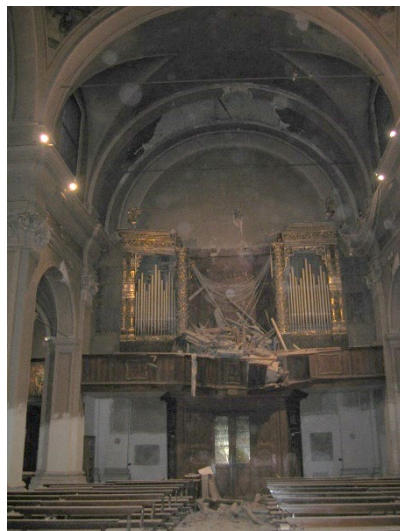
After the second shock, also the organ and the internal frame of the first span of the church were severely damaged (Figure 4- 20).

**Figure 4- 20** Collapse of the organ area behind the façade after the second shock (Superintendence of Brescia 2018).

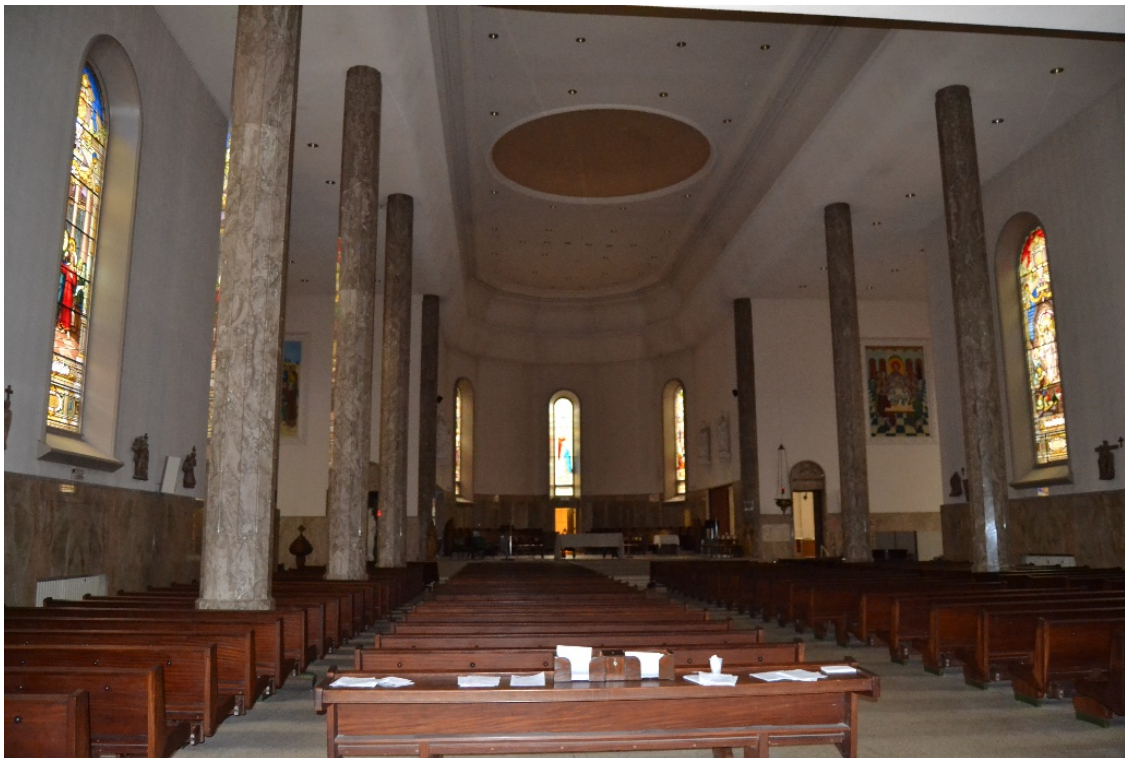
Following some renovation works, the interior was transformed from the original state, keeping the three-nave distribution, but replacing the vault and arch system, typical of a baroque church, with a flat non-structural slab (Figure 7- 19). Consequently, the

structural concept was deeply modified. It should be noted that in the renovation work the wood pillars have been covered by marble panels.

**Figure 7- 19** Interior of Notre Dame de Grâce.

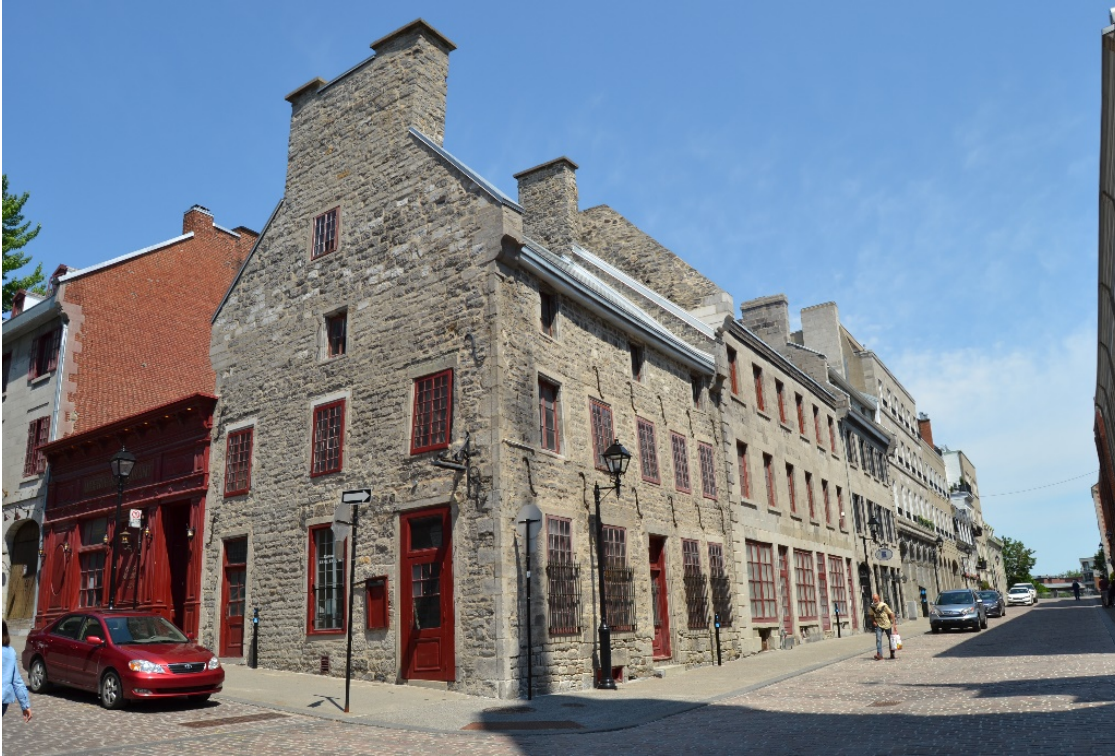
**Figure 7- 20** Old tie rods at the level of the slabs in both sides of this old house in the Old Montréal.

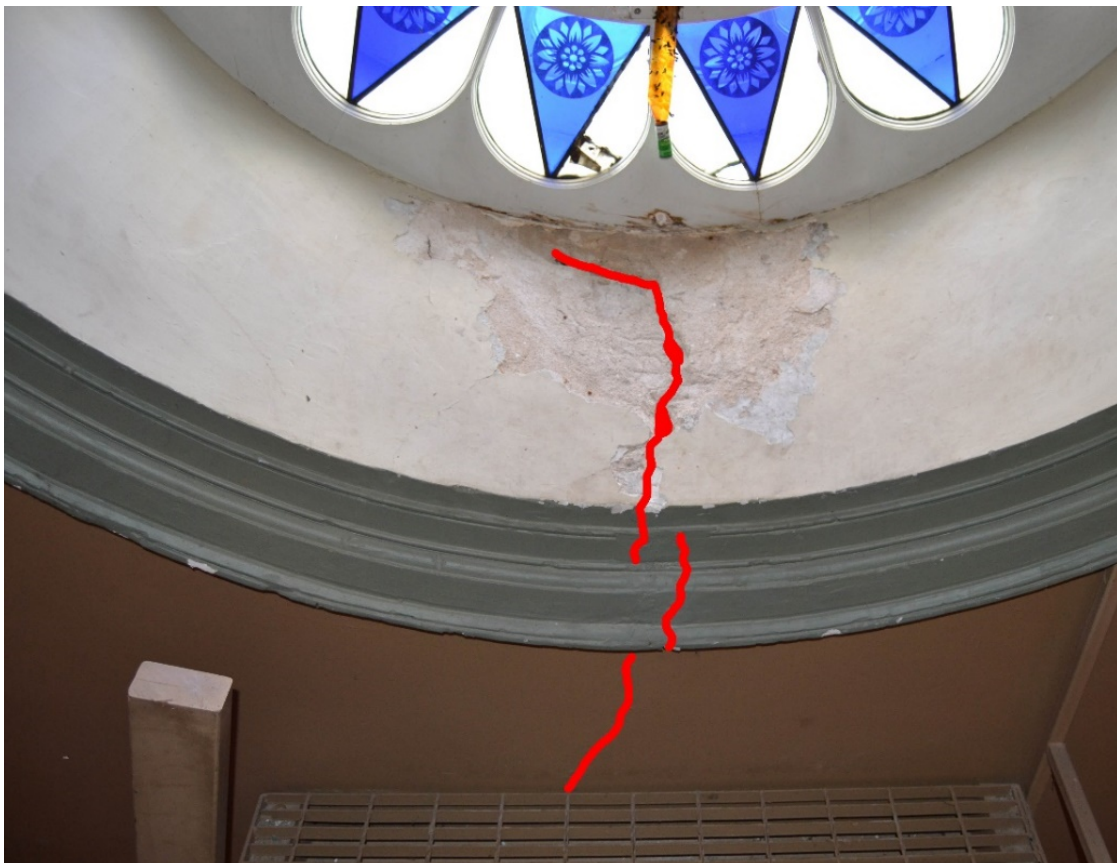
(a)

**Figure 7- 21** Cracks in Sainte Famille in Boucherville: **a.** Rose window; **b.** Left opening in the façade wall at the second order; **c.** Below the rose window; **d.** Right opening in the façade wall at the second level.

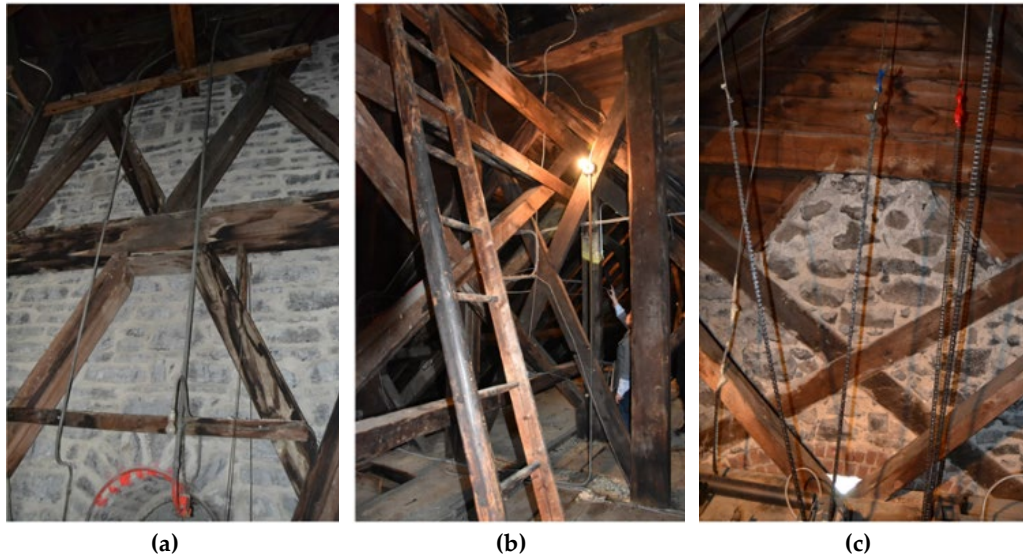
It is necessary to go beyond the rapid 28-kinematic mechanisms procedure. The consideration of other aspects of these macro-elements, such as how they are built and what is the connection between the bell tower and the façade, becomes crucial. Visual inspections of the above church examples show that the structure of the bell tower is strictly connected with the façade, the jubé and the lateral walls. Analysis of the construction materials visibly shows that the structure of the bell tower is made of timber while the supporting walls and façade are in multi-leaf stone masonry as shown in the St. Joseph case study (Section 7.4). Figure 7- 25 shows the timber structure of the bell tower observed from the interior of some churches at the level of connection with the masonry of the façade.

**Figure 7- 25** Examples of the structure of the bell tower at the level of connection with the façade: **a.** the timber structure of the bell tower is adjacent to the façade masonry wall; **b.** the structure of the roof intersects with that of the bell tower; **c.** the timber structure of the bell tower starts inside the masonry of the façade ('pan de bois').

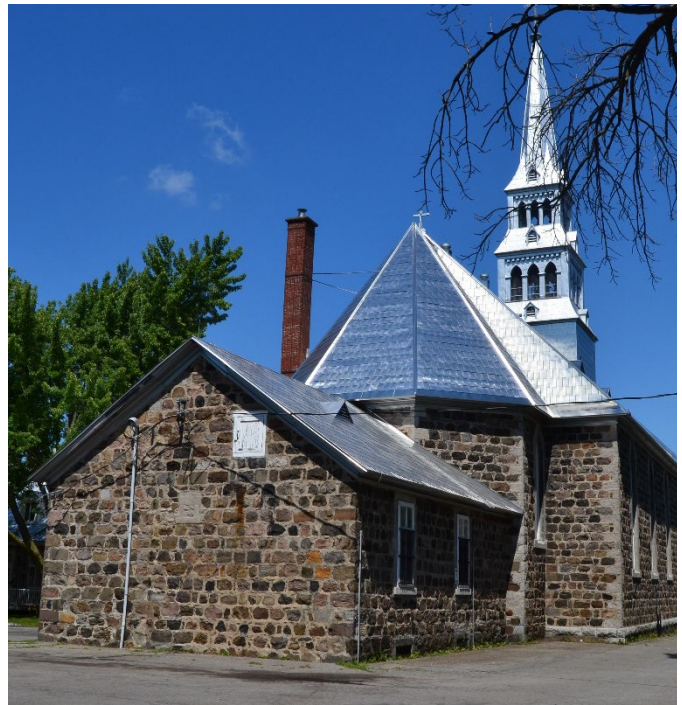
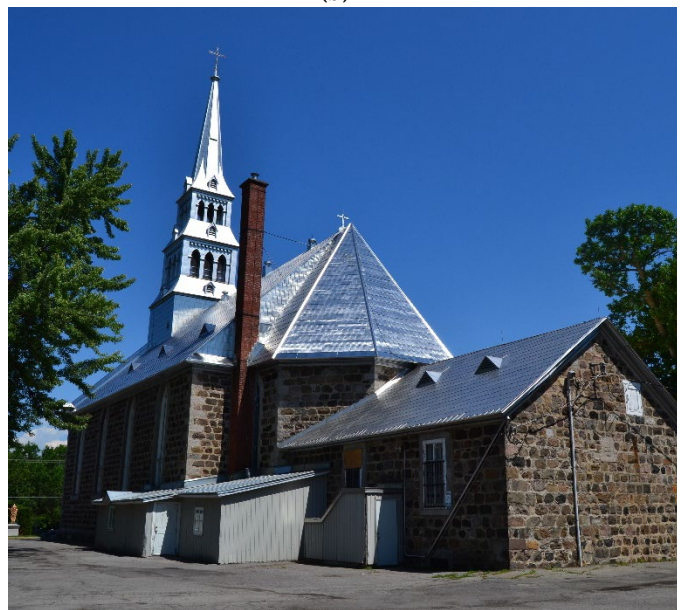
Considering the seismic vulnerability of the building, the presence of a high brick chimney in the backside of the church, in proximity of the apse, has to be pointed out (Figure 7- 30b, Figure 7- 30d, Figure 7- 47). As seen in Table 7- 2, where the reported damage of past earthquakes is listed, the chimneys frequently collapsed causing damage to the rest of the structure of the church. This functional element, added at a later time,

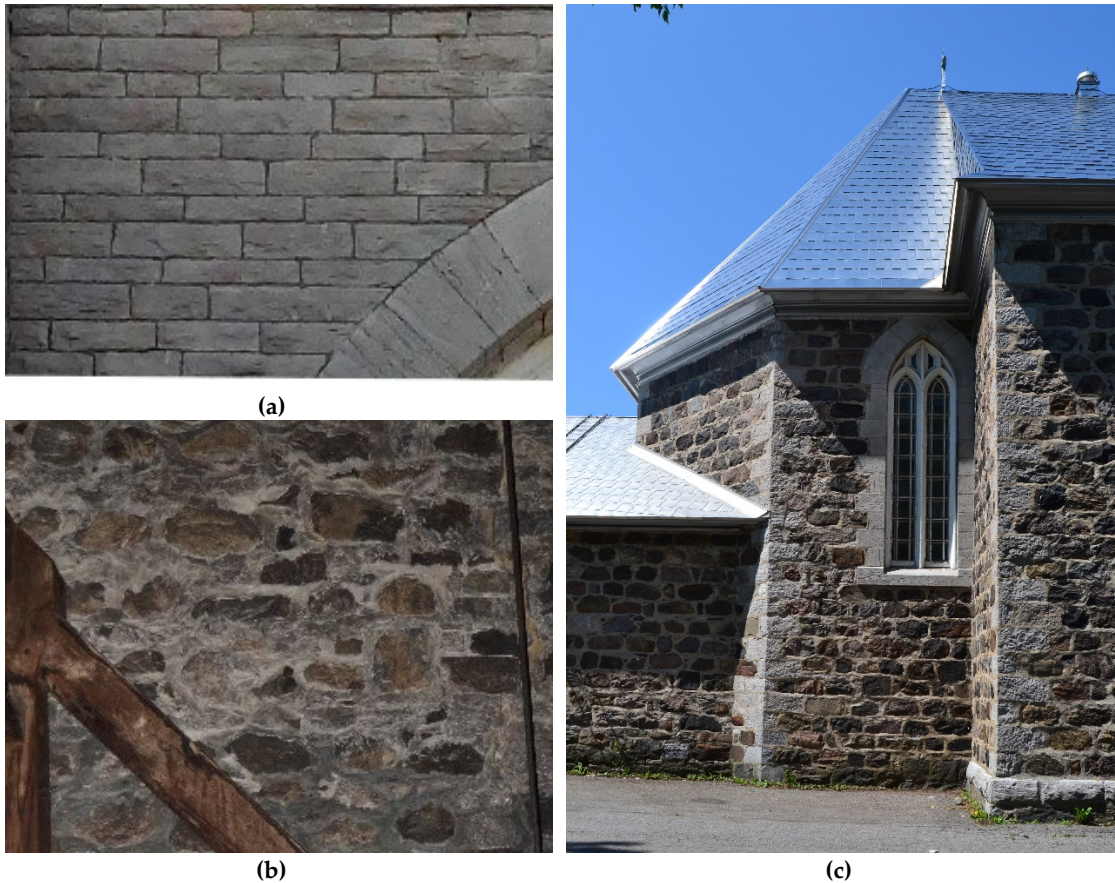
The principal façade is externally made of squared blocks of limestone, laid in regular joints (Figure 7- 31a). The interior inspection of the roof level allowed us to observe the interior fabric of the façade wall that differs from the exterior one because it is made of roughly squared stones of different size without a regular arrangement (Figure 7- 31b). In the absence of non-destructive tests, the section of the façade wall - about 90 *cm* - was assumed constituted by two leaves, the internal (roughly squared) and external one (square cut). From the external pattern, no transversal block, that could guarantee the

interlocking between leaves, is visible. On the contrary, between the different walls of the church, the interlocking is guaranteed by square blocks well defined and with an alternated pattern (Figure 7- 31c).

**Figure 7- 31** Constructive details: **a.** External leaf of the façade; **b.** Internal leaf of the façade, visible from the roof level; **c.** Interlocking between the different walls of the church.
