**POLITECNICO DI MILANO**

ABC **PhD** DOCTORAL PROGRAMME  
in ARCHITECTURE, BUILT ENVIRONMENT  
and CONSTRUCTION ENGINEERING

# SEISMIC VULNERABILITY OF CHURCHES: A TERRITORIAL KNOWLEDGE APPROACH

**Gessica  
Sferrazza Papa**

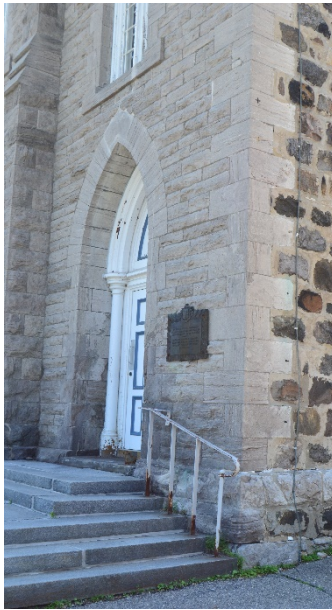
This aspect is a quite widespread construction practice in the visited churches, especially when the wall leaves are made of roughly squared stones. In St. Joseph, this attention is paid both between the façade and longitudinal walls of the nave (Figure 7- 32) and between the other walls of the church structure (Figure 7- 33). In the walls of the sacristy, the same stone is used for the wall elevation and the corner interlocking. This aspect is worth noting, considering that this material has not been the principal material of construction for this territory, especially before the major fires that occurred in 1682 and 1720, in Québec and Montréal respectively.

**Figure 7- 32** Interlocking between the façade and lateral walls of the nave.

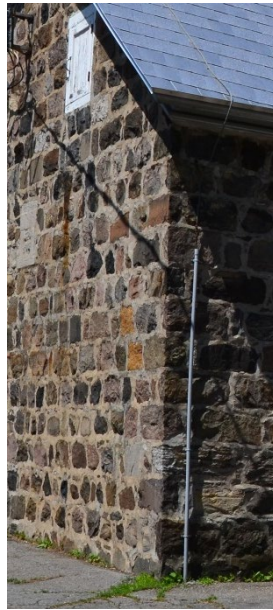
**Figure 7- 33** Interlocking between the walls of the church structure.

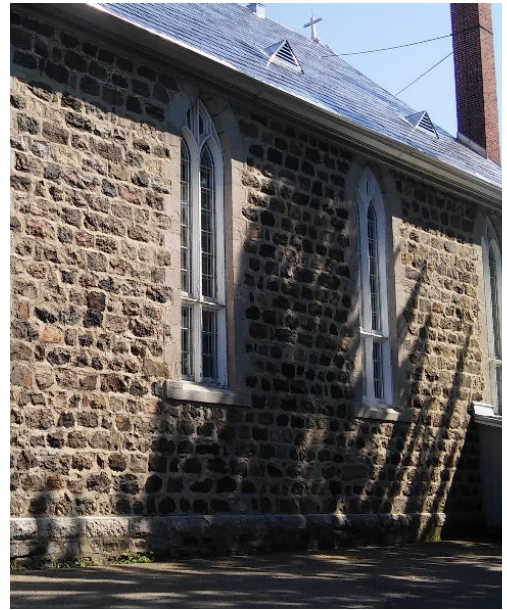
The rough stones, which constitute all the walls of the church, except for the façade, are laid in regular horizontal rows, but there is no regular vertical joint pattern. The lateral walls do not present any buttresses and have a repeated rhythm of big openings well

marked with square stones, like those used for the interlocking between the walls (Figure 7- 34).

**Figure 7- 34** External view of the lateral walls of the nave: roughly squared stones. The openings are marked using square blocks of stones.

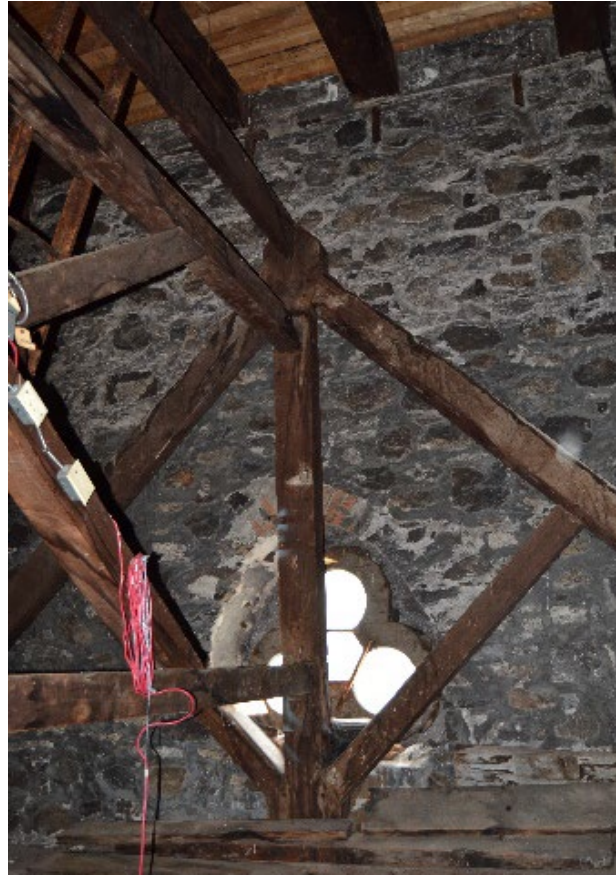
**Figure 7- 41** Last truss close to the façade wall and beams of the 2nd deck of the bell tower.

On the contrary, the roof structure does not interact with the façade. The top and bottom chord of the longitudinal stiffening structure end in the last transversal truss, which is separated from the façade wall by a gap of 50 mm (Figure 7- 41). On their side, the trusses are connected one to the other through a series of longitudinal braces (Figure 7- 42). Some of the trusses have the joints between the chord and the posts retrofitted with a metal element (Figure 7- 43). Towards the façade, the last brace of this longitudinal stiffening structure crosses the brace structure of the bell tower, without interconnecting with this last (Figure 7- 42, Figure 7- 40). On the contrary, towards the apse, the length of the last brace is smaller and the principal structure of the roof in this case has a radial set up (Figure 7- 44) Along the nave, the pillars of the colonnade are connected to the trusses that are the principal elements of the roof structure, creating a combined system that will be called here *roof system truss-columns* (Figure 7- 45, Figure 7- 46).

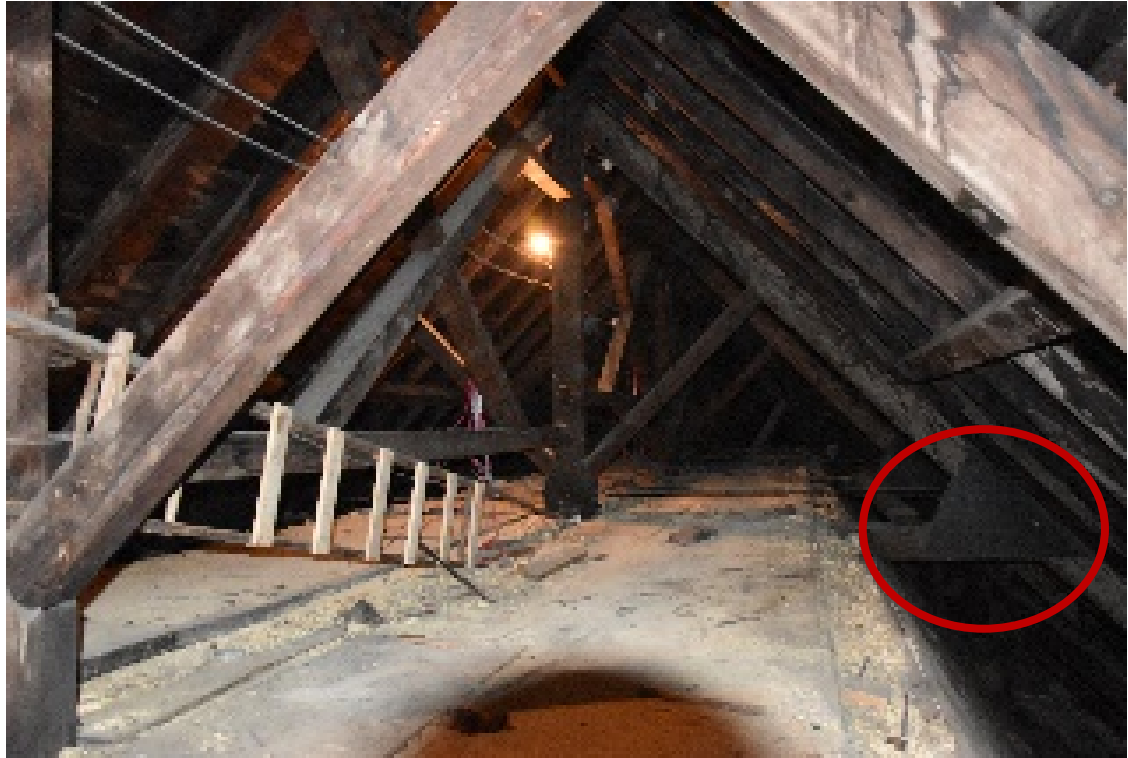
**Figure 7- 43** Wider view of the roof structure: trusses and brace structure between trusses. In the background, it is visible the retrofitted truss through a metal stiffening element.

- The connections of the roof system truss-bell tower and the longitudinal braces between units are well built and in good state of conservation, except for two retrofitted trusses. They play a significant role in containing the out-of-plane of the upper portion of the longitudinal walls and in distributing among the walls of the nave and the apse the response to horizontal actions. This property included in the form as 'boundary condition' in the 'other walls' macro-element reduces their vulnerability. Referring to the configuration and the modifiers the macro-element 'roof system truss-columns' was assessed with a medium-low level of vulnerability. The attention in this case should be paid to the connections.

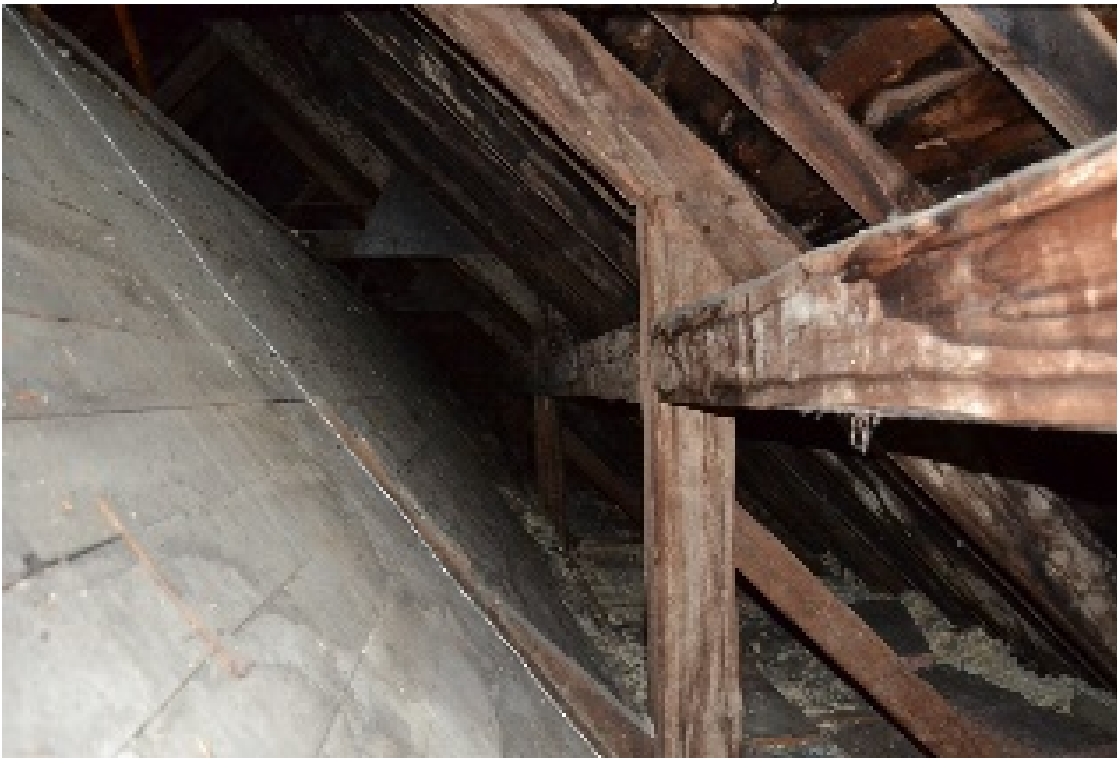
Figure 7- 46 Roof level above the lateral nave: longitudinal beams between the pillars of the colonnade. In the background the truss with the retrofitting metal element.

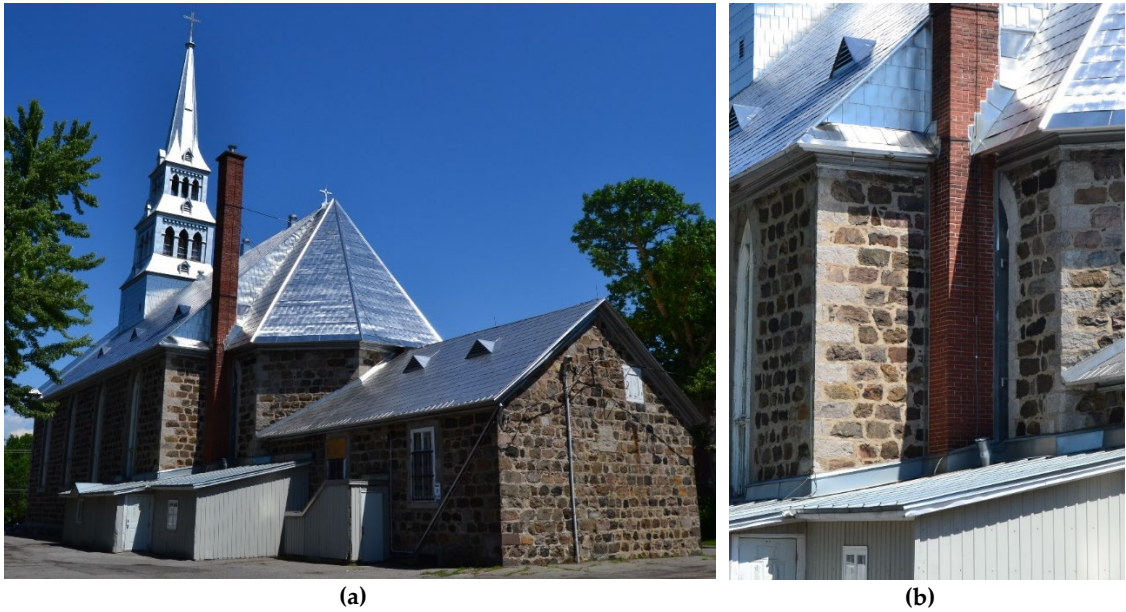
Considering the seismic vulnerability of the building, the presence of a high brick chimney in the backside of the church, in proximity of the apse, has to be pointed out (Figure 7- 30b, Figure 7- 30d, Figure 7- 47). As seen in Table 7- 2, where the reported damage of past earthquakes is listed, the chimneys frequently collapsed causing damage to the rest of the structure of the church. This functional element, added at a later time,

is not a structural element but has to be considered as an element that increases the seismic vulnerability of the church.

**Figure 7- 47** The chimney in St. Joseph: **a.** Brick chimney well visible in the back of the church close to the apse; **b.** Brick chimney partially covers one window of the apse.

- The presence of the beam of the jubé entering the longitudinal walls is another boundary condition that could determine a local damage.
- The 'chimney' macro-element is assessed with a medium level of vulnerability due to its slenderness and referring to the historical damage.

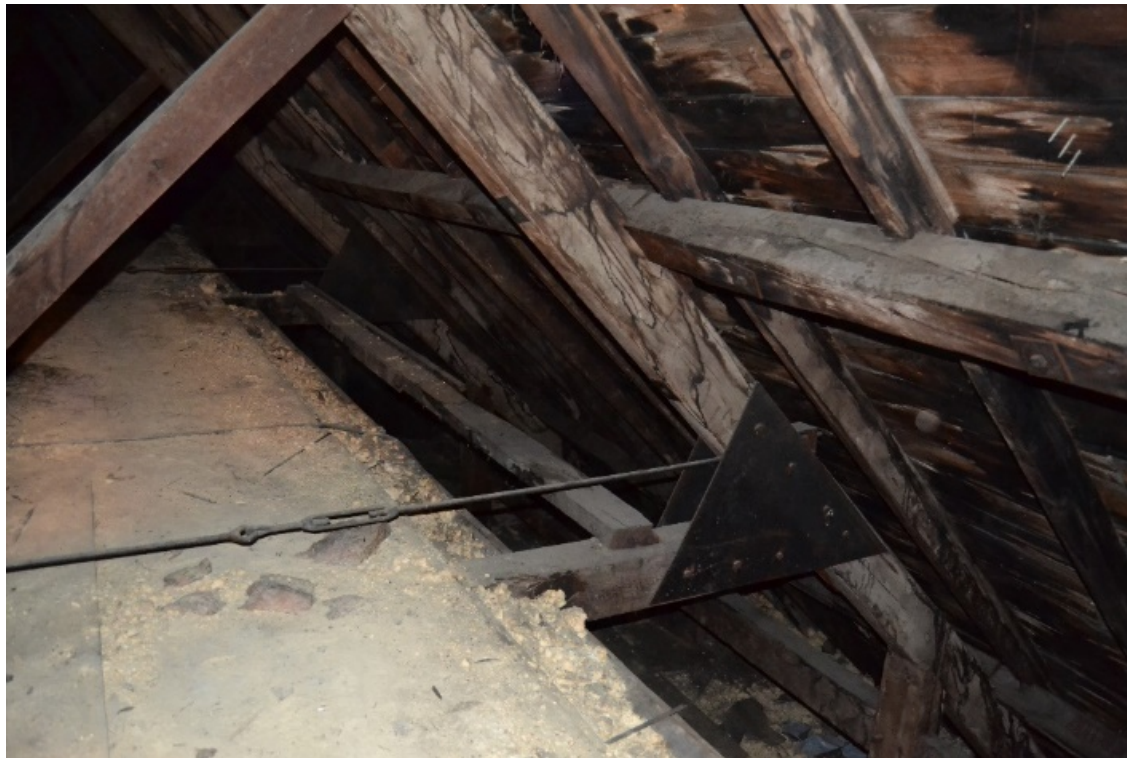
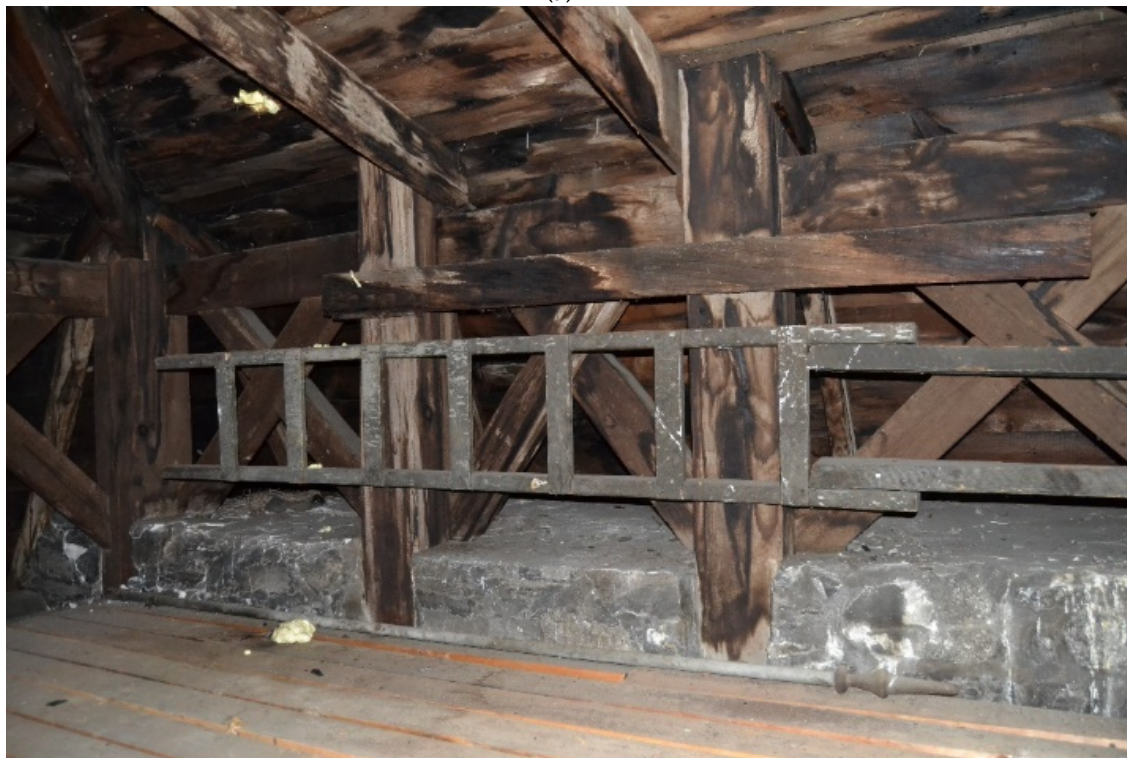
The roof and the bell tower present signs of humidity, probably due to the high difference in temperature from the interior of the nave to the roof one. Indeed, in Canada for climate reasons the churches are kept warm with a heating system. For such reason, the difference in temperature is significant between the heated area of the nave and the unheated area of the roof. At the roof level (Figure 7- 49a) and at the second deck of the bell tower (Figure 7- 49b), signs of humidity are visible both on the wood planks and on the timber beam elements.

**Figure 7- 49** Humidity on the timber planks and beams: **a.** Roof level; **b.** Second level of the bell tower.
