OPEN SPACE

Architectural Design Studio For Restoration of Complex Construction

Master Thesis in Building Architecture

Politecnico di Milano
School of Architecture Urban Planning Construction Engineering
AY 2019/2020

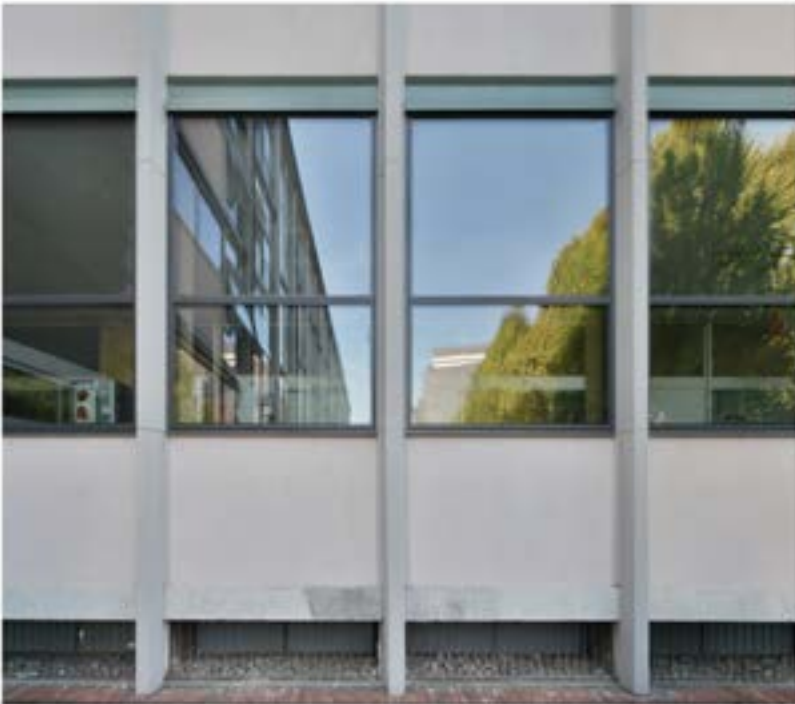
view of east facade

48 pillars in the east elevation, in reinforced concrete, are covered by these zinc coated steel plates. They divide the facade into 46 typical spans. According to our photographic survey these panels are remodeled from the original RC one.

The facade in east elevation has been refurbished. The wall is made of reinforced concrete, covered by a cement plaster with pink painted coating layer while the pillars are overlaid by a zinc coated steel plate.

On the east side, we do few things about exterior walls because these walls have been repaired once and it works well.

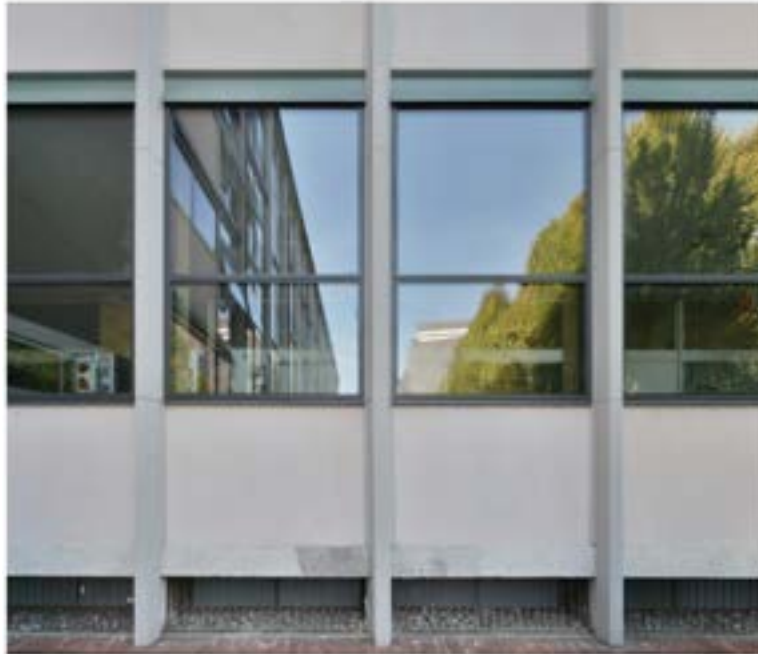
view of west facade

It is evident that west elevation of the building has not been renovated recently except the first two spans at the north side. The wall, in reinforced concrete, has a decadent painting orange layer with patially detached/cracked cement plaster layers.

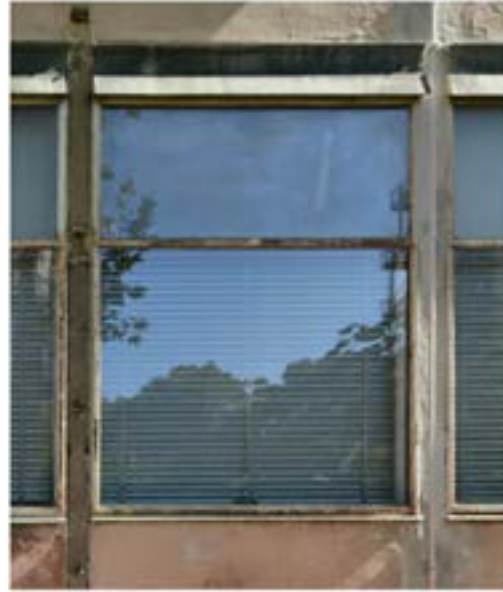
Typical window in west elevation

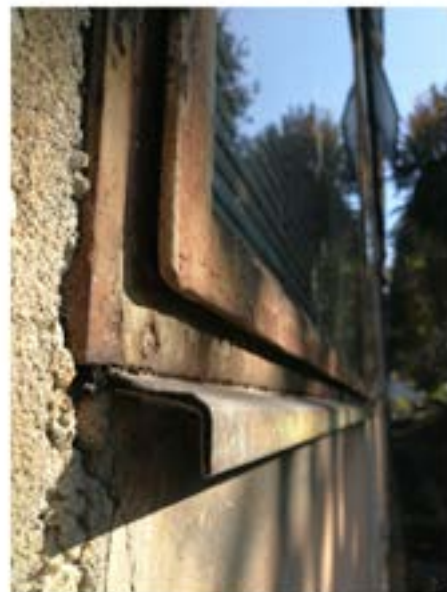
Detail of a window in west elevation

As we can see on the west elevation, the window frames, which are made of steel, are corroded because of direct contact with rainwater and oxygen due to the lack of a protective coating. We assume that the reason is due to the lack of maintenance, the painting on the framings are detached then the steel frames were in direct contact with water and air that has resulted in corrosion.

We have to remove the rust from the steel framings.

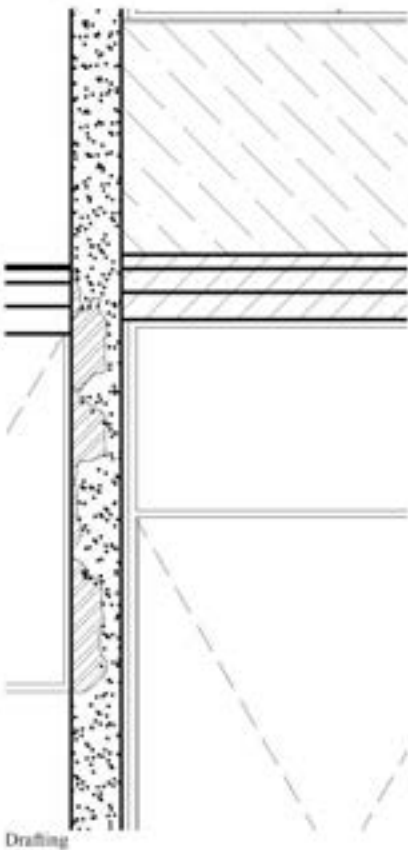
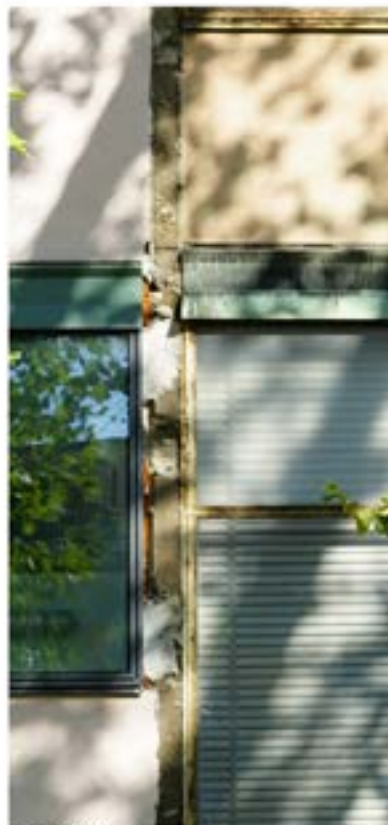
3 of them were the three edges of the facade. 1 of them were covered with alloy metal. 2 of them a large part were remained. 37 of them only a bottom were remained, the upper part were removed. 6 of them were completely removed and additional drainage pipes were embedded in it.

- discoloration
- missing part
- deposit
- integration

The decay of integration only happened where there is a replacement of the windows or other elements. The cement mortar was filled to cover the gap.

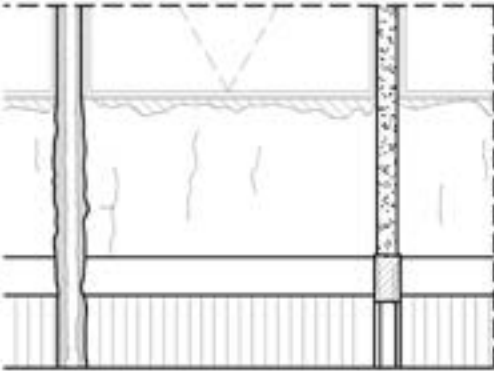
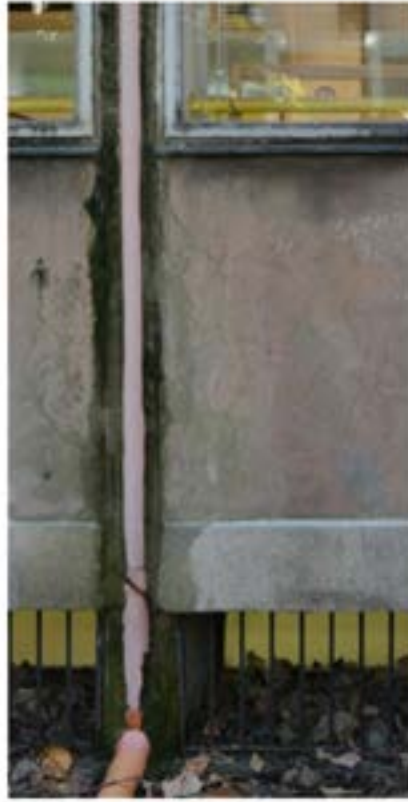
Decay survey_decay mapping
Biological colonization

Location of the decay: it's localized in number(33) and number (34)

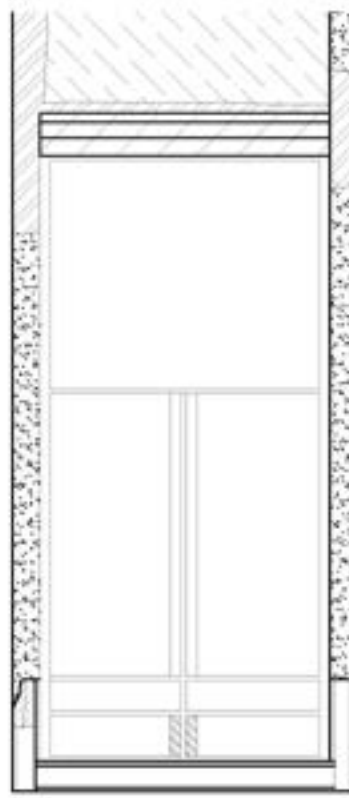
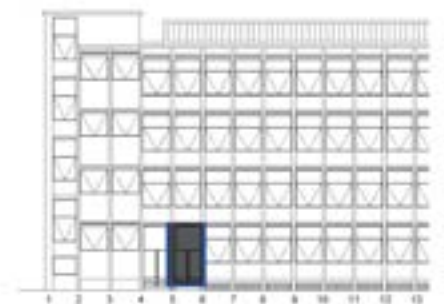
Decay survey_decay mapping
Detachment

-   discoloration
-   deposit
-   corrosion
-   missing part
-   intergration
-   detachment

Location of the decay: it's localized in number(5)and number(6)

Cleaning and removing some parts and then adding the replacement with same materials and color. At first, we can remove and clean the deposits on our surface by brushing. Then the solution is grouting of missing parts, detached and removed parts bay using lime mortar, added with natural pigments in order to acquire the same color with the existing ones on our surface. We can also fill the cracks with lime mortar.

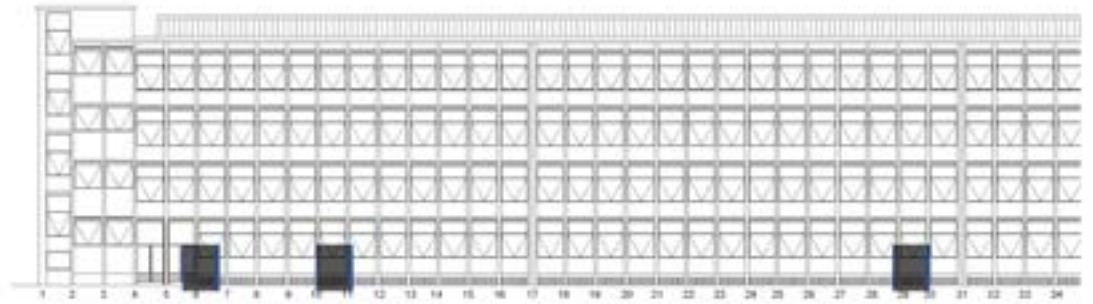
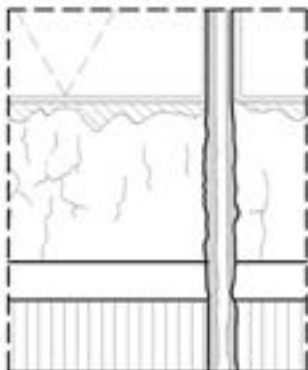
Decay survey_decay mapping
 Elements decay: finishing of the closure wall

Location of the closure wall: there're localized in span(29) (6) and (10)

Drafting of hair cracks (Position1)

- missing part
- biological colonization
- detachment
- hair crack
- moist area

A general state of the plaster of the closure walls: most of the faded in color, minor parts of them peeled off , meanwhile ,minor part of them there is a hair cracks happened.

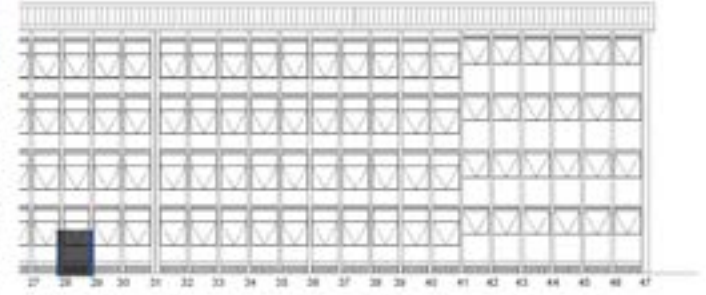
Finishing detached partly (photo from the front)

Location of the lintel: it's localized between vertical elements of number(28) and number(29)

Totally, there are 44 lintels. Most of them all covered in good condition. One of them on which detachments happened and another one of them the finishing completely detached.

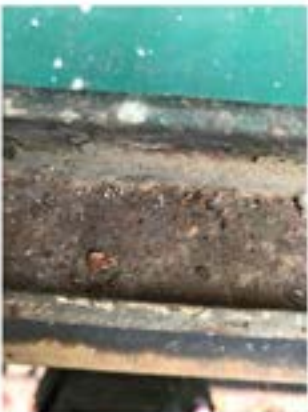
channel of the frame

Corrosion and discoloration

In west facade, there is only two doors in span(4) and (5): they are closed normally. From the frame inside stays well. Only a part of the bottom there is a corrosion. There are 225 windows in west facade:(14) are refurbished windows on the north part, the rest(211) windows are corroded with deposit on the flashing, discoloration on the copper profile and corrosion on the windows frame.

Cleaning by hand is the best way to remove thick corrosion layers, working with fine hand-tools and with the aid of a low power microscope. Chemical cleaning maybe is not the best way because it cannot easily be controlled and some chemicals may remain on the object.

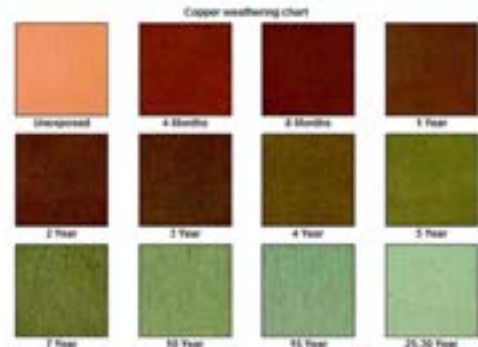
On the west elevation the flashings and awnings are made of copper that allow rainwater to fall down without contacting the facade in order to prevent damaging. Over time copper will naturally change colors-transformation from a shiny brown color to darker browns. Then blues and finally greens after a number of years. When exposed to the natural elements such as wind and rain, copper develops this "painting" which actually protects and preserves the metal underneath.

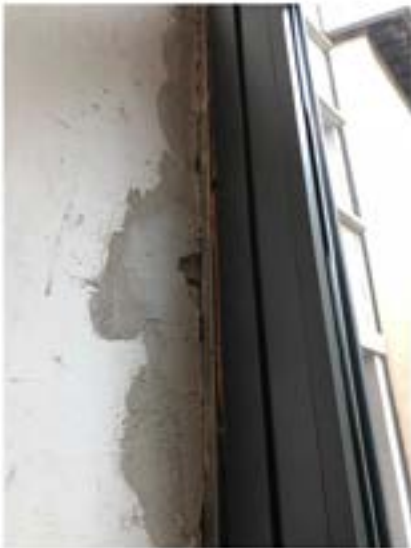
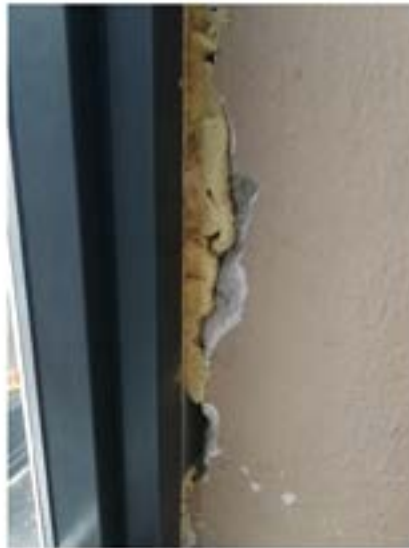
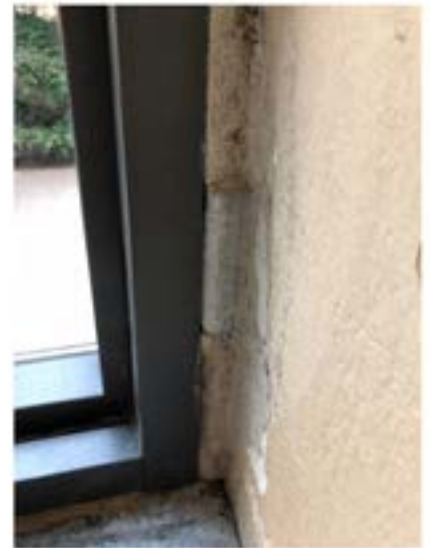
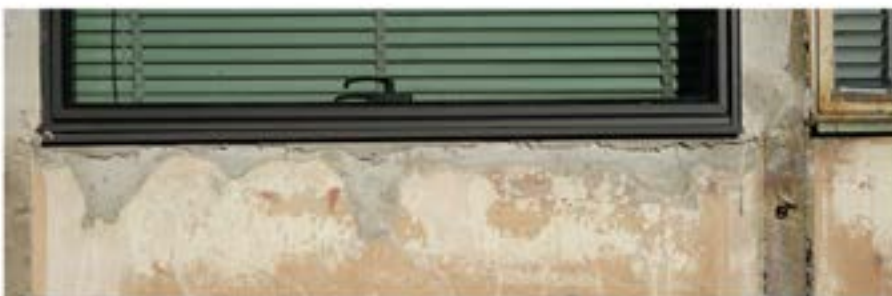
For assembling the sub-frames of doors and windows, the refurbishment is done in a very inappropriate way.

They have engraved the columns for connecting the subframes with walls. Then it is exposed and in some parts are covered by a layer of cement mortar in an inappropriate way.

| | Grouting lime mortar on cracks and detached parts of the surface. | | Removal of inappropriate cement mortar from the surface. |

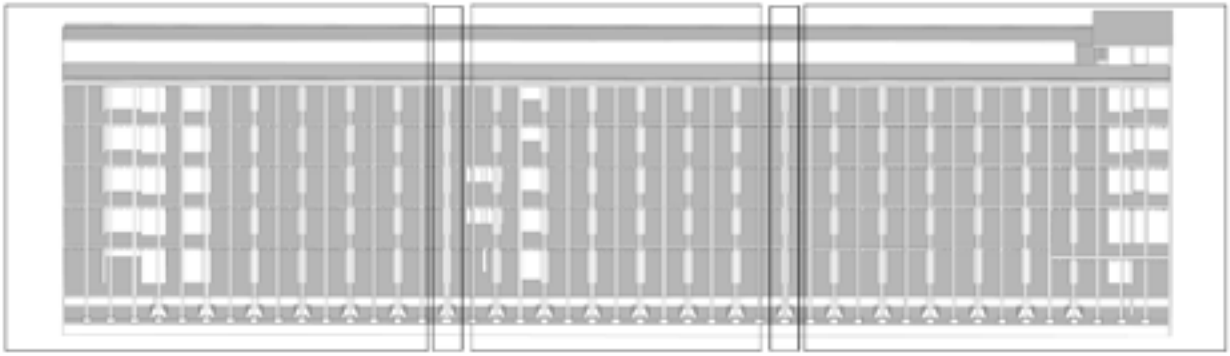
There are two junctions between the whole building. So, this building is like three separate buildings from structure view. However, there are only shear walls on both sides. The first thing we need to consider is to reinforce the middle part of the building.

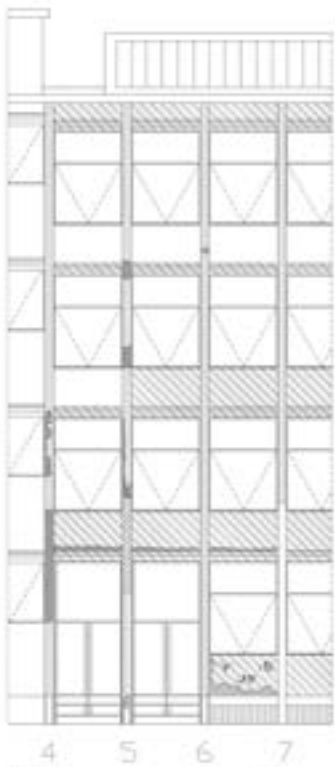
Material mapping and preservation detail

Mortars detachment and cracks of facade
