The study area: Mendelssohn Street

Current situation

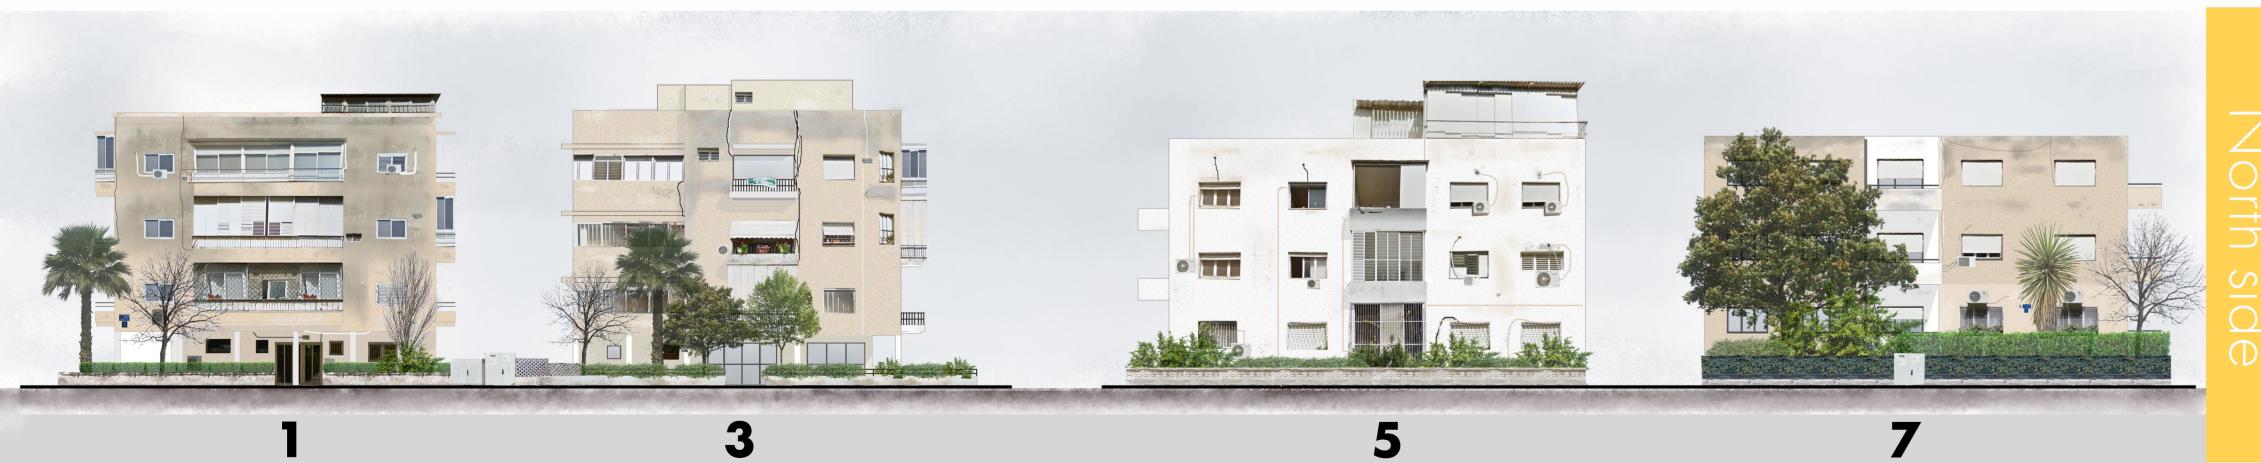
- -Pouring
- -Exfoliation -Falling surface layer of the plaster
- -Improper integration
- -Improper elements
- -Pouring
- -Exfoliation

- -Falling surface layer of the plaster
- -Improper integration
- -Improper elements
- -Deterioration of dimming systems
- -Pouring
- -Falling surface layer of the plaster
- -Improper integration
- -Improper elements
- -Deterioration on dimming systems
- -Pouring
- -Exfoliation
- -Falling surface layer of the plaster
- -Improper integration
- -Improper elements
- -Improper colour integration

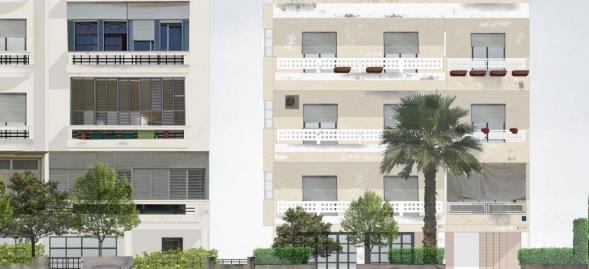
-Pouring

- -Improper elements (visible -Pouring
 - -Exfoliation
 - -Falling surface layer of the plaster
 - -Improper integration
 - -Improper elements
 - -Improper colour integration
- -Pouring
- -Falling surface layer of the plaster
- -Improper integration
- -Improper elements
- -Anthropic modifications
