# RESTORATION

In the history of Società Umanitaria building, a restoration work occurred in the 90's. The work has been mainly made on the plasters, which have been cleaned, repaired and, for some of them, painted.

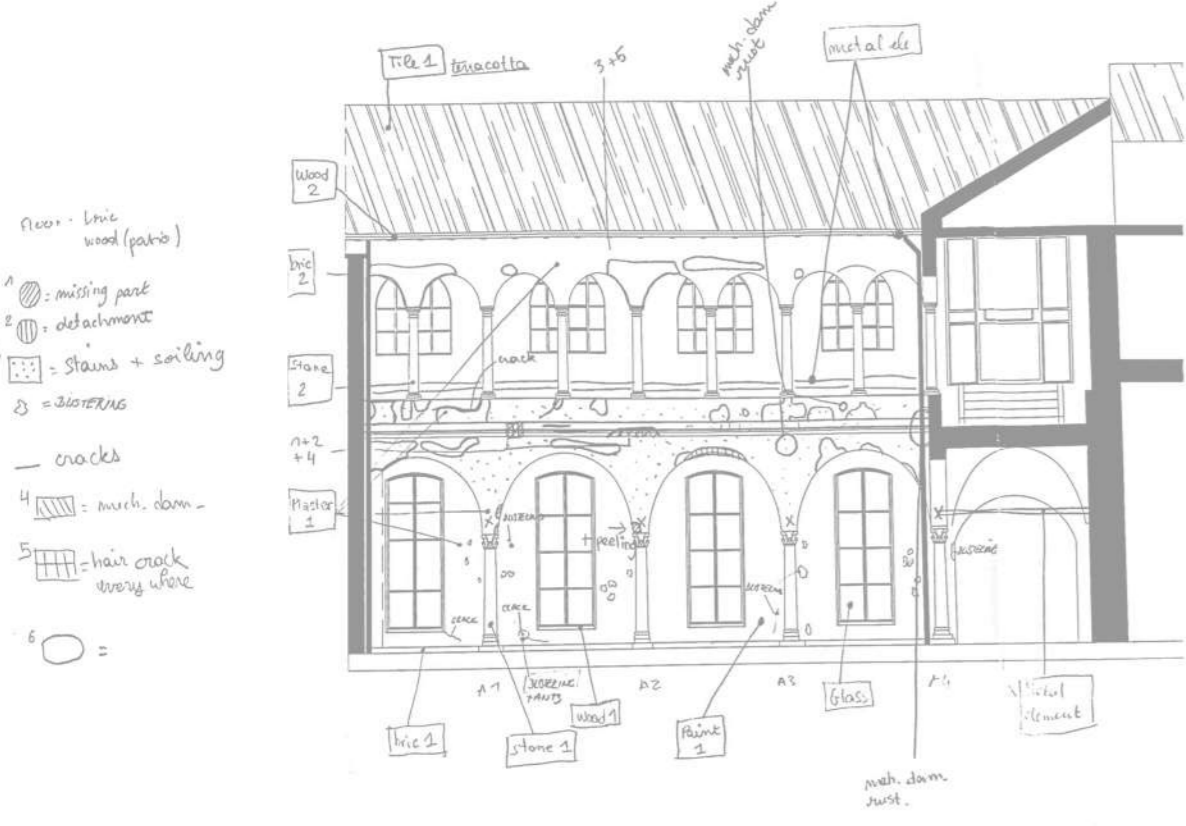
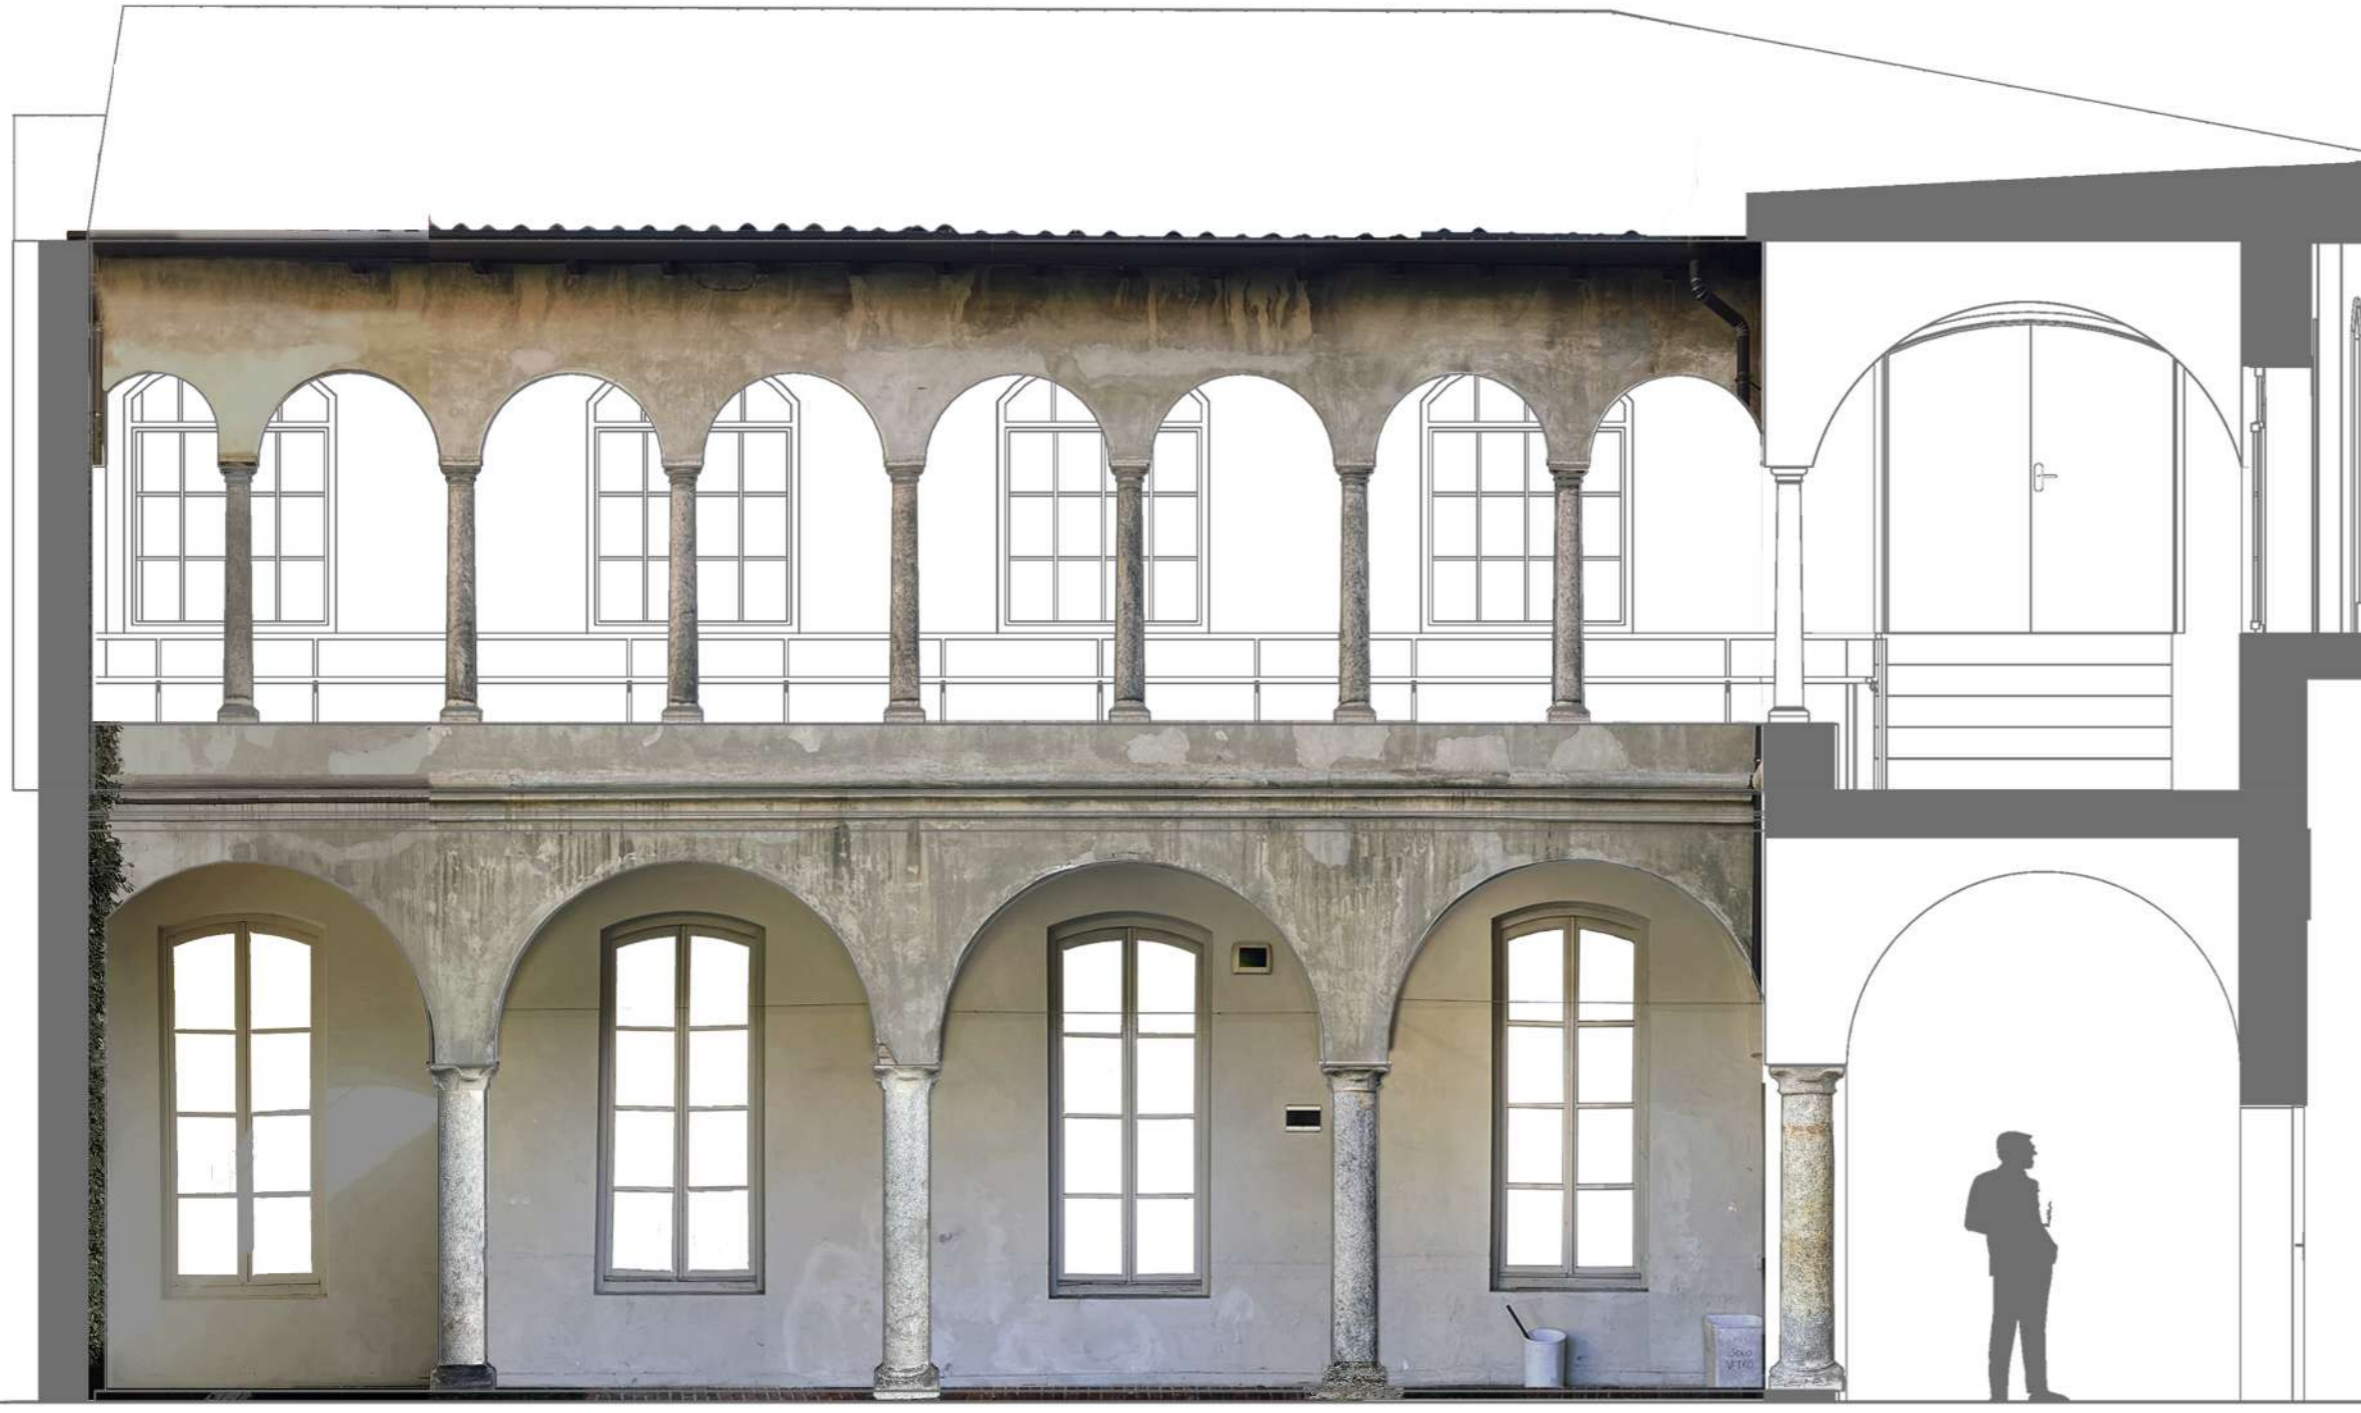
ORTHOPHOTO  
1/50

Unfortunately, the work marked the architecture in time. The technics left some clear decays on the work itself but also on the original materials. The products used were not fitting the cloister's components and it created deterioration. After a deep analysis of the cloister's structure and the existent materials, a different method of intervention has been chosen to repair and restore Società Umanitaria. The intervention is presented on Chiostro della Memoria.

The exterior plaster will be entirely removed and replaced by a plaster which fits the original brick structure. The interior plaster will be restored taking care of the humidity and rising damp problem. Concerning the columns in serizzo stone, they will be cleaned and their mastic will be replaced by a stone fitting mortar.
