POLITECNICO DI MILANO

CORSO DI LAUREA IN INGEGNERIA DEI SISTEMI EDILIZI

**APPLICATION OF THE FACTOR METHOD TO THE PREDICTION OF
THE SERVICE LIFE OF CERAMIC EXTERNAL WALL CLADDINGS**

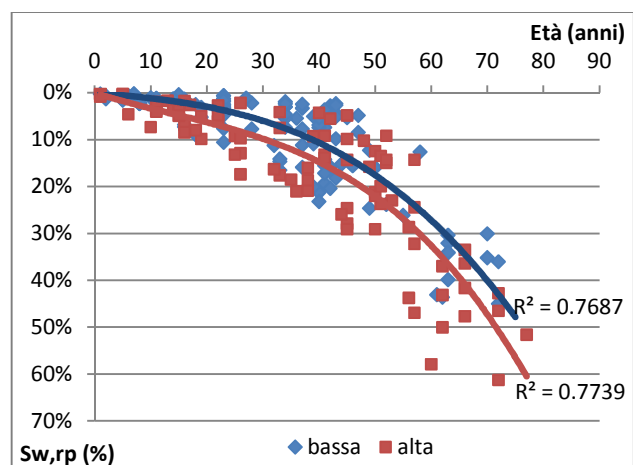
Figura 4.3 - Evoluzione del degrado in base all'esposizione all'umidità

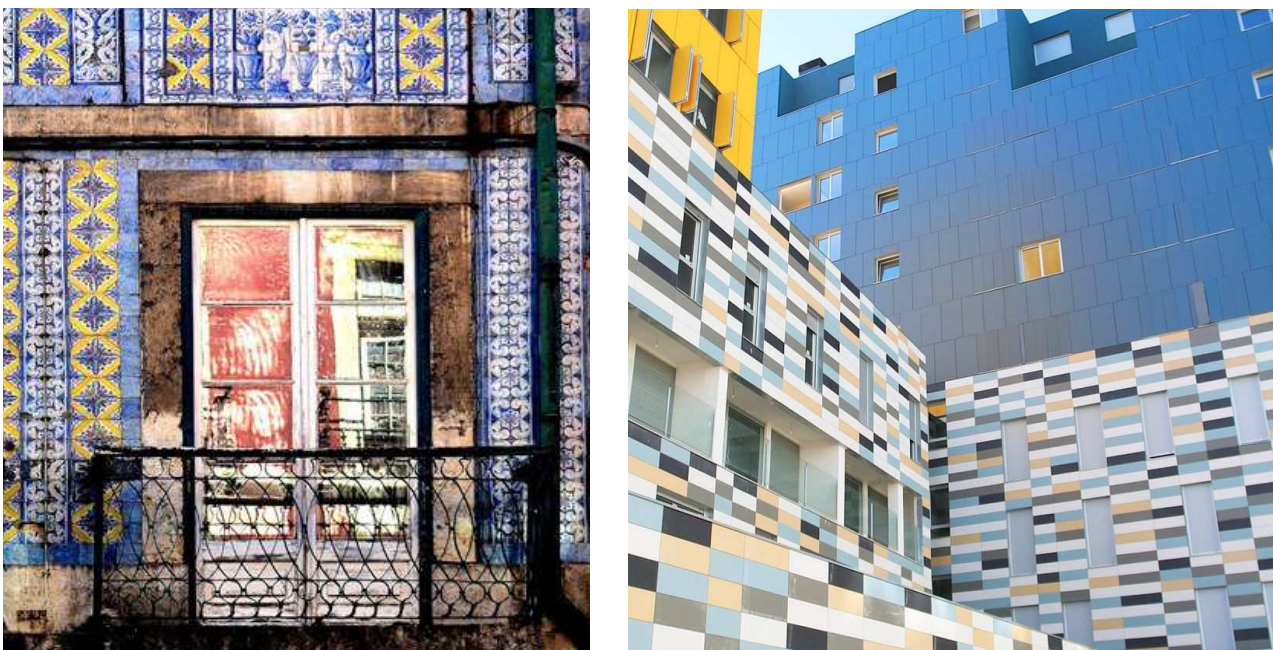
Only recently, with the current awareness about the importance of these aspects, did the use of ceramic tiles as an external cladding system begun to increase again, with the enhancement of installation techniques and the development of new applications (Figure 1.1). An example is represented by ventilated façades, which have been widely used in the last years.

Figure 1.1 - Examples of ceramic external wall claddings: traditional and new façades

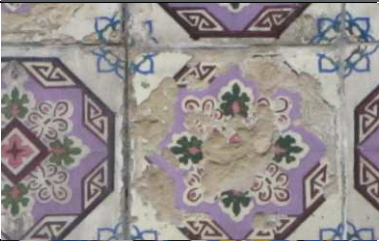
Degradation	Areas showing scratching or abrasions or missing tiles glaze	Natural aging/Incorrect cleaning/Choice of materials not suitable for use/Shocks

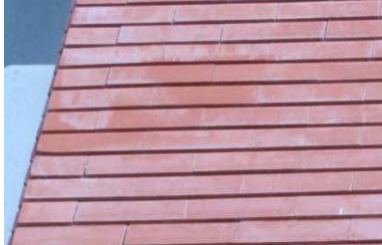
Efflorescences	Presence of salts in tiles, bedding material or substrate that, as a result of humidification, are transported to the surface and therein crystallize	Moisture/Incorrect choice of materials

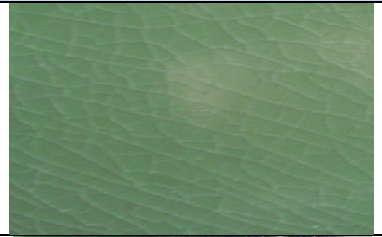
Anomalies		Description	Possible causes	Examples
Cracking	Glazing cracking	Cracks only affect the glazed surface; they intertwine in the form of a lacework	Different thermal expansion coefficient of the glazed surface from the body of the tile/Thermal shocks/Contraction of bedding materials transmitted to tiles surface

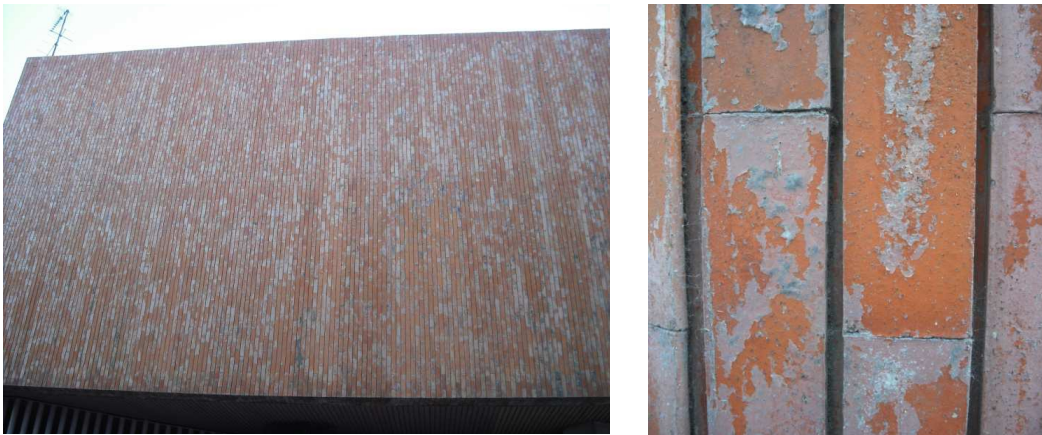
After an inspection *in situ* it has been ascertained that the high severity of the degradation is due to the efflorescence, which is widespread all over the wall cladding (Figure 3.4). This is probably the result of a seriously wrong (or missing) design of the bedding mortar materials; the salts efflorescence affects most of the façade surface. As a consequence of the bad design, this case cannot be statistically modelled; in fact, it corresponds to an abnormal situation and it would not make sense to include it into the sample.

Figure 3.4 - Façade excluded; on the right a detail of the efflorescence affecting the cladding

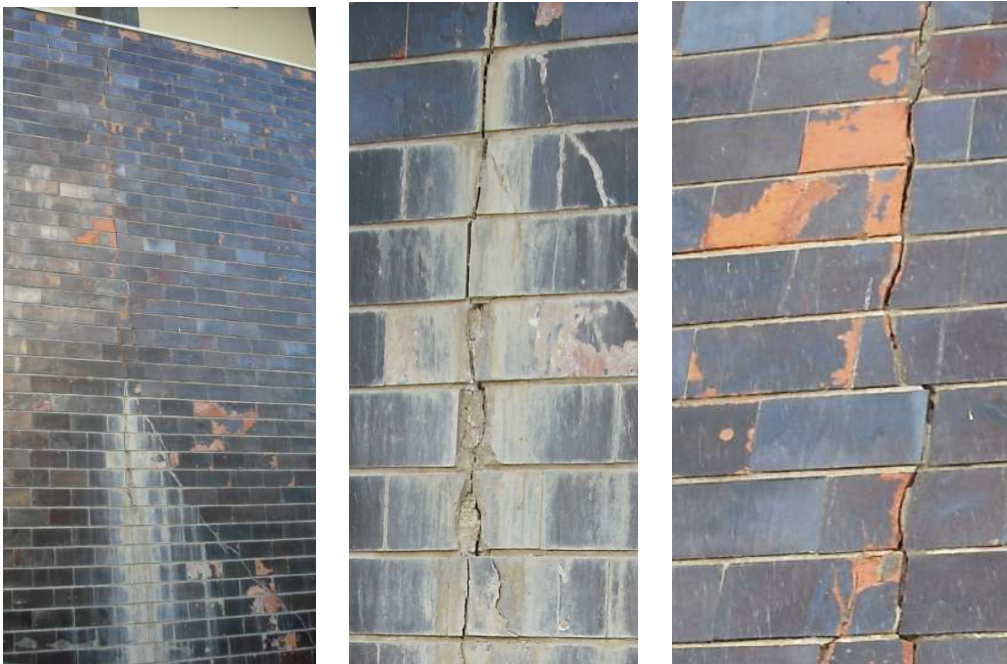
In this case of the evaluation of the degradation is obviously far from reality because of a big markedly orientated crack that runs through the whole height of the wall (Figure 3.5). It affects not only the cladding, but also the structure and it causes serious infiltration and efflorescence. This situation is clearly

caused by a problem of foundations settlement and it is not related to the normal degradation evolution of the ceramic cladding.

Figure 3.5 - Cracking in the building in Avenida do Infante Santo.

On the left the whole crack can be seen; the centre and right pictures show details thereof

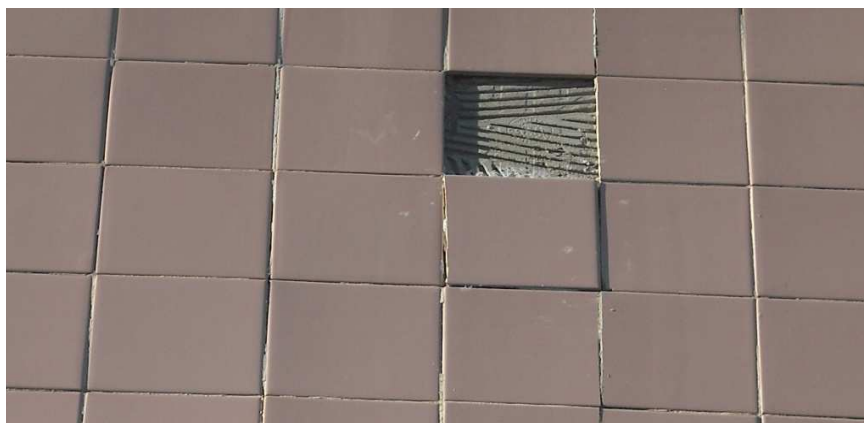
Figure 3.7 - Detachment detail of the excluded façade

The façade is part of the previously analyzed building; but in this case the abnormal degradation value (very high if compared with the façade age) is probably the result of a grossly deficient execution. The cladding features joints deterioration, lack of flatness and localized detachment. Figure 3.7 shows how the mortar has not been properly pressed, causing swelling and detachment.

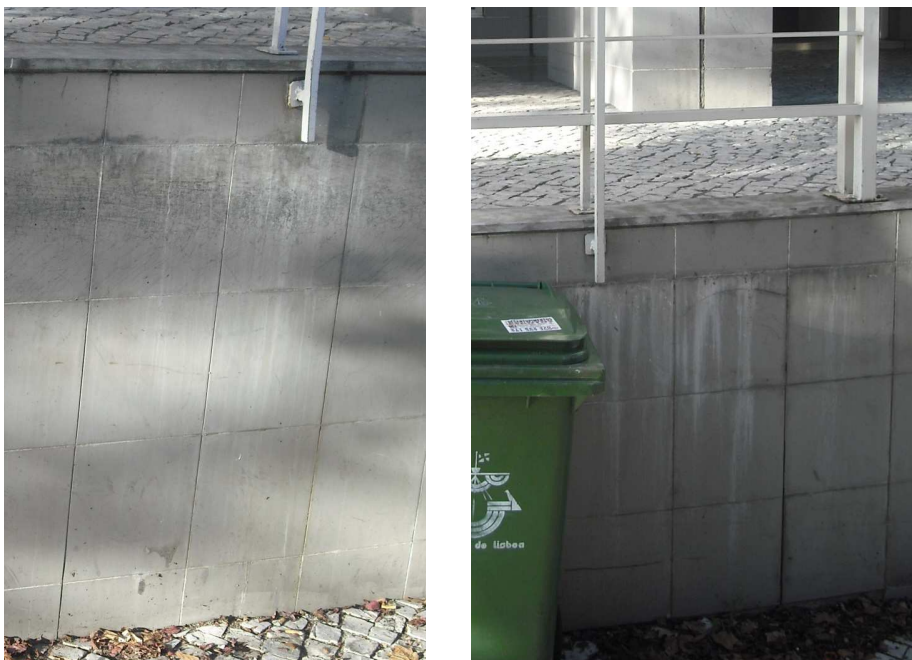
Figure 3.8 - Evidence of the anomalous state of deterioration of the excluded building

These are two façades of the same block of flats (orientation South and East). In the evaluation of degradation of Sousa (2008) a widespread joint deterioration came out, raising much the degradation level. After the *in situ* inspection, was determined that the claddings don't present any defects but a severe lack of flatness, as seen in Figure 3.9. So, what had been considered as joints degradation is actually really poor execution and it's not related to a "normal" deterioration evolution. For this reason it has been decided to remove the façades from the collected sample.

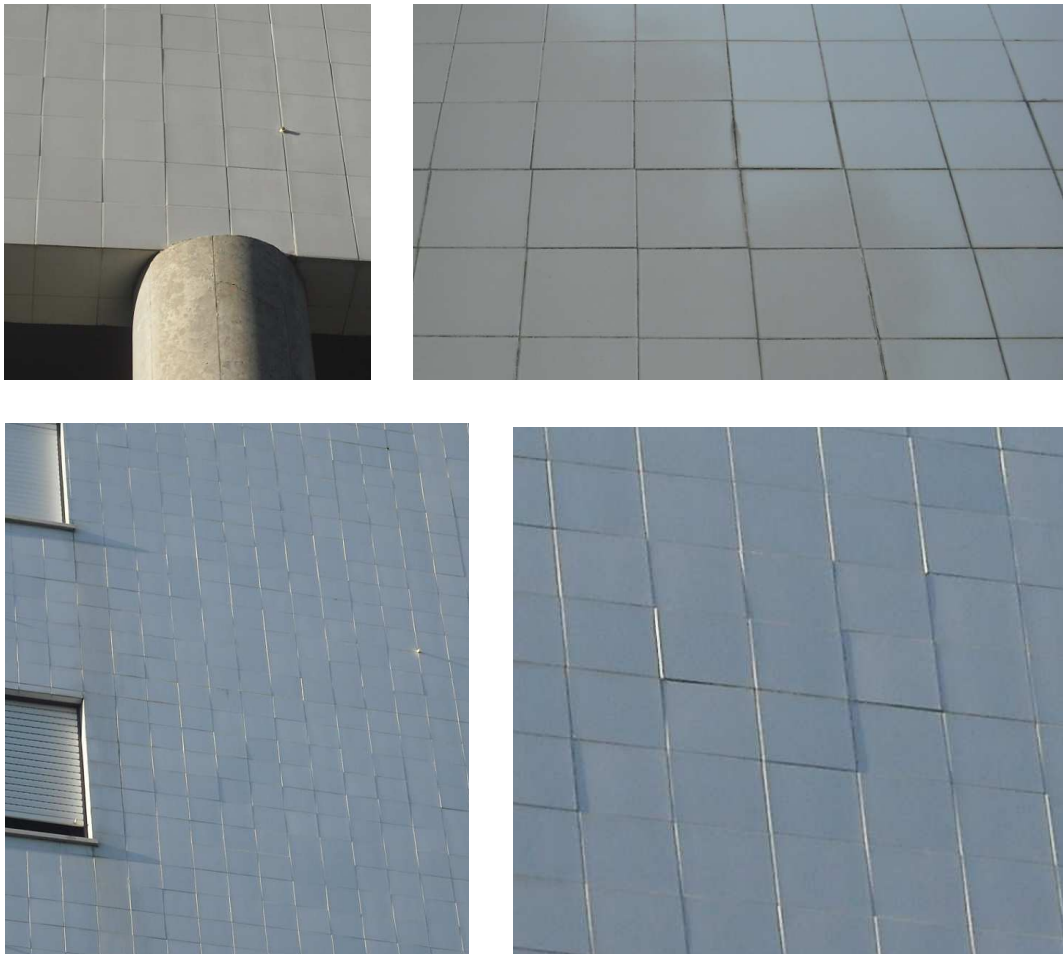
Figure 3.9 - Lack of flatness of the cladding in the building located in Rua José Escada.

The first two pictures refer to the East façade. The pictures below refer to the South façade

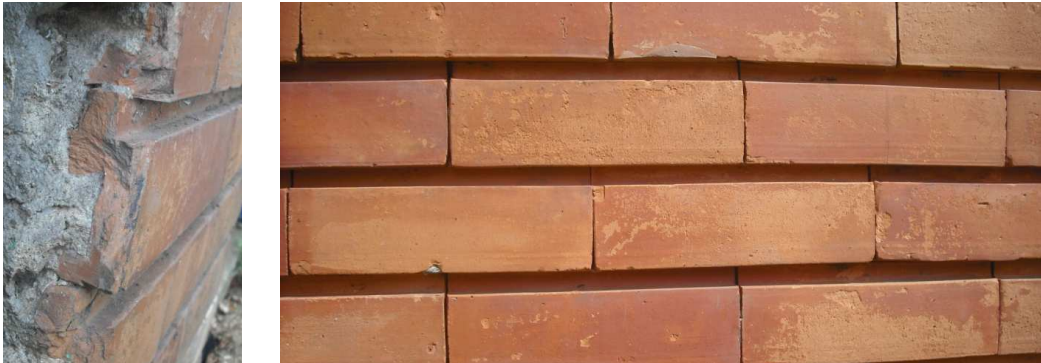
Figure 3.15 - Bricks façade of the Encarnação Norte market

This is no ceramic cladding, but a solid bricks wall (Figure 3.15). It has been taken out from the sample.

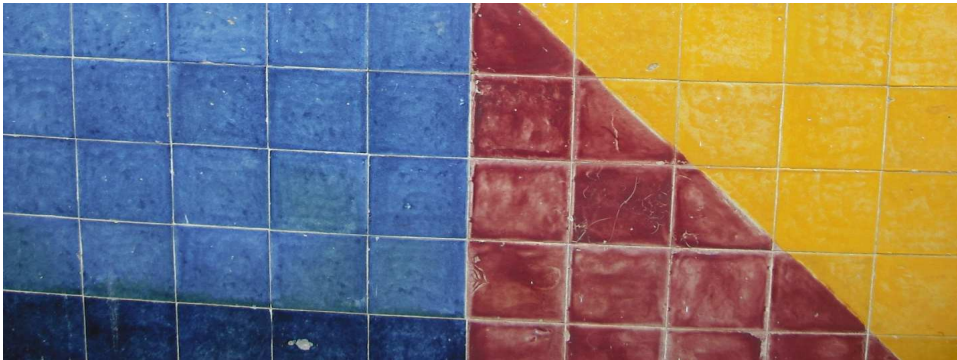
Figure 3.16 - Portion of the façade of the building in S. Domingo de Benfica; one can see the hand painted tiles

An inspection proved that these are hand painted matt tiles. For this, the opaque effect is an artistic choice and it is not due to degradation (Figure 3.16). In addition to this, the cracking and the joint deterioration had been overvalued; visual inspection proved that the percentage area affected by those anomalies is significantly less than in Sousa's (2008) assessment. The method used for the evaluations is the one described in Gaspar (2009), already used by Silva (2009) and Emídio (2012). It consists of visual inspection, application of image processing, computer aided design and spreadsheet. It is described more thoroughly in section 3.5.1.

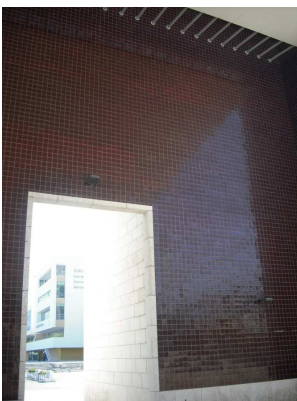
Figure 3.19 - The opposite façades of the Pavilhão de Portugal, located in Santa Maria dos Olivais

Regarding the detected anomalies, the north façade was considered to have the 90% of the surface affected by the change in brightness; after the current inspection was found that this is not change in the tiles colour, but superficial dirt. More than this, the cracking in the façade had been definitely overvalued by Sousa (2008). The final value of the degradation severity (3.8%) is more similar to the Silvestre (2005) one (4.4%); the percentage of Sousa (2008) was 10.2%.

The same goes for the opposite façade. An accurate inspection led to a value of the severity that replaces the previous ones in the sample. In this case the 2005 degradation evaluation is considered to be lightly undervalued, whereas the analysis of Sousa (2008) is more reliable. The severity values regarding this façade are: 0.1% (2005), 5.9% (2008) and 4.9% (2012).

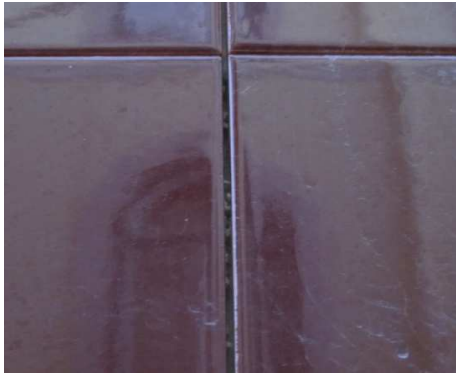
Figure 3.42 - Façade featuring joints deterioration

The first case concerns a building located in São Mamede. Here the façades had been recently repaired (2010), contextually to the refurbishment of the entire house. But, in spite of the young age of the cladding, it features widespread joints deterioration with loss of material (Figure 3.42). As the date of the refurbishment that was found in the archives of the Lisboa Municipality has been confirmed by the tenants and the neighbours, this has been considered reliable. The only explanation for this degradation severity is the bad execution, causing the cladding elimination from the sample.

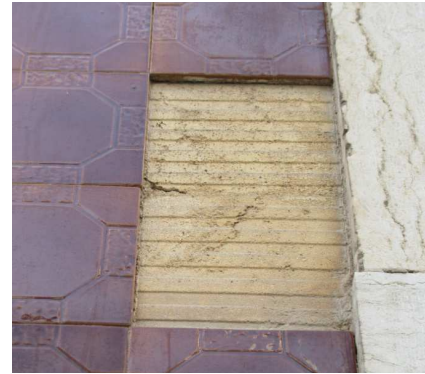
Figure 3.43 - Excluded façade: the mortar has not been adequately pressed

The second element that has been removed is a façade located in Santo Condestável. This building is 47 years old. It presents glaze cracking and joints deterioration with loss of material. But the most severe anomaly is the adhesive failure: this increase the severity value up to 46.4%. Also in this case the cause of

such a bad deterioration has been found in a deficient execution of the façade. As seen in Figure 3.43, the mortar has not been properly pressed, with the result of adhesive failure and detachment.

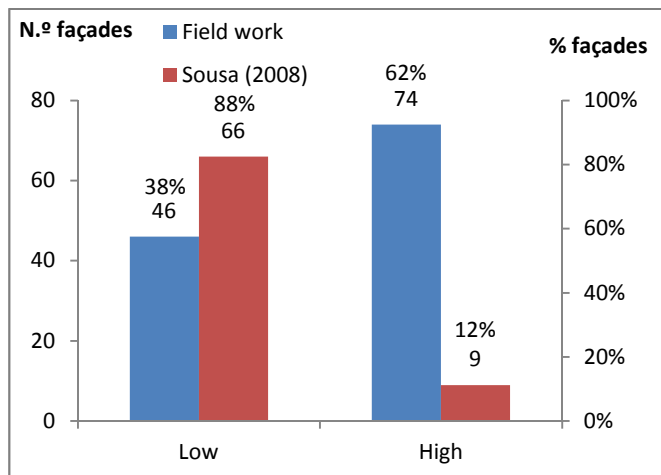
Figure 3.52 - Comparison between the results of Sousa (2008) and the current work

The same goes for the humidity exposition. In the final sample the gap existing in the outcomes of Sousa (2008) has been narrowed (Figures 3.52 and 3.53).

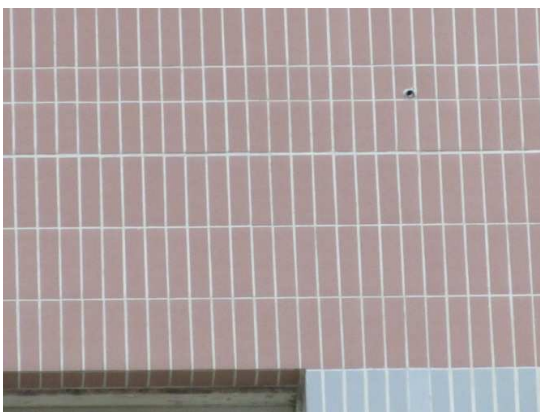
Figure 4.1 – Degradation level 1

In order to give a general visual idea of the set categorization, the pictures below show ceramic claddings featuring values of $S_{w,rp}$ that involve a change of the degradation level. Figure 4.1 concerns a façades that does not present visible degradation ($S_{w,rp}$ around 1%). The façade in Figure 4.2 has a severity value of around 6%; it is visible how it features mainly aesthetical defects (superficial dirt). Figure 4.3 shows an external cladding that has reached the end of its service life ($S_{w,rp}$ around 20%). One can notice the widespread aesthetical anomalies, as the emergence of some serious defects like joints deterioration and detachment; this causes the non-fulfilment of the aesthetical, functional and safety requirements of the ceramic cladding. The façade of Figure 4.4 is far beyond the limit state of service life ($S_{w,rp}$ over 50%), being affected by extensive serious anomalies, such as generalized detachment.

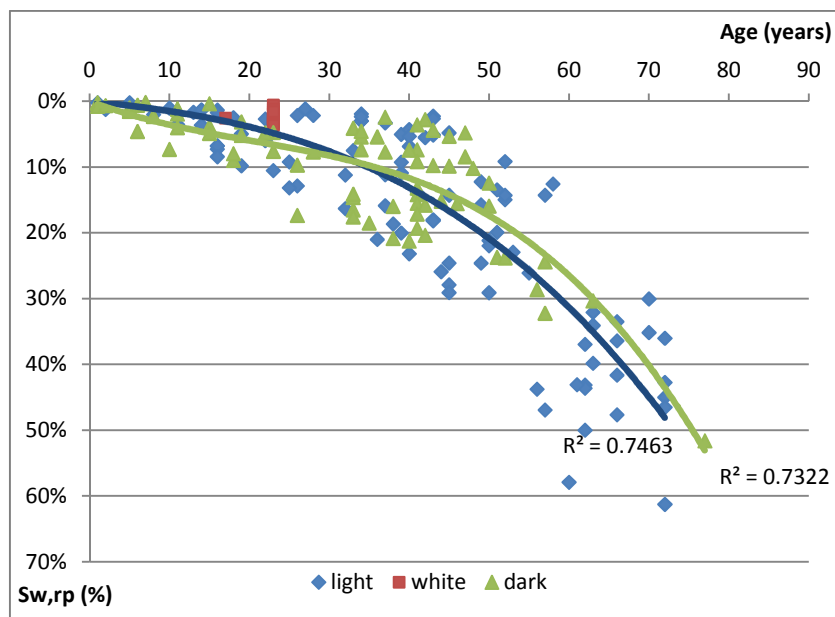
The same happens with the colour (Figure 4.18). Although the R^2 coefficients are rather high (values higher than 0.7), the layouts of the curves are inconsistent. The light coloured claddings were expected to show a slightly better condition, but the lines cross at approximately 30 years. Concerning the white coloured tiles, it was not possible to reach a sufficient number of elements to plot a graph. In fact, only 15 white claddings have been collected during the field work. As mentioned in paragraph 3.6.2, this is an indication of the infrequent use of this type of tile.

Figure 4.18 - Overall degradation curve according to tiles colour

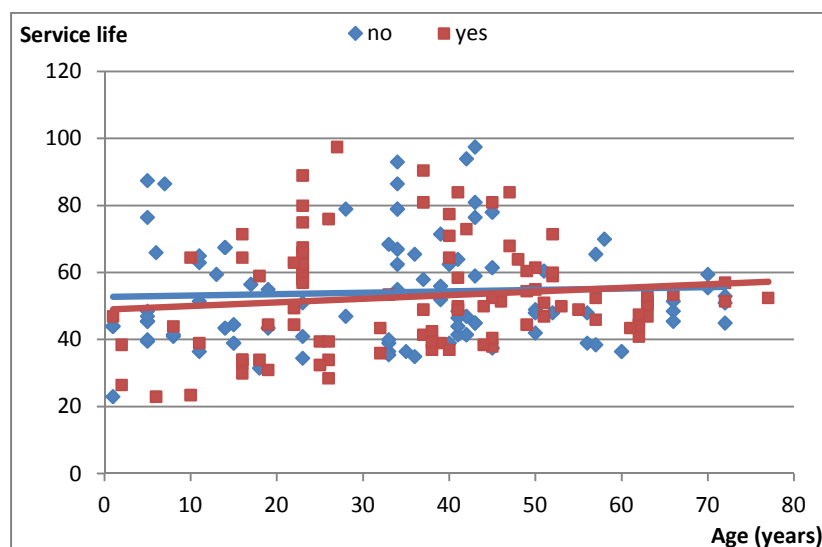
Figure 5.16 - Service life distribution over time according to peripheral protections

Concerning peripheral joints and protections, the outcomes are presented in Figures 5.15 and 5.16. Regression lines are overlapping; in addition to this, claddings with peripheral joints gave worse result than the façades that does not have any, which does not make sense. The cause is probably traced to the lack of data regarding protected façades. For this, both analyses are considered inconclusive.

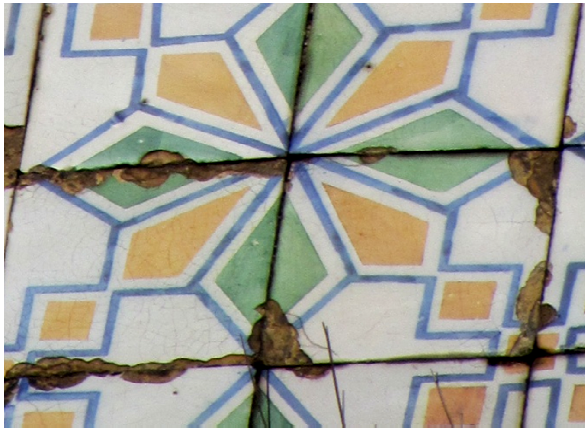
Edge crushing

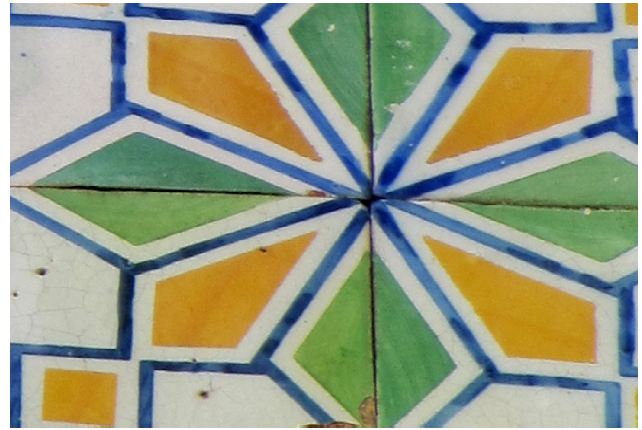
Small spots on the surface

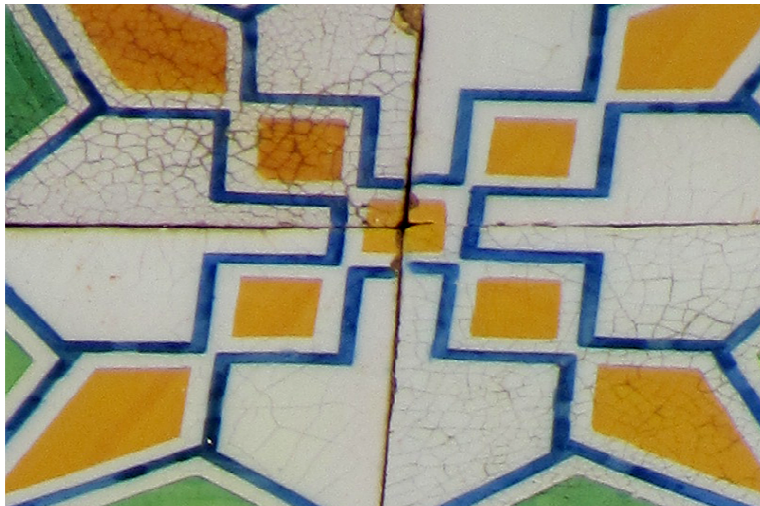
Glazing cracking

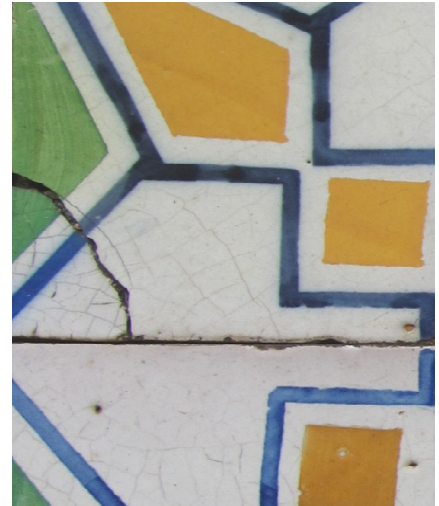
Cracking without predominant direction

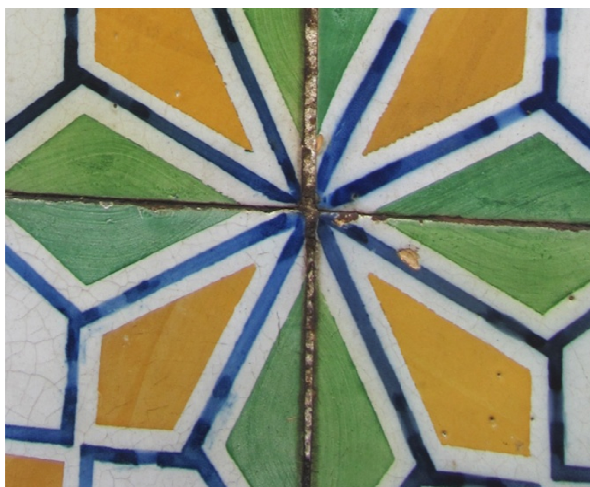
Joint deterioration without loss of material

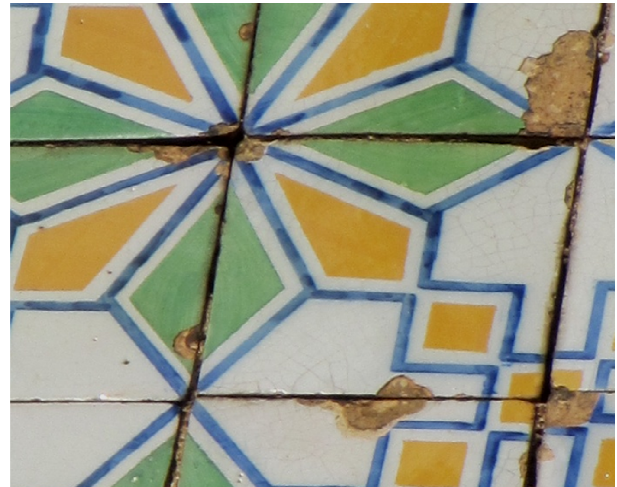
Joint deterioration with loss of material
