Case Study 2.1 Deep retrofit with extension

Renovation of residential area in Dieselweg 3-19, Graz

Case Study 2.2 Deep retrofit

Renovation of residential area in Dieselweg 4, Graz

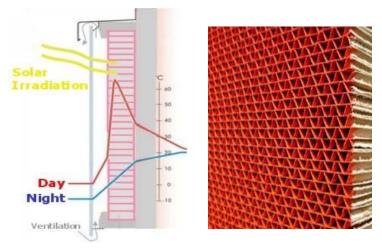
Figure 4 - basic behaviour of the solar comb and cavity detail

The solar façade basic principle is the one of the solar comb, which is arranged in the OSB board, covered by a glass panel. A rear-ventilated air space is located in between these two layers and accumulates sun heat gains to store it. During the night, it is released in the internal ambient giving higher night-time comfort. The incoming sunlight enter through the glass and increase the temperature in the comb holes, which during the night insulate the wall, and during the day convey the heat in the ambient (see Figure 4).

The increased temperature in the day in winter limits the losses towards the ambient and gives an improved effective U-value (compared to the static U-value). In addition to this system, produced by Gap Solutions GmbH, the façade modules are equipped with further integrated components like windows, shading appliances. In this case, the blinds are arranged between the glass panels of the windows. The ducts are located beside the windows, behind the more bright yellow glass panels in order to avoid look-through.

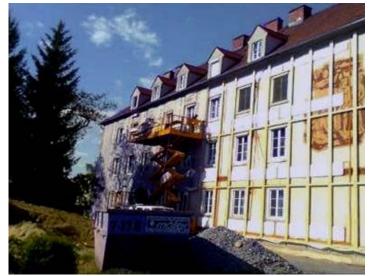
Figure 6 - Heat distribution and XPS-boards are installed on the existing facade

- 5 m3 heat storage tanks have been installed in the basement, with three of them just for the Dieselweh 3-19. They are supplied by the solar thermal plant and by a ground heat pump.
- Supply pipes are installed in the space between existing façade and new façade modules, resulting in a new system of heat distribution.
- The heat distribution system is mounted on the outside of the exterior wall. The heating pipes are integrated in insulation boards made of XPS and visible in Figure 6.
- Domestic hot water production is decentralized for each apartment, but supplied by the heat storage tanks

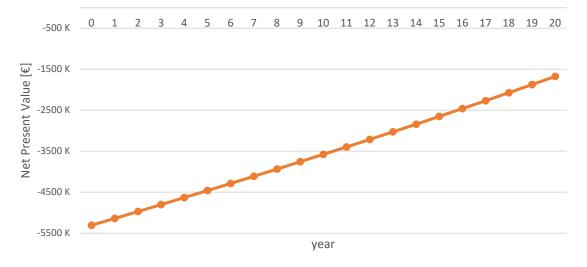
Figure 10 - Extimated investment scenario

In the following an approximated evaluation of the economic balance (Net Present Value). A possible observation is that without incentives and without rent increase (usually reached thanks to a space extension) is very difficult to reach a reasonable payback time.

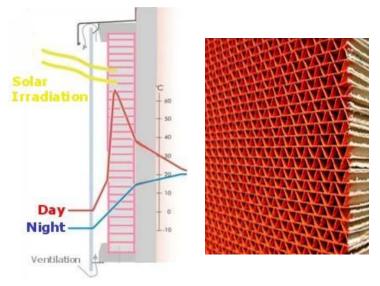
Figure 4 - basic behaviour of the solar comb and cavity detail

The solar façade basic principle is the one of the solar comb, which is arranged in the OSB board, covered by a glass panel. A rear-ventilated air space is located in between these two layers and accumulates sun heat gains to store it. During the night, it is released in the internal ambient. The incoming sunlight enter through the glass and increase the temperature in the comb holes, which during the night insulate the wall, and during the day convey the heat in the ambient (see Figure 4).

The increased temperature in the day in winter limits the lossed towards the ambient and gives an improved effective U-value (compared to the static U-value). In addition to this system, produced by Gap Solutions GmbH, the façade modules are equipped with further integrated components like windows, shading appliances. In this case, the blinds are arranged between the glass panels of the windows. The ducts are located beside the windows, behind the more bright yellow glass panels in order to avoid look-through.

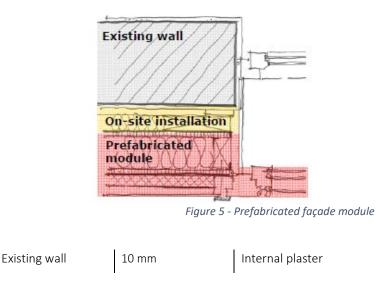
300 mm	Existing exterior wall
	25 mm	External plaster
On-site installation	100 mm	Levelling laths inbetween rock wool
Prefabricated	19 mm	OSB-board
module	120 mm	Timber frame between rock wool
	15 mm	OSB-board
	19 mm	MDF- board
	30 mm	Solar comb
	29 mm	Rear ventilation

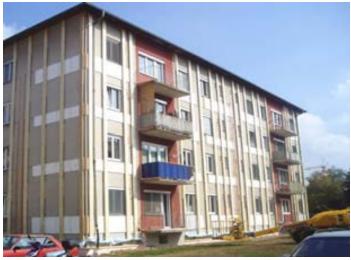
Figure 6 - Heat distribution and XPS-boards are installed on the existing facade

- A 5 m<sup>3</sup> heat storage tank has been installed in the basement for Dieselweg 4 only.
- Supply pipes are installed in the space between existing façade and new façade modules, resulting in a new system of heat distribution.
- The heat distribution system is mounted on the outside of the exterior wall. The heating pipes are integrated in insulation boards made of XPS and visible in Figure 6.
- Domestic hot water production is decentralized for each apartment, but supplied by the heat storage tanks.

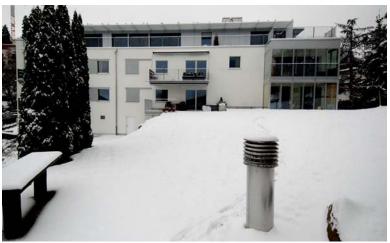
Figure 3 - Air intake is placed 20 m in front of the house

A heat recovery system was installed, with the addition of a moisture recovery system, in order to prevent dry air during winter. A central air intake pipe was installed a short distant from the building, as it is visible in the figure.

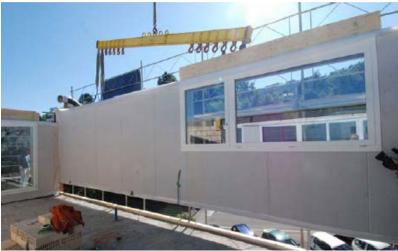
Figure 5 - Mounting of the prefab structure

A peculiarity of this intervention is that the prefabricated attic was installed next to the old structure. While the old structure was made of concrete floor slabs and brick walls, the lightweight structure was completely prefabricated in timber with glass wool infills. In this perspective, it is important to limit the weight of the superimposing element in order to keep under control the static forces. This strategy of creating a new attic allows to not be limited by the geometry of the below building, leaving the possibility to not stay in line with the old walls. In order to mount the new roof elements, the existing inclined roof was removed and the existing wooden beam slab has been reinforced with lightweight concrete and screw bolts.

The existing balconies were clearly bringing cold thermal bridges inside. For this reason they were removed and a new larger steel balcony were installed, already prefabricated, by crane. As the final intervention, the facades of the prefabricated elements were covered with an aluminium cladding.

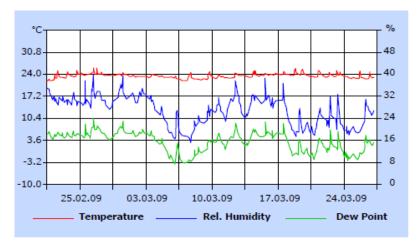
Figure 7 - Room temperatures and relative humidity in typical apartment

After the renovation, temperature and humidity were monitored in the period of time that goes from Christmas to March 2009. Indoor temperatures and humidity were monitored in all the 5 renovated apartments in order to check for the effectiveness of the intervention. Indoor temperatures were as expected by the precalculations, but the humidity was found to be lower than the previous analysis:

- Mean room temp.: 23.4°C
- Lowest room temp.: 18.3°C
- Highest room temp.: 24.1°C
- Mean relative humidity: 29.9%
- Lowest rel. humidity: 17.5%
- Highest rel. humidity: 47.9%

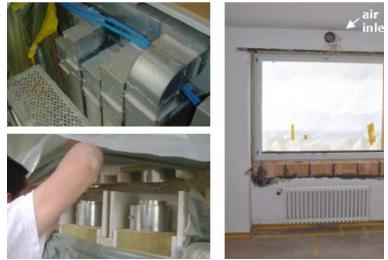
Figure 3 - Ventilation main distribution with space saving rectangular ducts (top left), connecting the telescopic vertical round ducts between façade elements (bottom left), air inlet above window (right)

In the new prefabricated elements, the ventilation ducts are integrated in the new façade elements with the air inlets positioned above each window. They guarantee optimal ventilation of each room and optimizes spaces, since this solution does not consume any valuable interior space to occupy for the ventilation system. In this way the interior room dimensions are not affected by the systems and a suspended ceiling is not required anymore. However, the integration of the ventilation ducts into the prefabricated elements was a technical and constructive challenge since it requires best attention in the design phase.

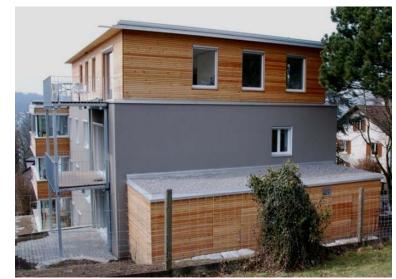
*Figure 5 - Renovated building from the north-eastern side. The building annex is used as technical space for the new heating system (ground coupled heat pump)*

A geothermal heat-pump and by vacuum solar collectors supply space-heating and domestic hot water. 75% of the hot water and 7% of the energy for the space heating are renewable energy from the sun exploitation. On the upper roof, a PV-system was installed with an area of around 115 m<sup>2</sup> and a peak power of production of 16.1 kWp. A small building was added on the north-east side of the house to host the heat pump and the ventilation devices necessary for the systems.

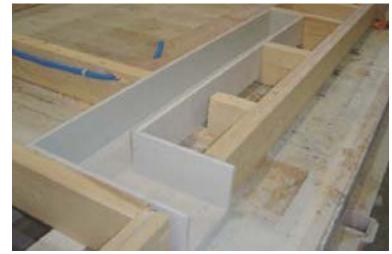
Figure 6 - Factory assembling of façade module with fire proof ventilation cavity

The prefabrication of the façades with timber elements are a newly developed construction method, which has not often been applied in Switzerland previously. The prefab elements were built as large as possible in order to reduce the detail design, e. g. height: 3 m, length: 10 m.

The air distribution system and the electric conduits were placed in the prefabricated elements before they were in-stalled at the building, this practice allow to allocate less space for systems. Unfortunately, the windows arrived too late to the work shop of the carpenter and they could not be built in, and instead they had to be mounted on-site.

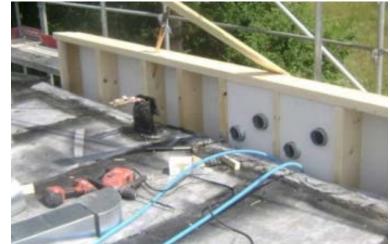
*Figure 7 - The step back of the penthouse floor is used for the horizontal ventilation distribution*

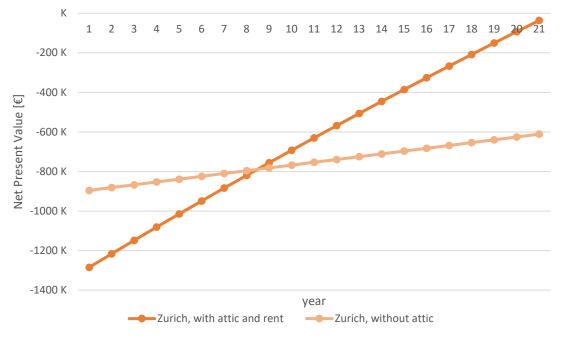
In the following an approximated evaluation of the economic balance (Net Present Value) evaluated in the case of the attic addition and the related rent (dark blue line). The light blue line is instead the case in which the attic is not added and the relative rent income disappear. The lower investment of this case does not allow for an economic reasonable return time.

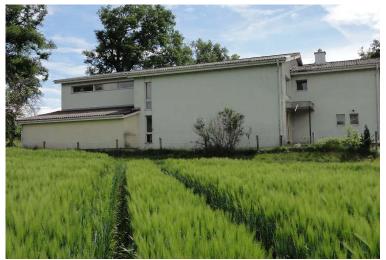
Figure 1 - View of old building and project

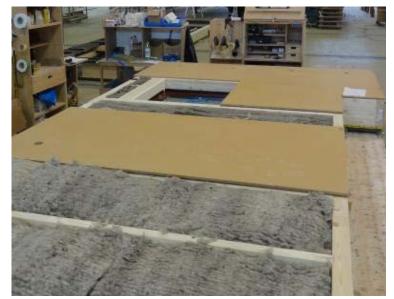
Figure 2 - Timber frame with infills and a medium dense fibre board

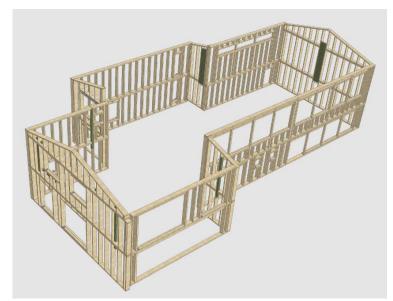
Figure 3 - 3-D sketch of the timber frames, also showing the integrated ventilation pipes (source: Renggli HolzbauWeise)

The vertical distribution is performed connecting vertical pipes to the horizontal ones, and they are fire-protected with a special fireproof mineral wool, as it is visible in Figure 3.

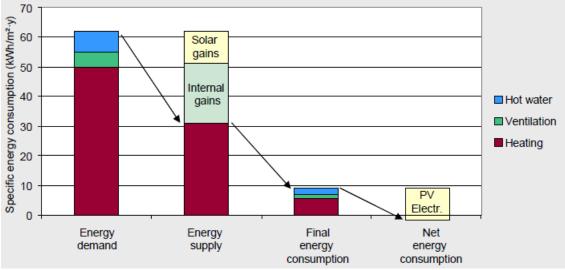
Figure 8 - Energy consumption for heating, ventilation, hot water of renovated Krummbach school building

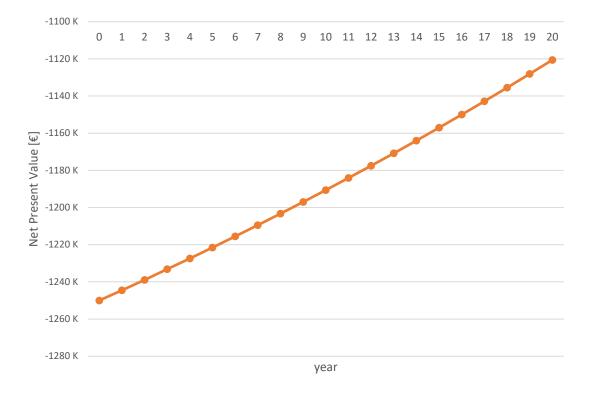
In the following an approximated evaluation of the economic balance (Net Present Value). A possible observation is that without incentives and without rent increase (usually reached thanks to a space extension) is very difficult to reach a reasonable pay back time. The fact that a school does not receive any rent makes it difficult to pay back the investment, giving a very low NPV in front of the great investment outlay.

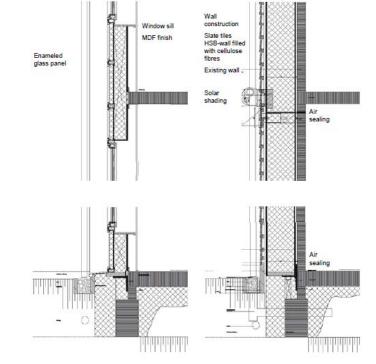
Figure 3 - Wall and basement prefab renovation

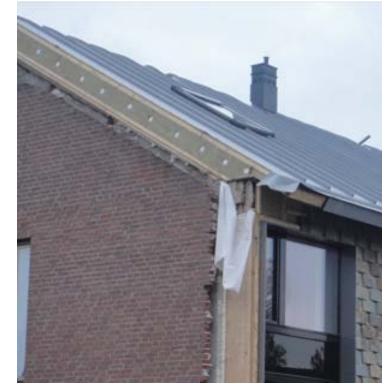
Figure 4 - real section of the timber frame. The external slates and the cellulose insulation are visible, together with the new roof and triple glazing windows

The renovation of Kroeven's complex 505 consisted, as a first step, of the demolition of the outer leaf of the cavity wall. The second phase was to insulate the perimeter around the houses with EPS insulation, and to create the foundation for the prefabricated timber elements. The new prefabricated timber elements are 360 mm wide and contain cellulose fibre insulation of 350 mm. The U-value is 0.11 W/(m<sup>2</sup>·K). Thermally broken windows with triple glazing have been factory mounted on the prefabricated wooden frames. The U-value of the frame is 0.87 W/(m<sup>2</sup>·K), the U-value of the glazing 0.5 W/(m<sup>2</sup>·K) with a g-value of 0.47. The new cavity between the inner leaf and the timber element is sealed around the window frames to avoid thermal bridges. Eventually, battens were mounted on site to allow the installation of natural slate tiles. The external tile, in this way, provides the building with a ventilated façade.

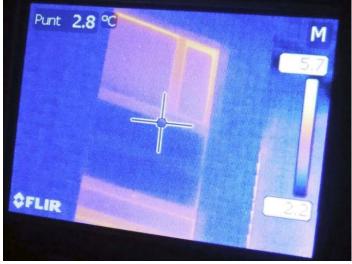
Figure 8 - the energy performances were evaluated with thermal cameras

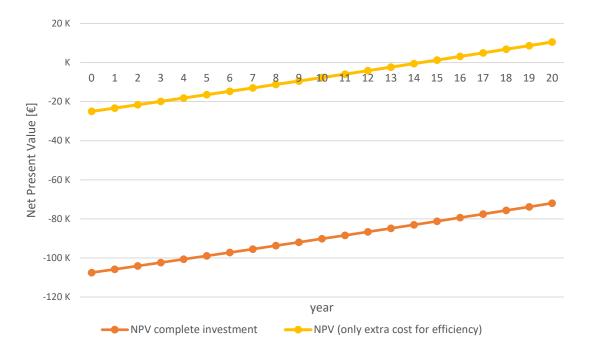
In the following an approximated evaluation of the economic balance (Net Present Value). A possible observation is that without incentives and without rent increase (usually reached thanks to a space extension) is very difficult to reach a reasonable payback time. In yellow the case in which only the extra cost for energy efficiency is considered, in which the "anyway" measures are excluded. This perspective gives a completely new point of view, which push the owner to add energy efficiency when other renovation works are already scheduled.
