ARCHITECTURAL DESIGN STUDIO FOR RESTORATION OF COMPLEX ARCHITECTURE

Conceptual Design Proposal:

ARCHITECTURAL DESIGN STUDIO FOR RESTORATION OF COMPLEX ARCHITECTURE
POLITECNICO DI MILANON
SCHOOL OF ARCHITECTURE, URBAN PLANNING AND CONSTRUCTION ENGINEERING
BUILDING ARCHITECTURE
A.Y. 2018-2019

STUDENTS
XIFANGYAN 891924
DOUHAOMING 893079

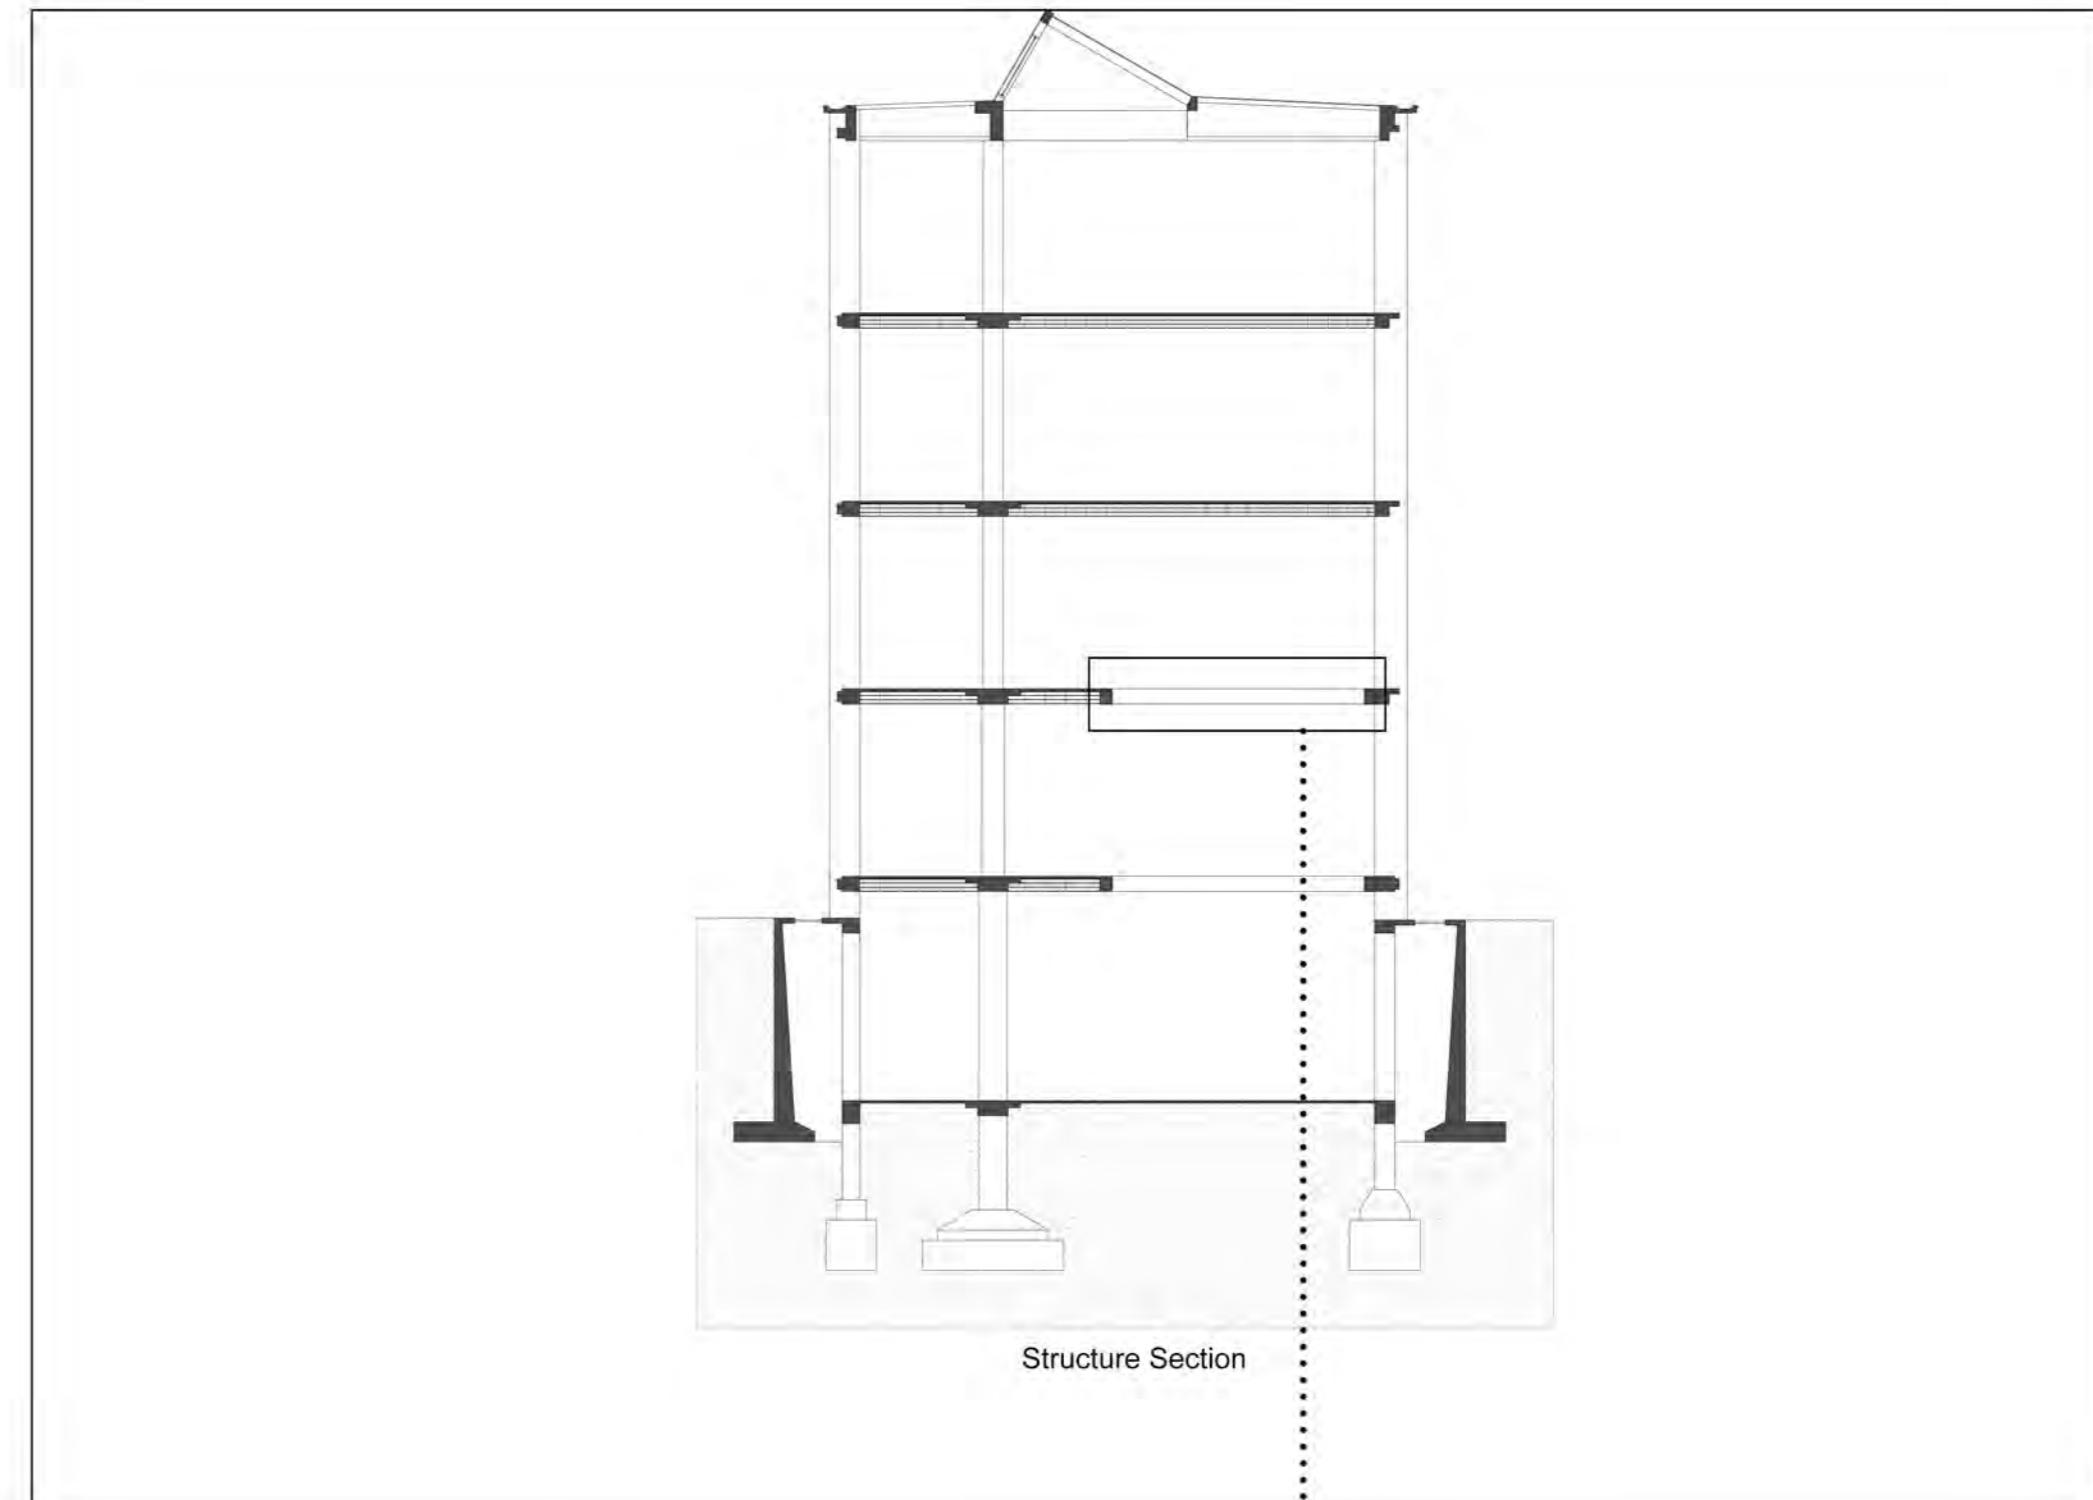
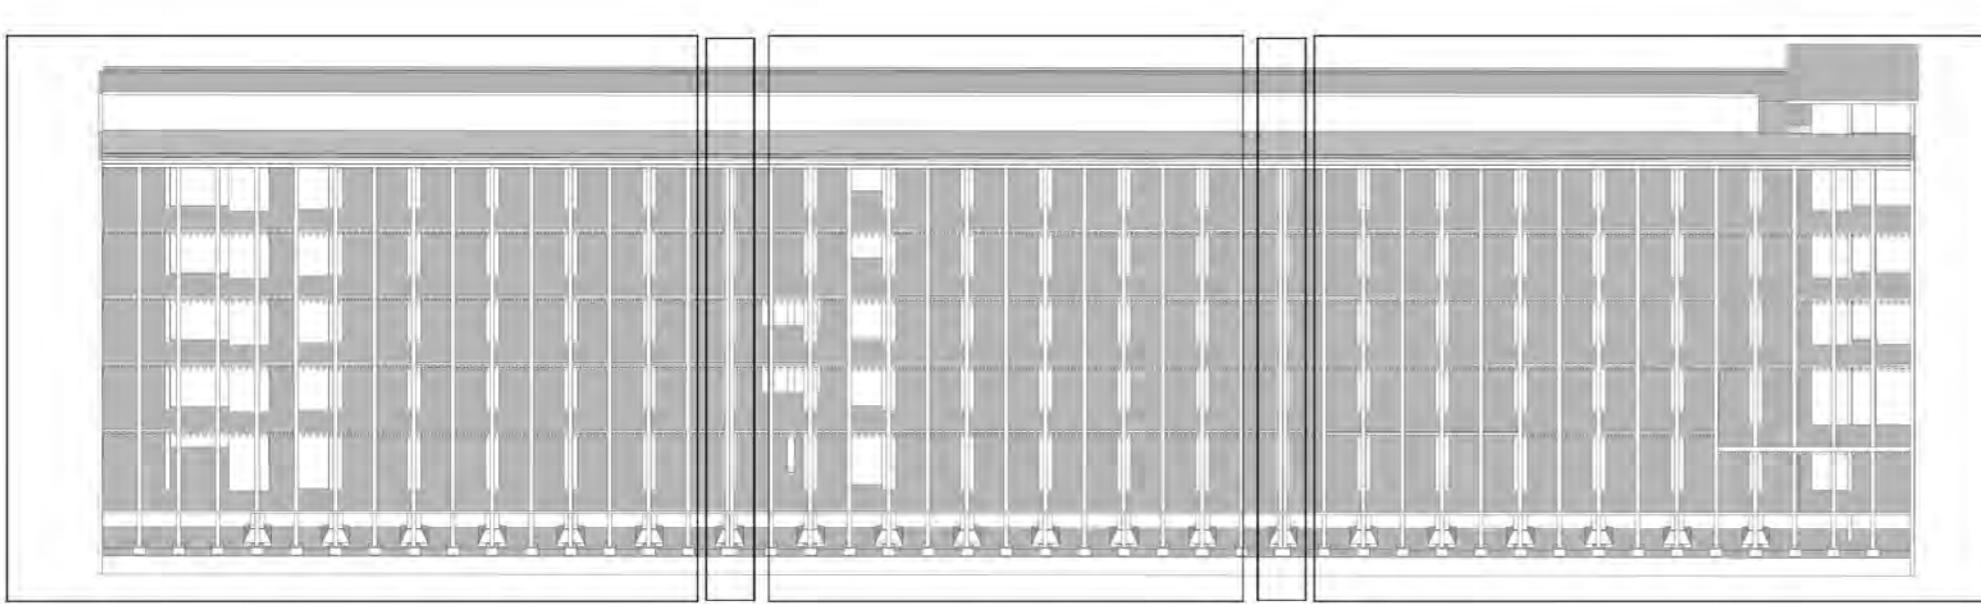
There are two junctions between the whole building. So, this building is like three separate buildings from structure view.
However, there are only shear walls on both sides. The first thing we need to consider is to reinforce the middle part of the building.

In order to build the middle staircase, you need to make a hole in the existing floor. After the hole is finished, two reinforced concrete beams are placed in the lateral direction of the U-shaped floor to reinforce the floor.

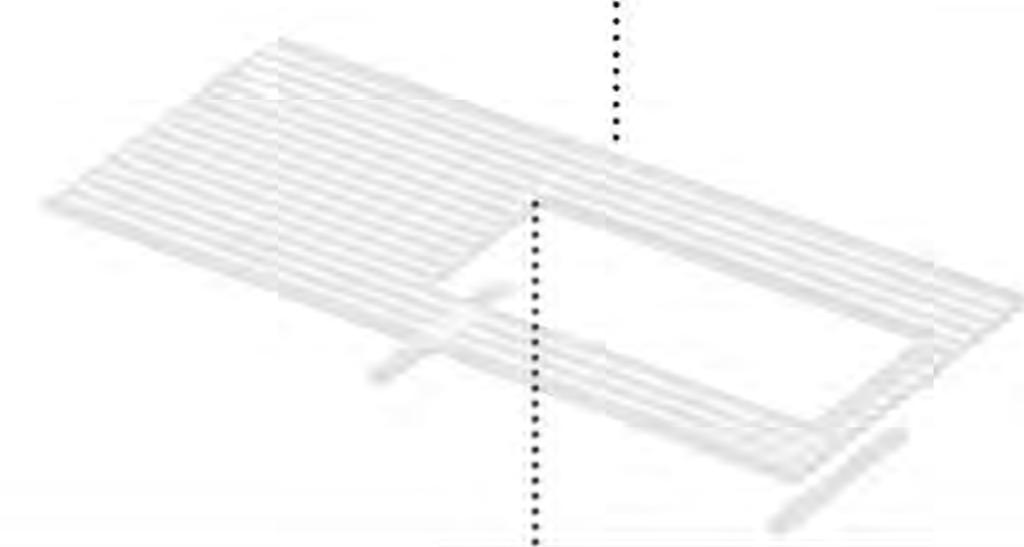
Section of additional beam

When the hole was cut, some parts were also taken away and exposed internal rebar of beam. And then, the new secondary beams were put there and connected with existing beam to reinforce the slab.

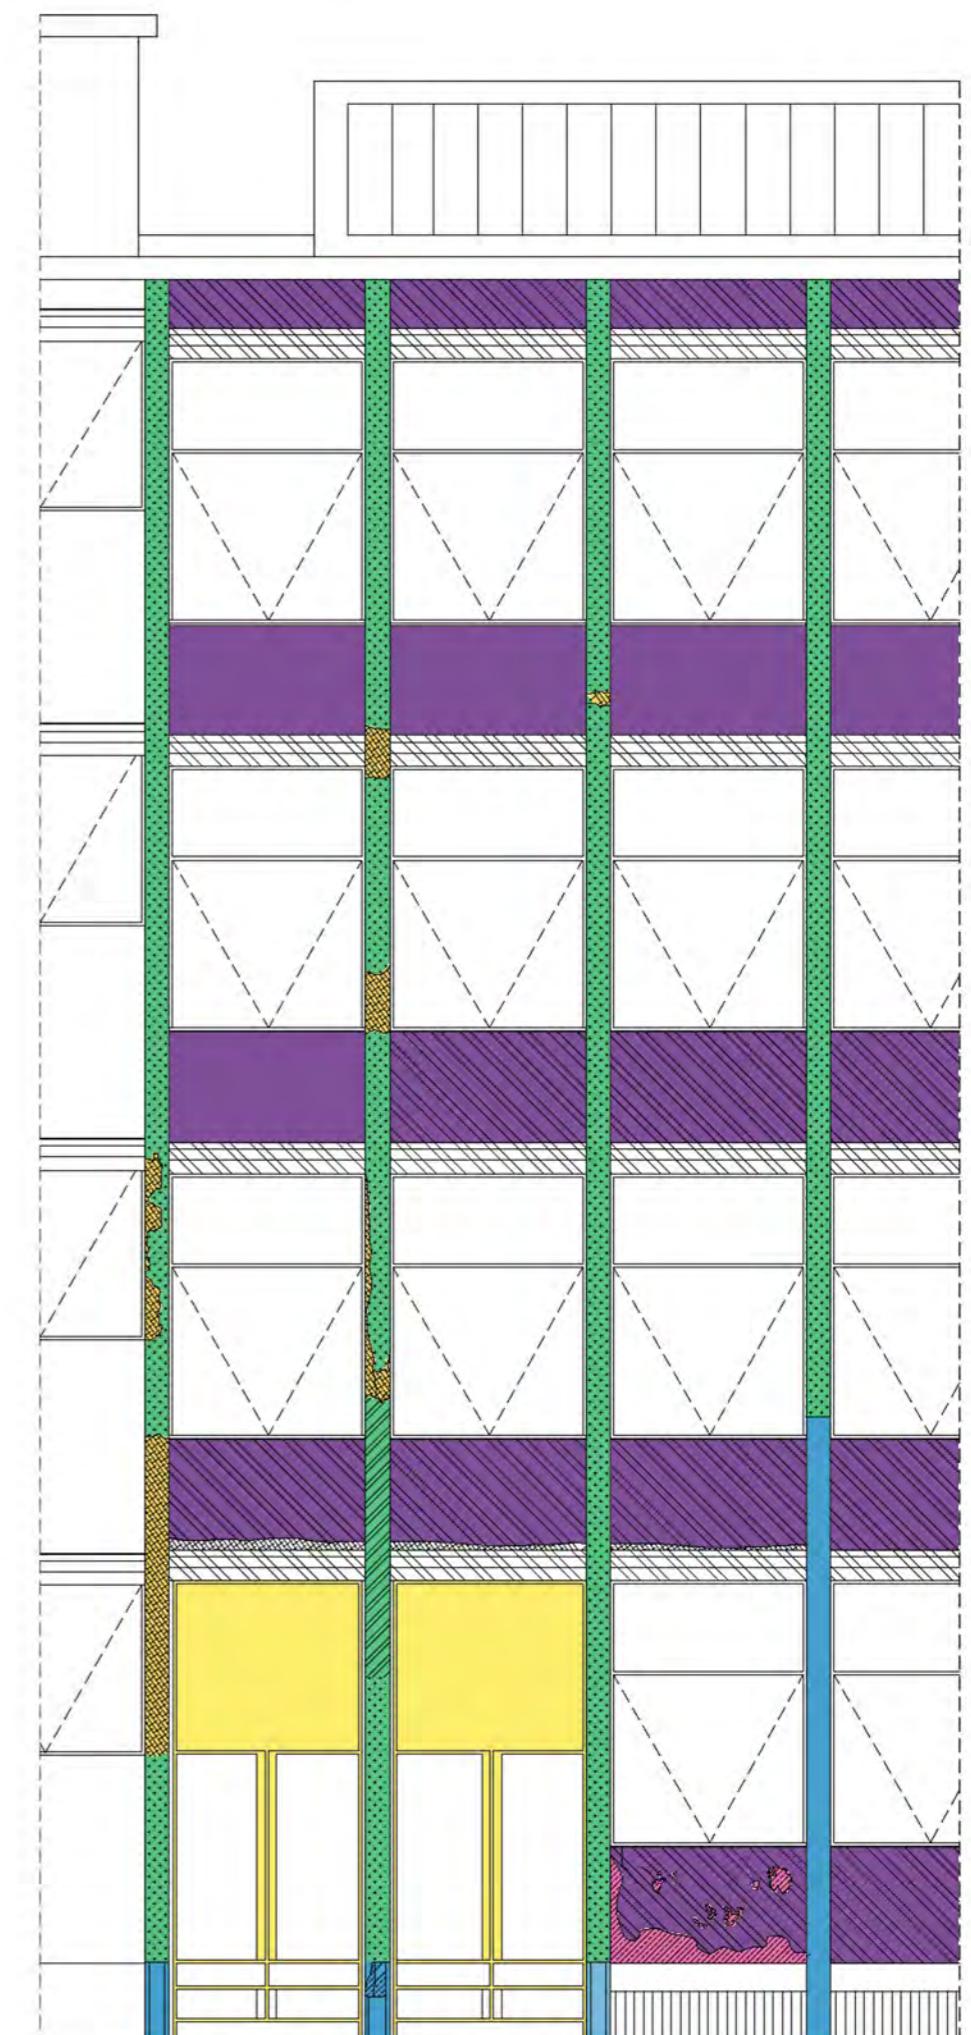
Cleaning the deposit from the plaster mortar.
	Removing the remaining eroded vertical elements made out of reinforced concrete.
	Grouting lime mortar on cracks and detached parts of the surface matching with existing.
	Removal of inappropriate cement mortar from the surface.
	Adding aluminum vertical elements.
	Painting a new layer as coating for protection after cleaning the rust to avoid corrosion.

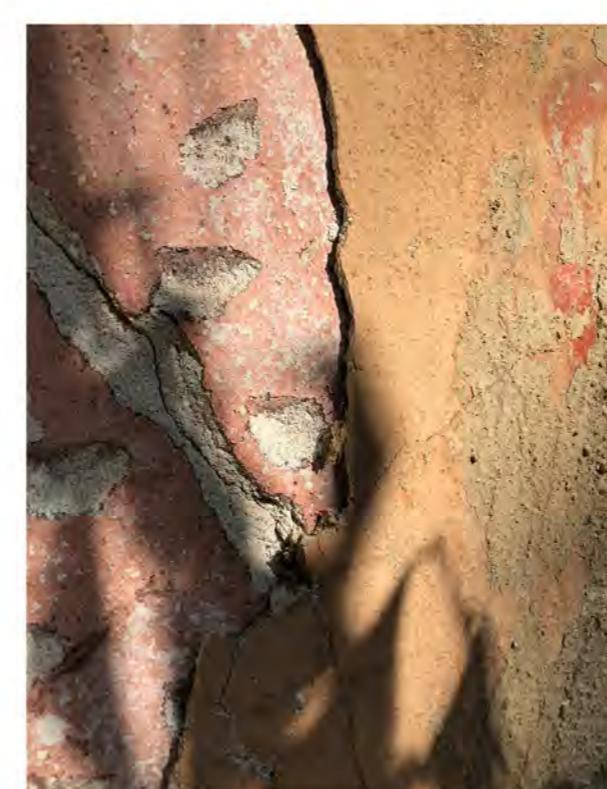
Mortars detachment and cracks of facade

Cleaning and removing some parts and then adding the replacement with same materials and color. At first, we can remove and clean the deposits on our surface by brushing. Then the solution is grouting of missing parts, detached and removed parts bay using lime mortar, added with natural pigments in order to acquire the same color with the existing ones on our surface. We can also fill the cracks with lime mortar.

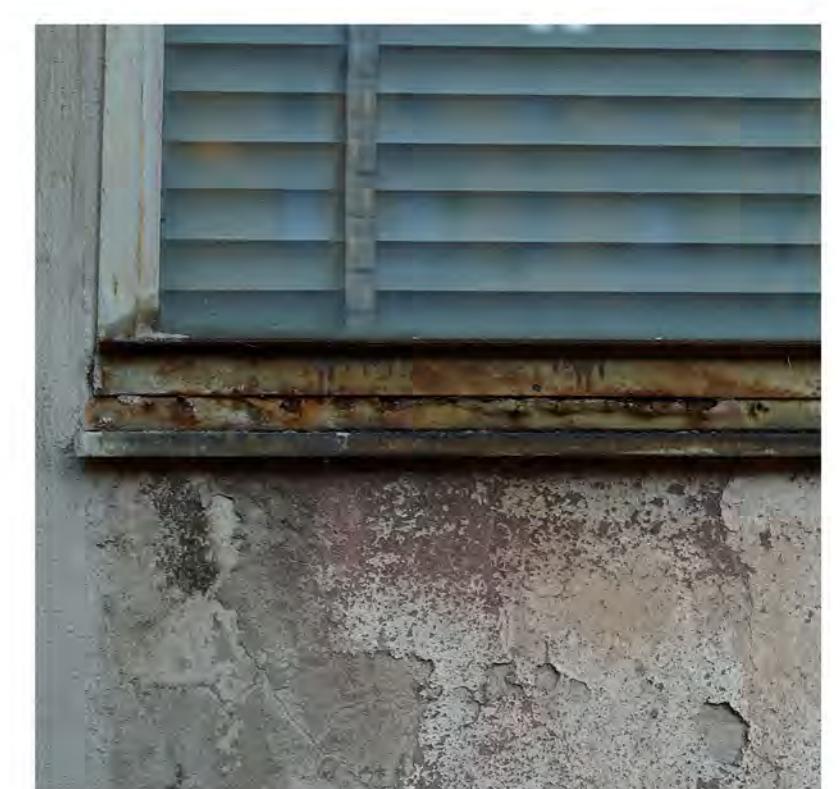
Windows and doors framings, flashings, windowsills

Cleaning by hand is the best way to remove thick corrosion layers, working with fine hand-tools and with the aid of a low power microscope. Chemical cleaning maybe is not the best way because it cannot easily be controlled and some chemicals may remain on the object. We have to remove the rust from the steel framings.

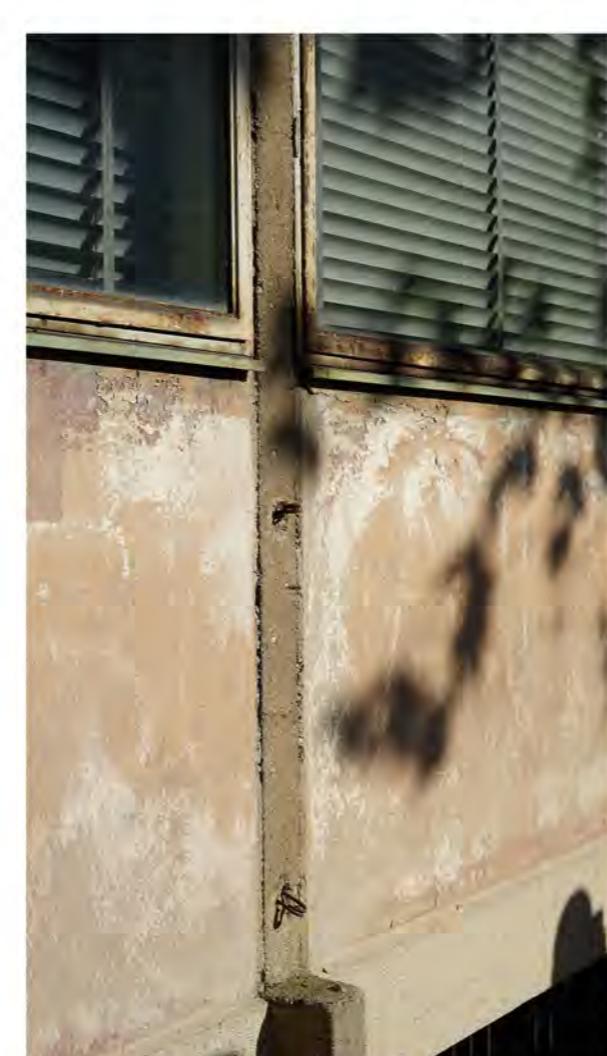
Vertical elements

Adding the vertical elements with the same material as the refurbished elements. After that, we could follow the original form. It could hide drainage pipes. Also it can help avoid our columns from erosion so it works as a protection.

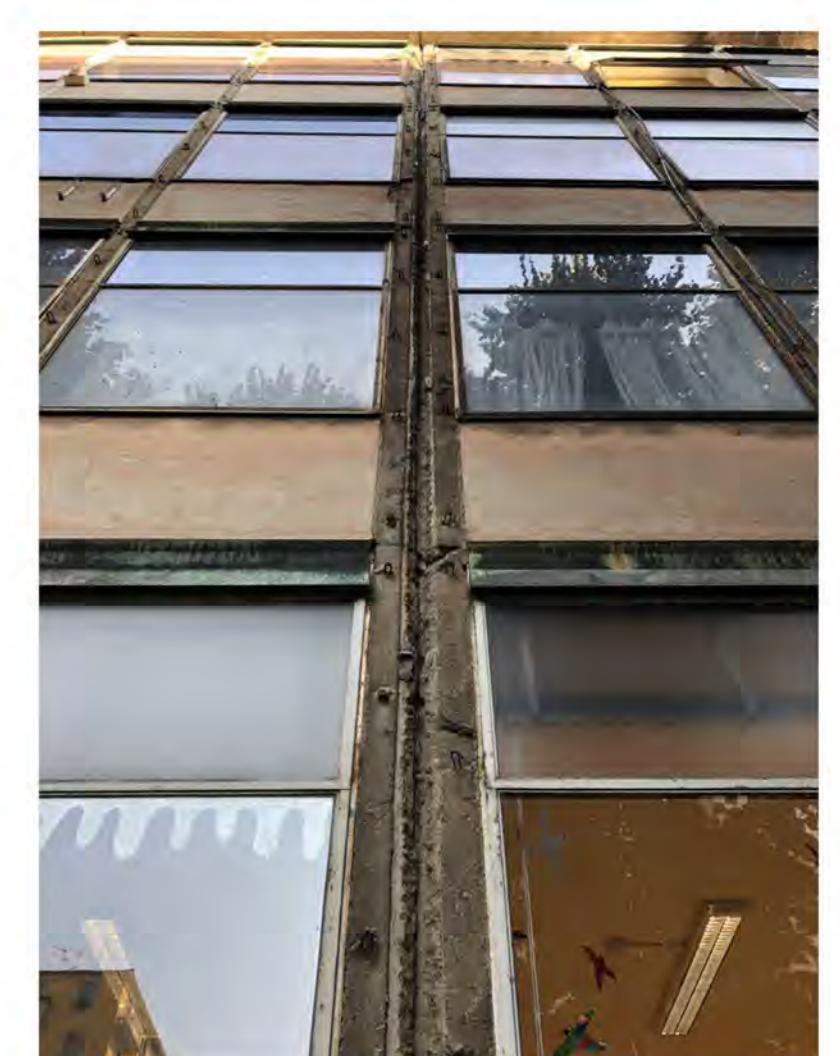
Expansion joints

Removing of the cement mortars at these borders are needed then we can cover the gap with expansion joint system.
