Department of Architecture:  
«Sustainable Architecture and Landscape Design»  
2022

*«Applying Sustainable Methods in Renovation of the Historical building in Tver, Russia.»*

*«How to apply sustainable renovation technique to a protected historical building?»*

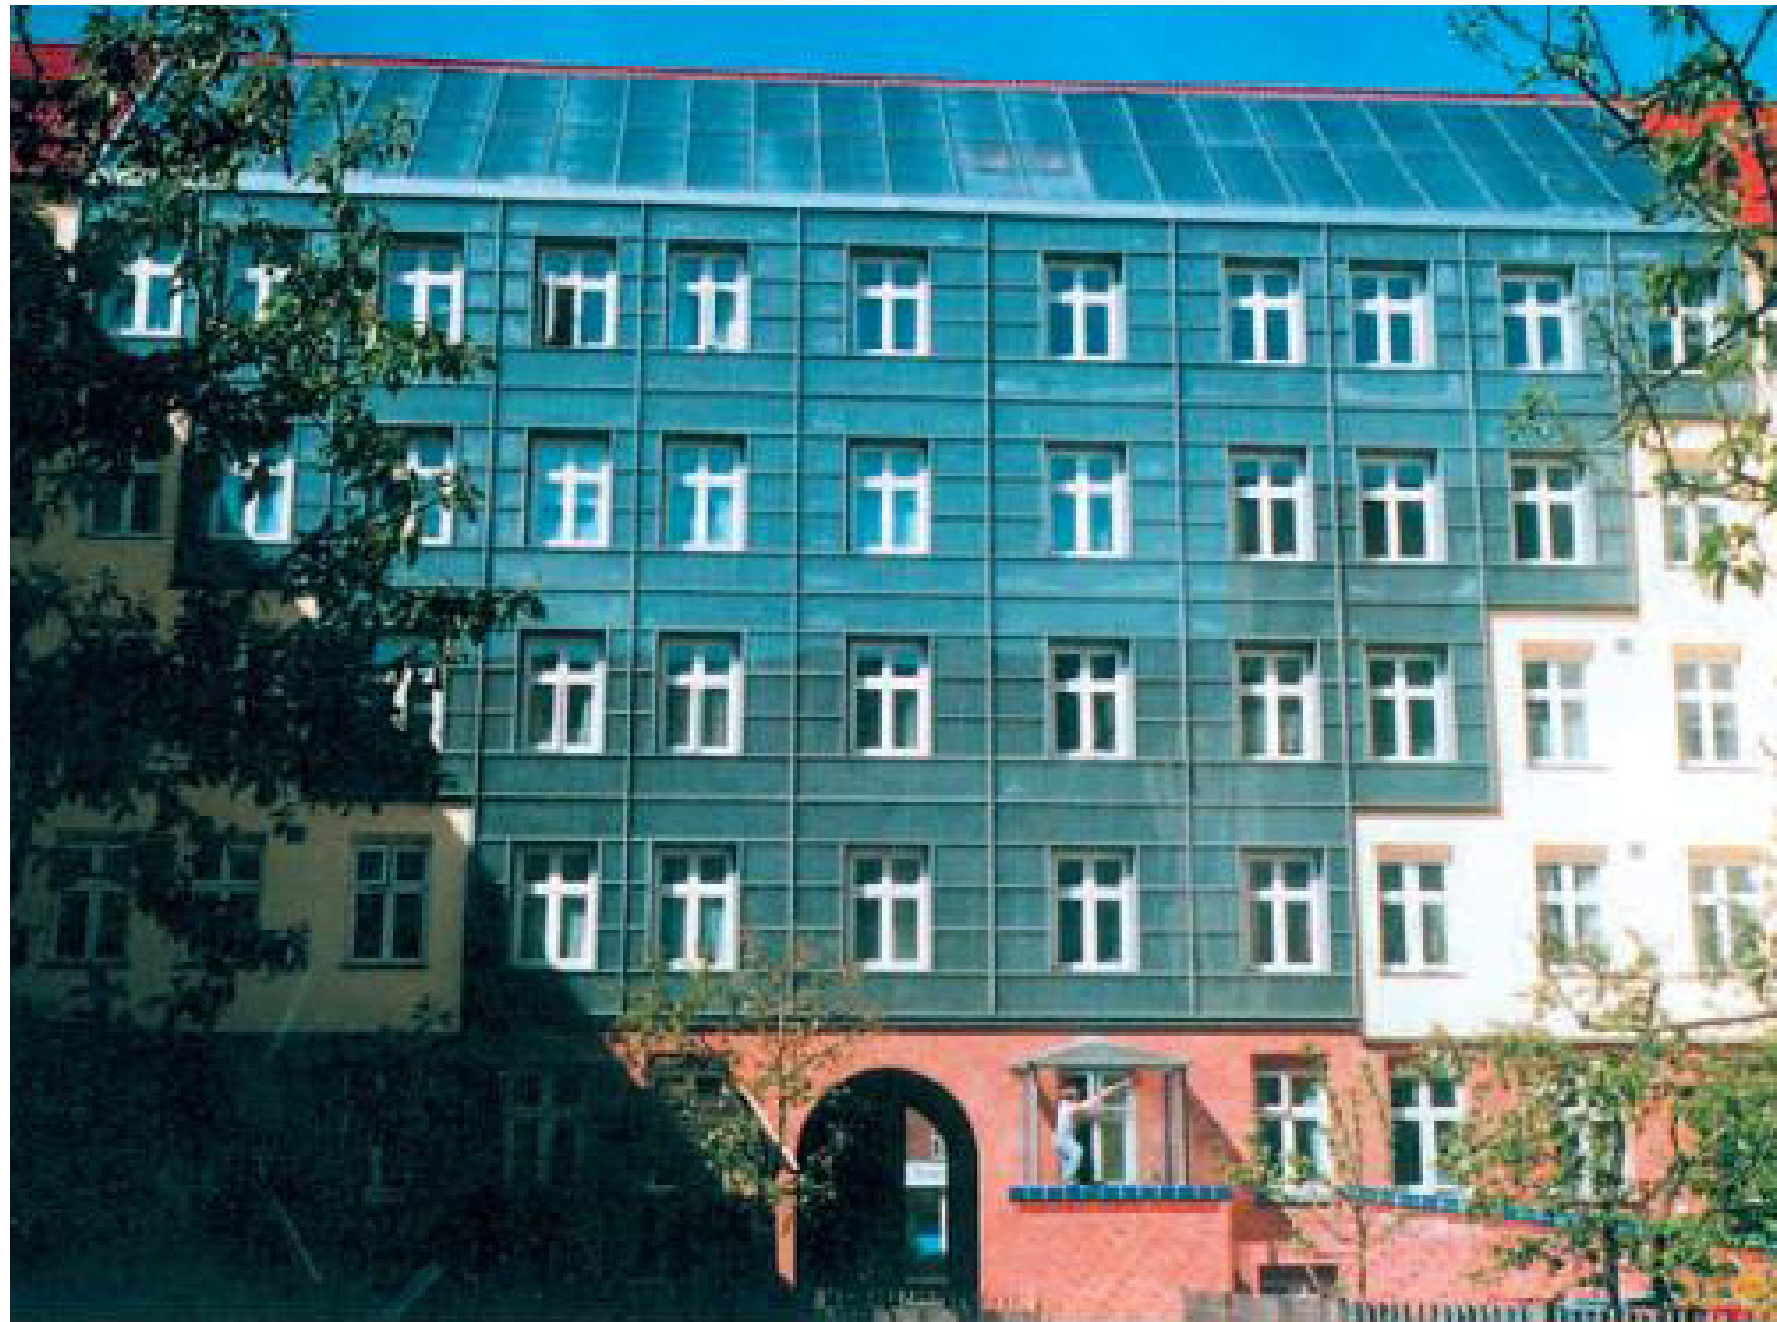
1 - «солнечная» стена  
2 - солнечные коллекторы  
3 - застеклённые балконы

The main energy-saving measures taken during the reconstruction of the building:

After the reconstruction, the energy consumption of the building decreased by 51%.

- New Solar panels surfaces on the sun facade and roof.
- Glazing balconies surfaces to reduce heat loses.
- New water hot supply from solar radiation.

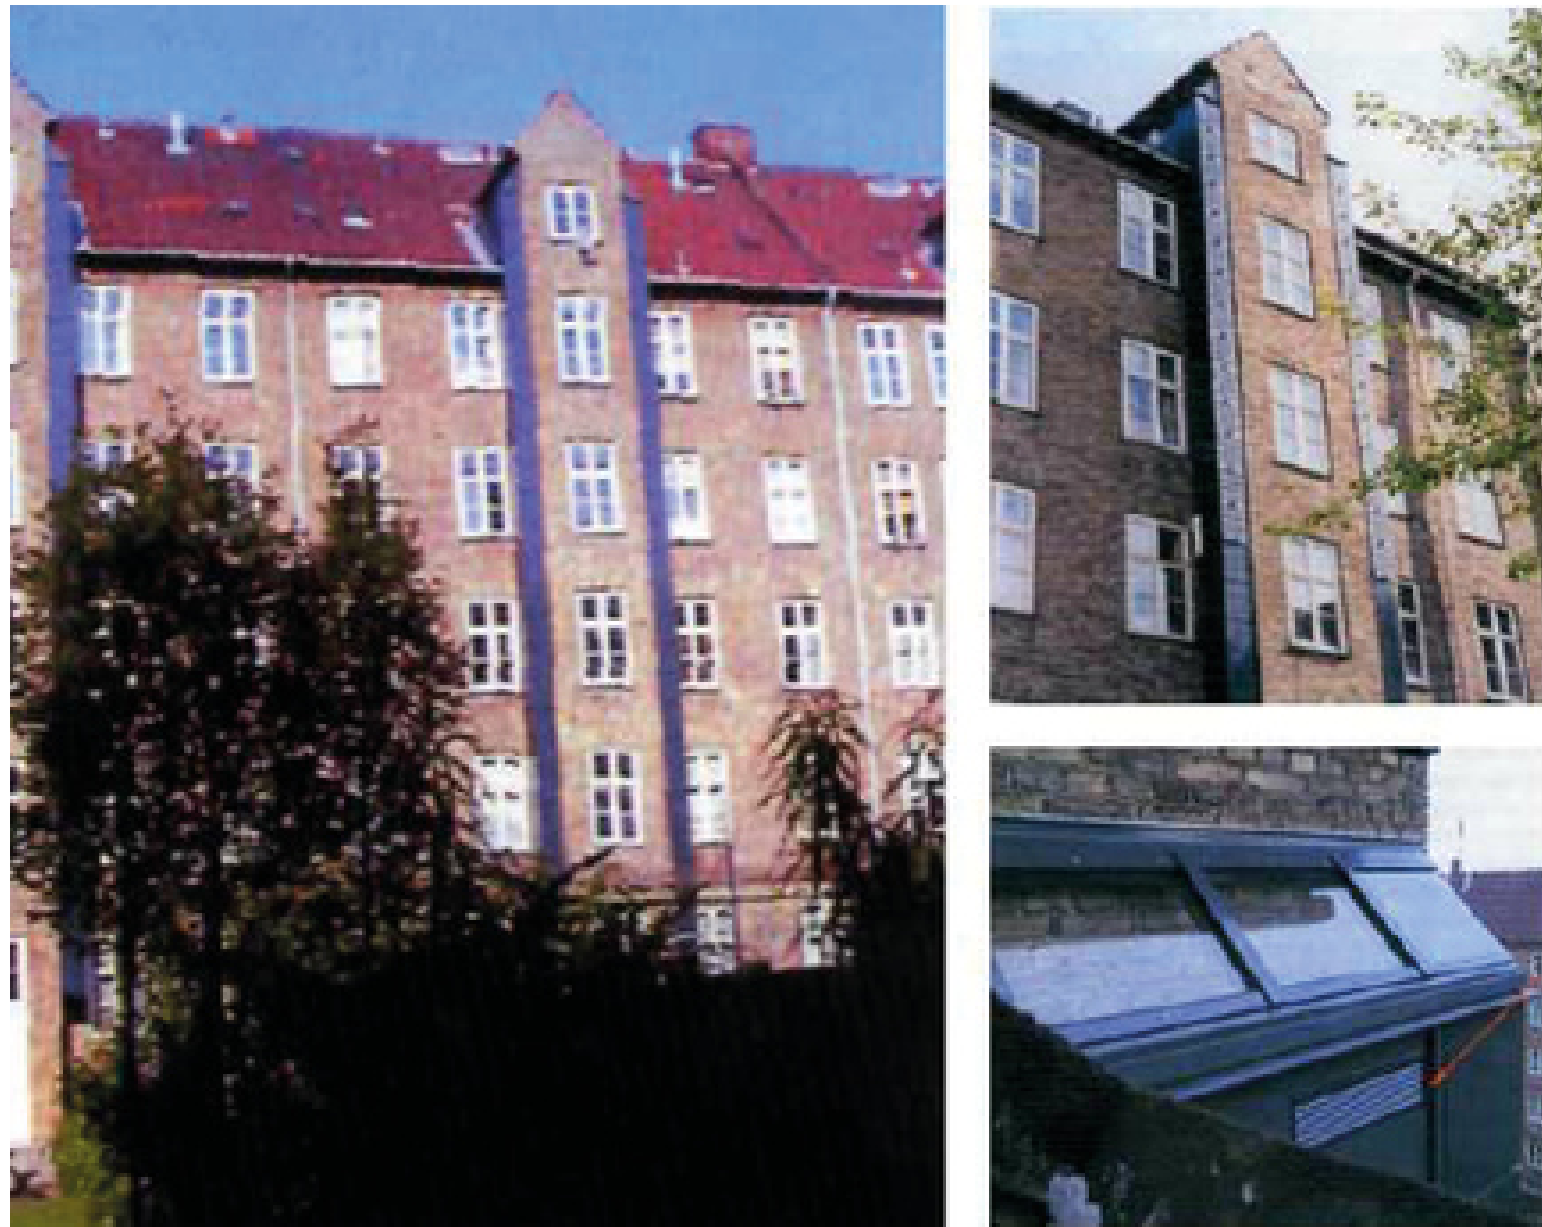
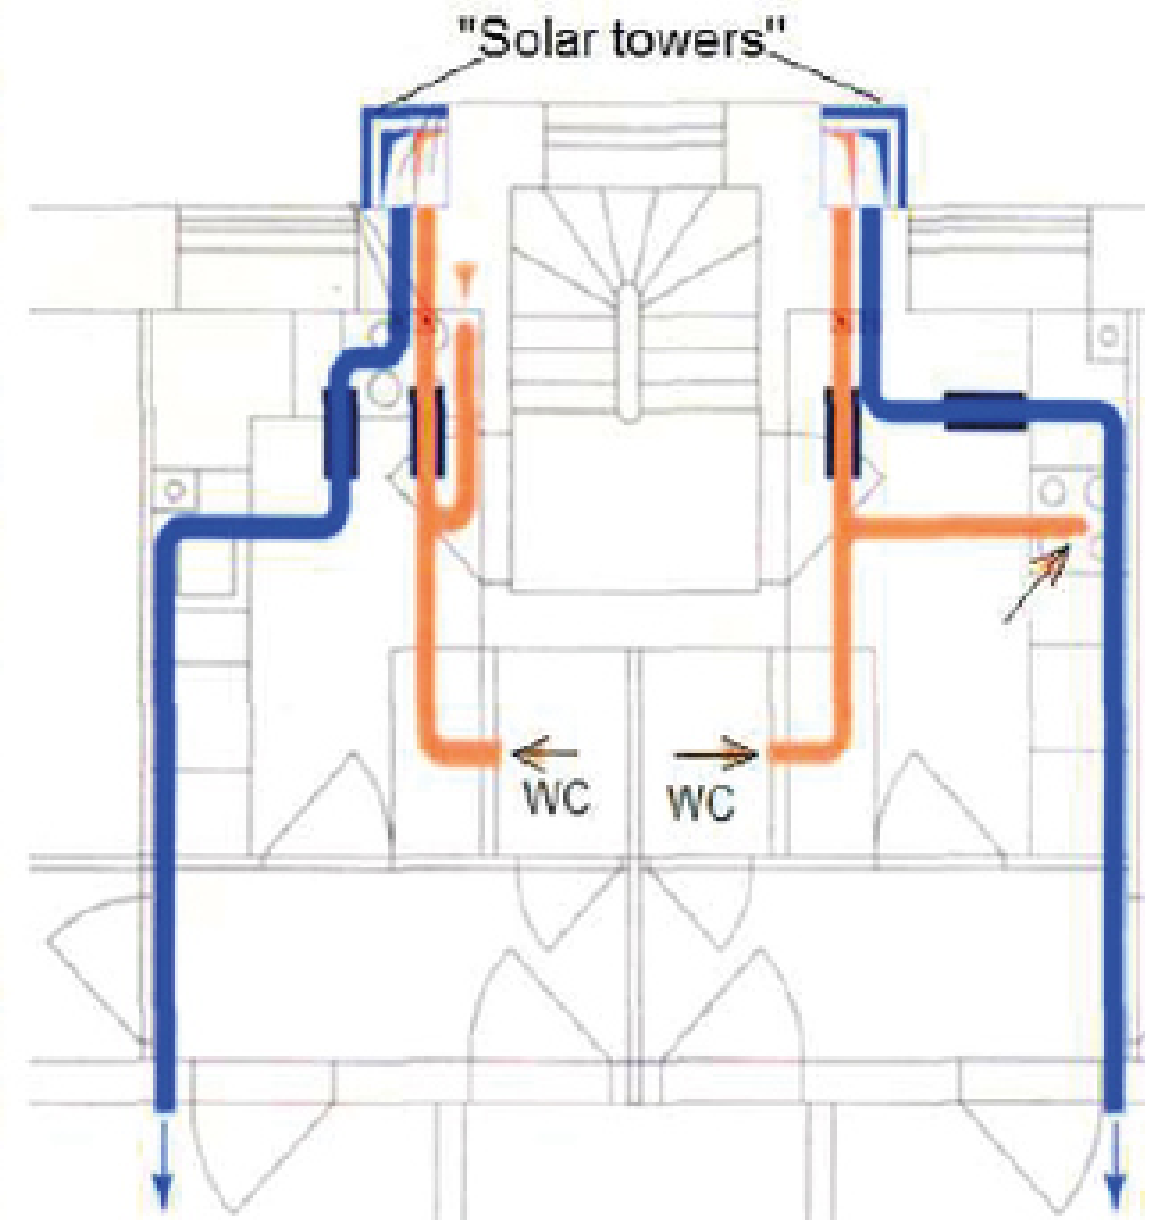
The aim of the project was the construction of «solar ventilation towers» and the creation of a ventilation system with heat recovery as a new element of the old residential areas. This building is an apartment building built in 1920. This project demonstrates the possibility of integrating a ventilation system using solar energy with heat recovery into an old building without significant changes in the building structure.

- New solar ventilation towers to decrease heating energy consumption.
- Modern upgrade in ventilation system without any significant changes.

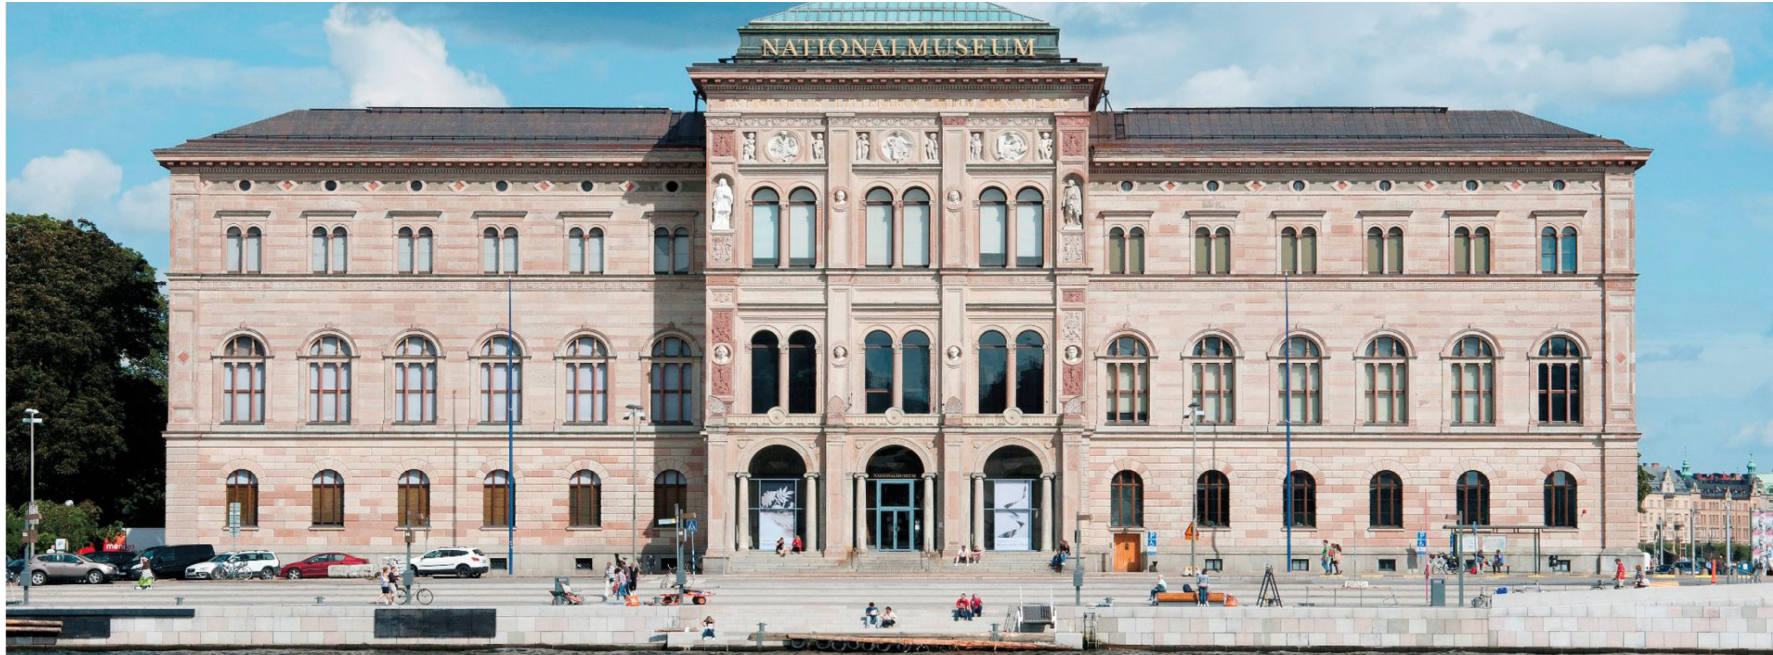
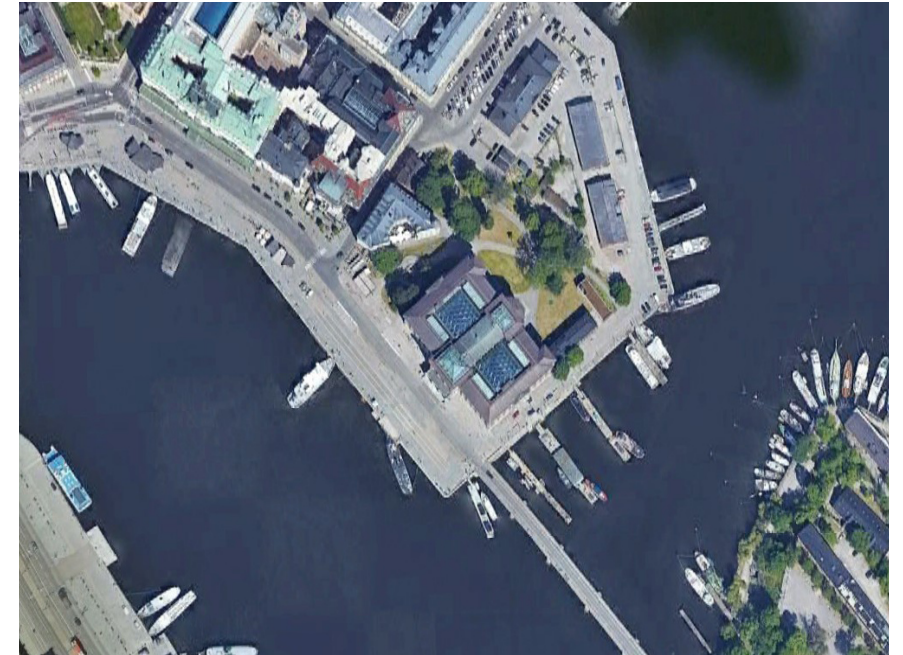
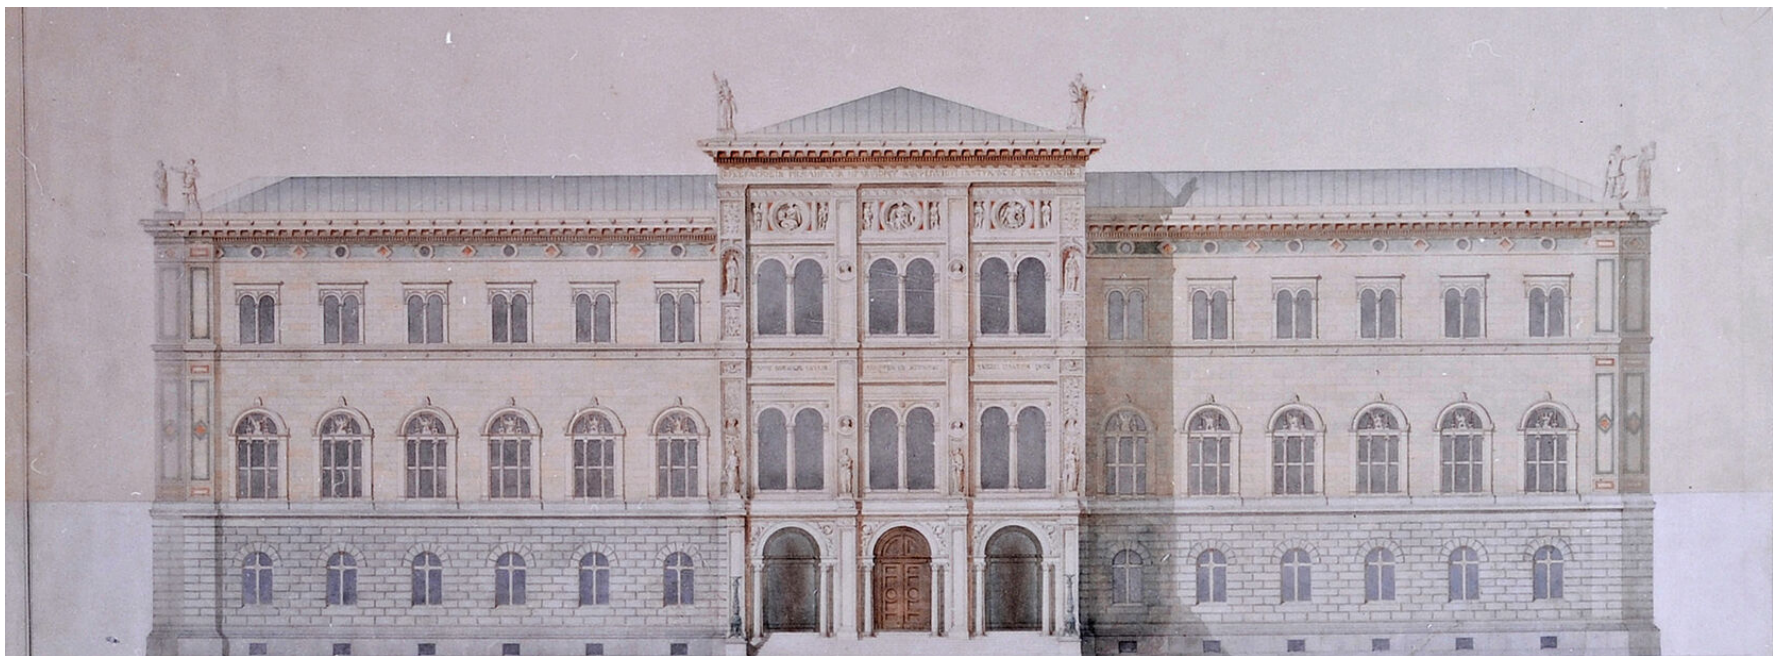
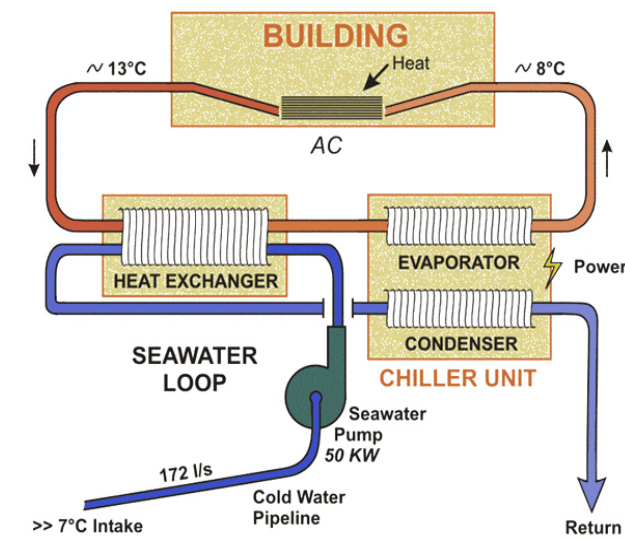
NATIONALMUSEUM RENOVATION, Stockholm, Sweden

- Additional new experimental ventilation seawater system, which decreases energy consumption and can produce energy by using seawater air vaporation method.

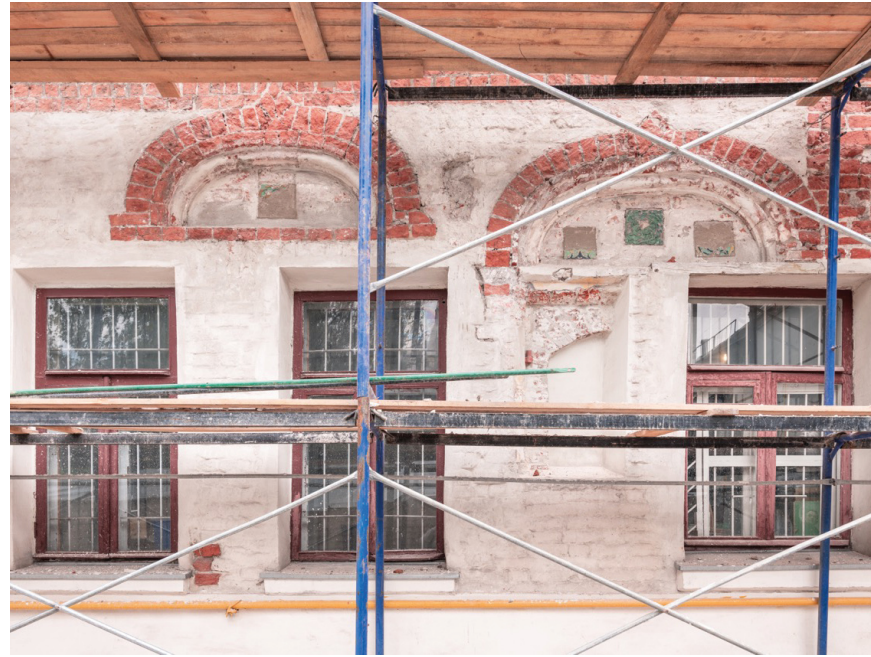
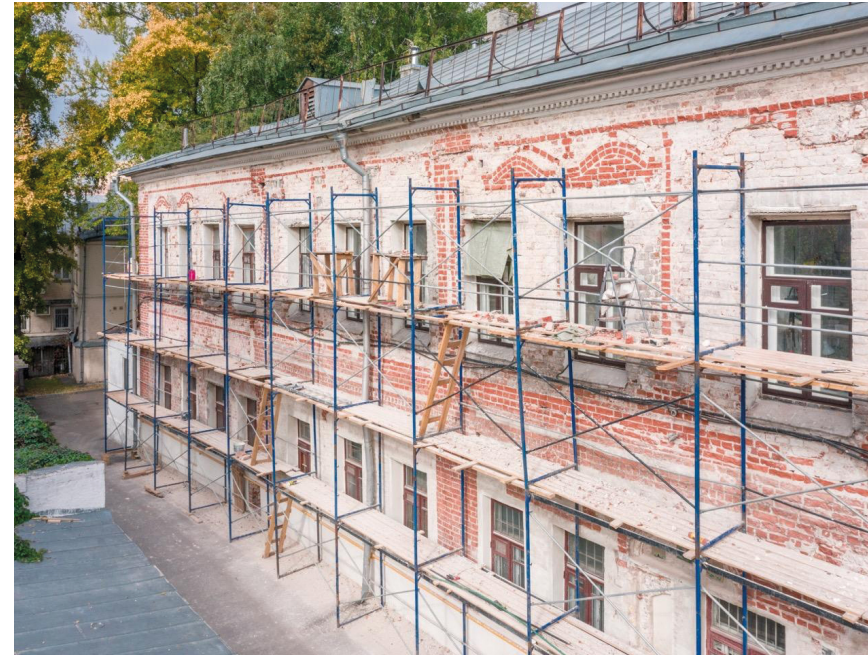
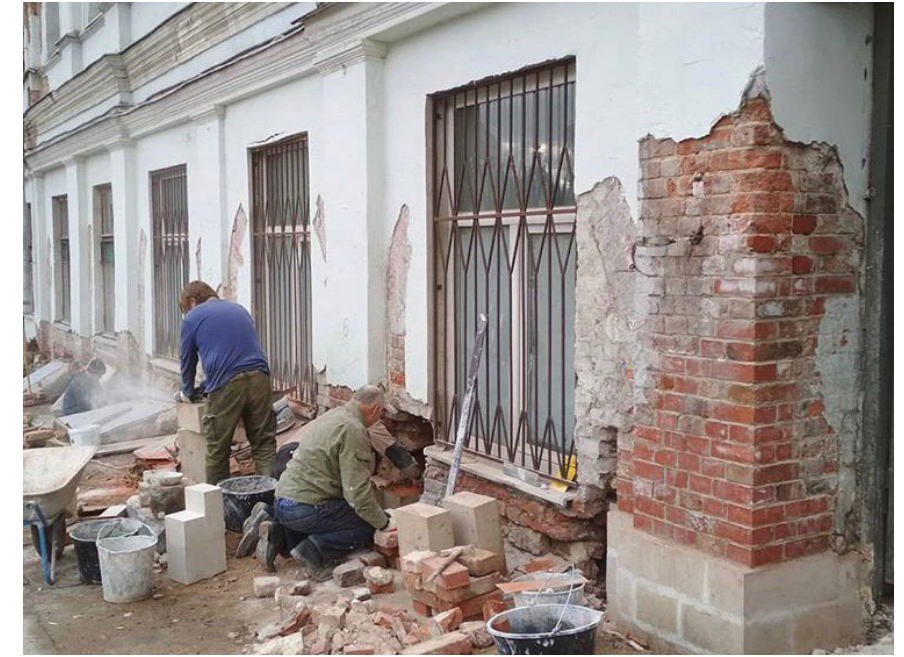
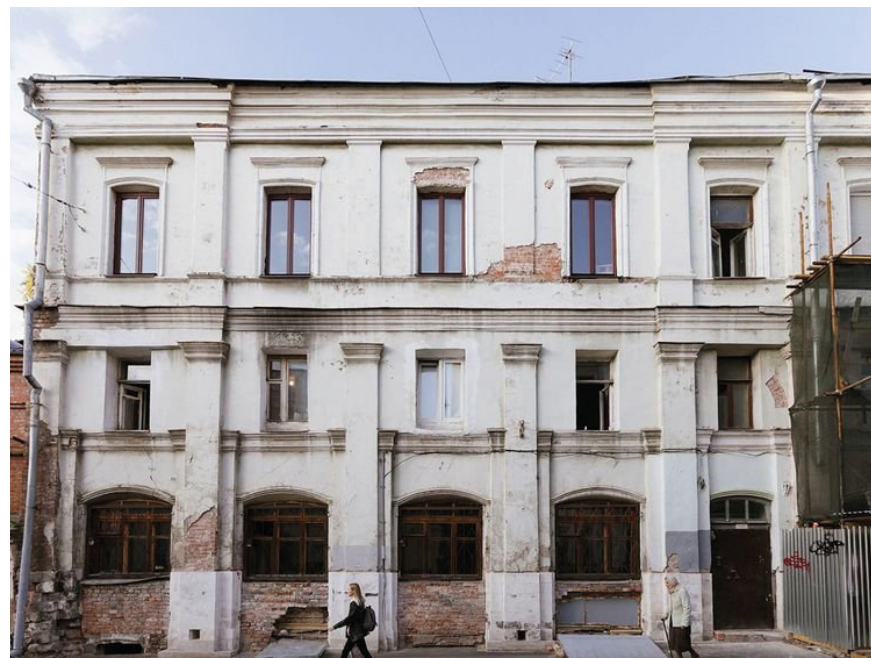
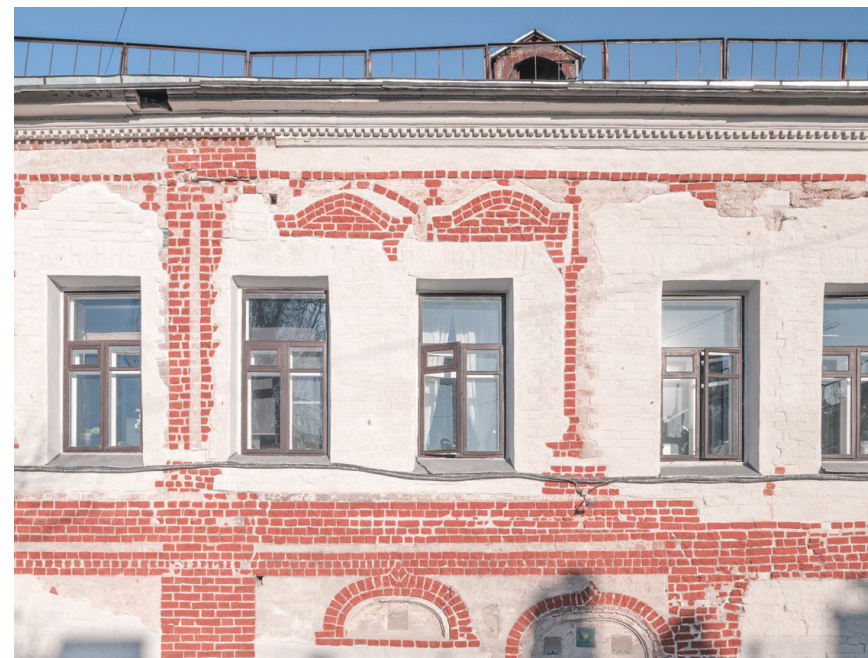
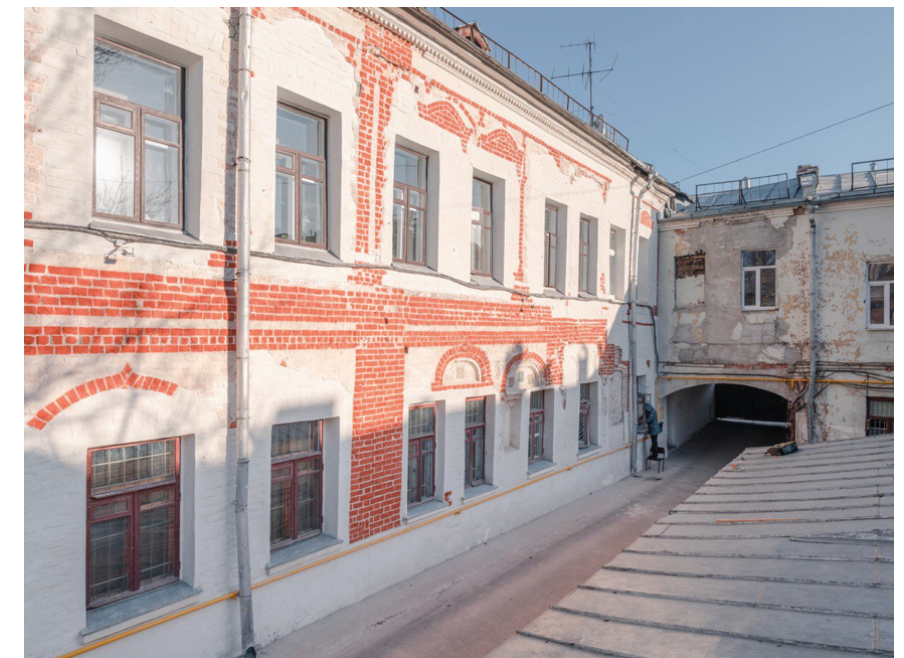
HOUSE OF YAROSHENKO, THE OLDEST RESIDENT BUILDING OF MOSCOW - XVII century

*During the repair and restoration work in one of the apartments on the second floor, it became clear that not only the first, but also the second floor was preserved from the chambers. There was a lot of work to explore all parts of the building.*

- Use of modern materials inside the building structures
- The modern facade of the building must fully comply with the historical one.

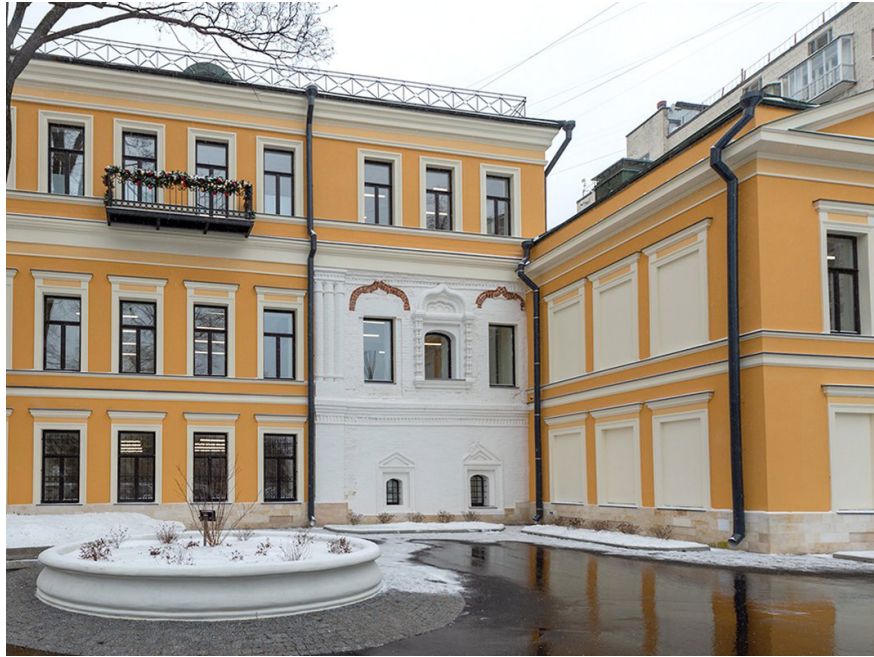
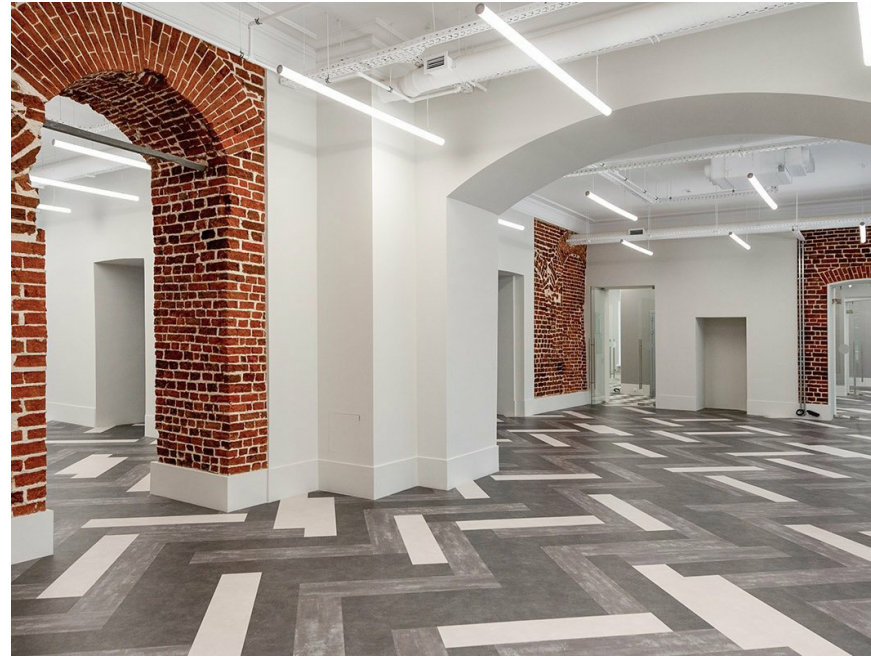
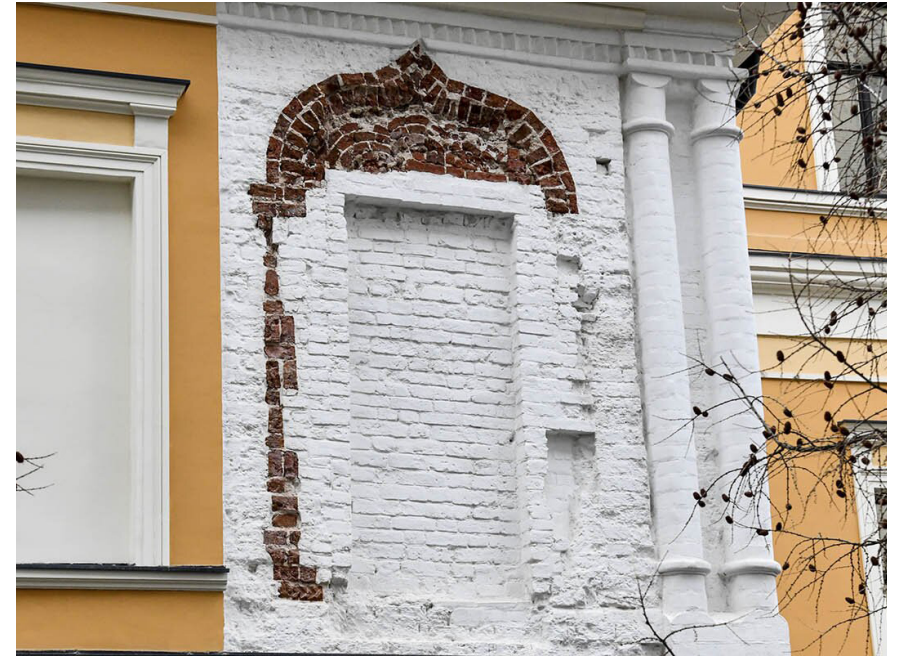
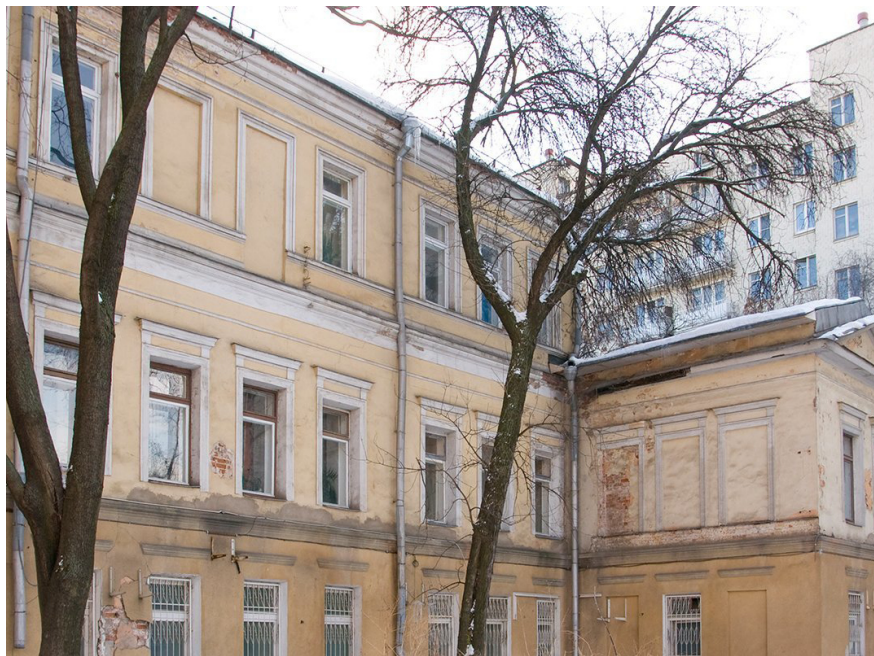
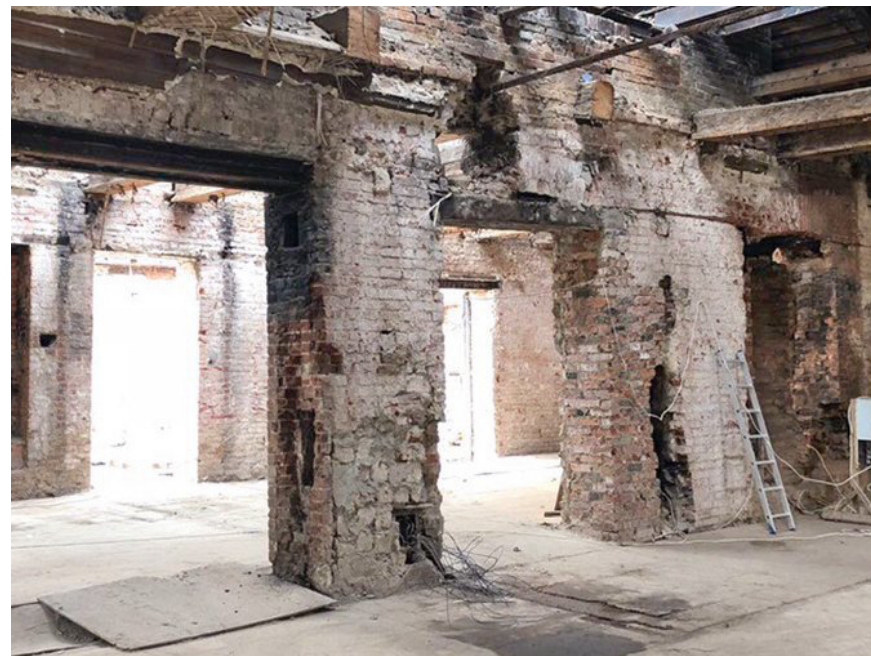
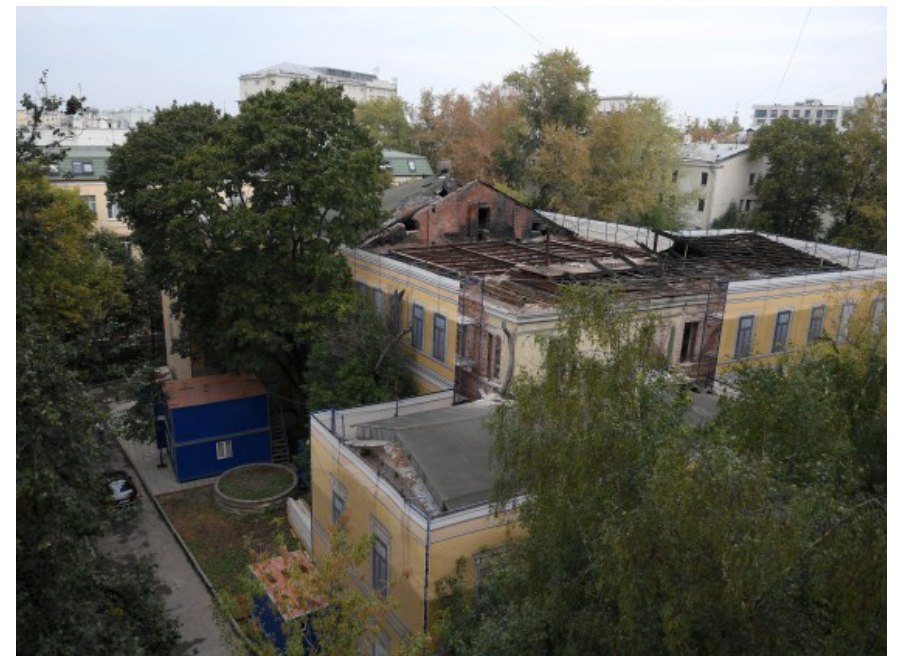
MOSCOW LAND SURVEY OFFICE, 400 years old building building in Moscow

- The modern facade, interior spaces of the building must fully comply with the historical one.

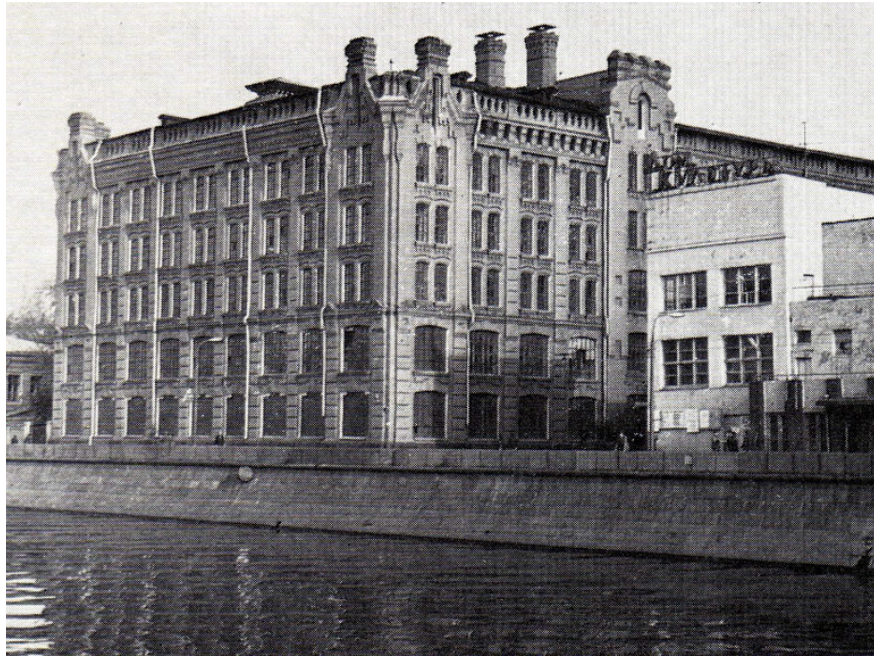
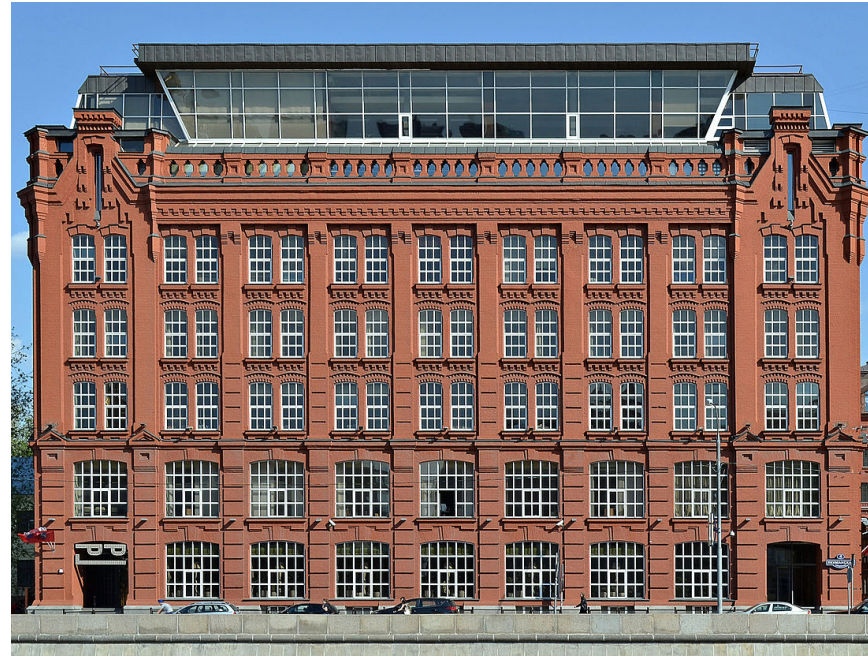
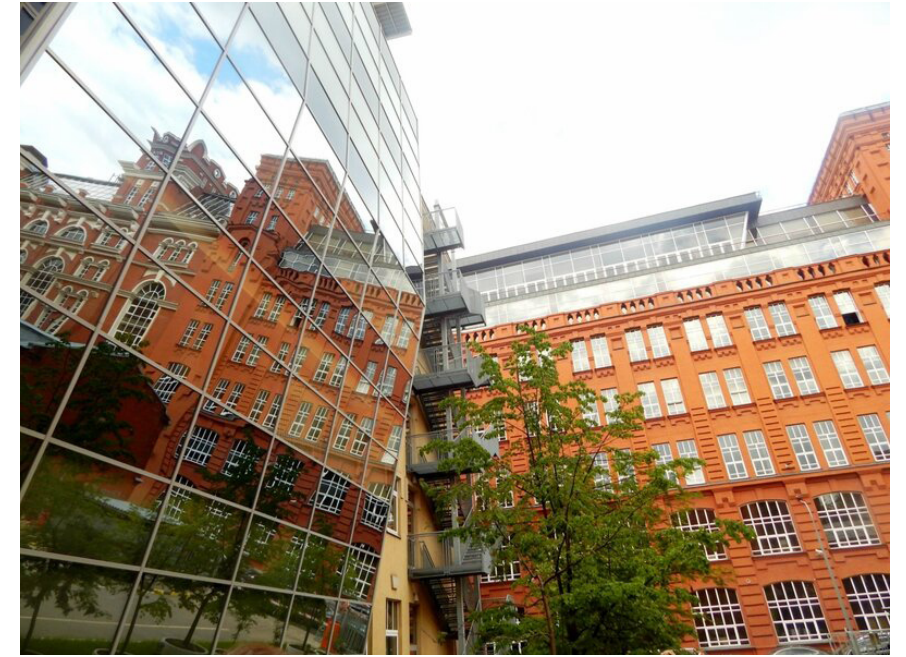
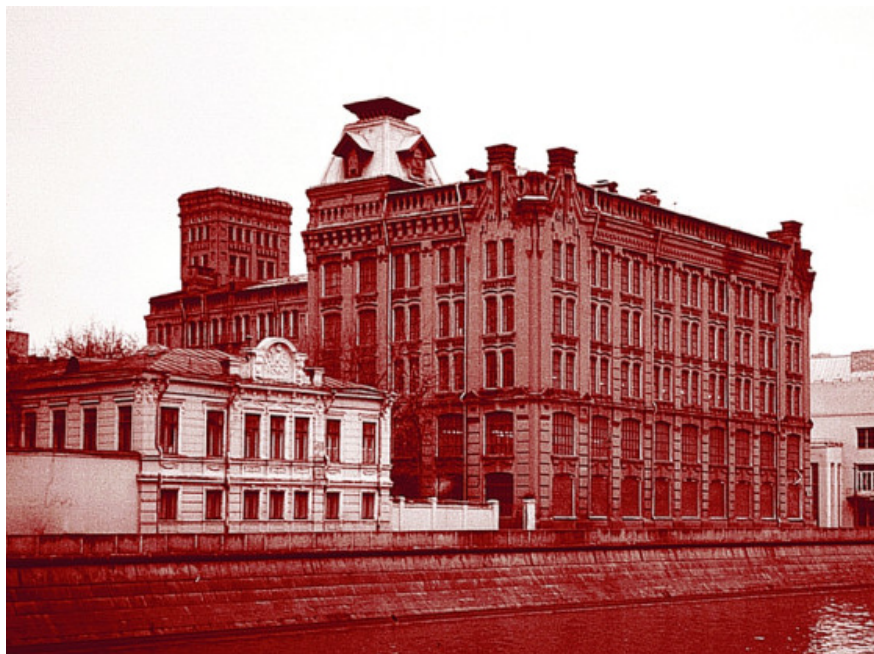
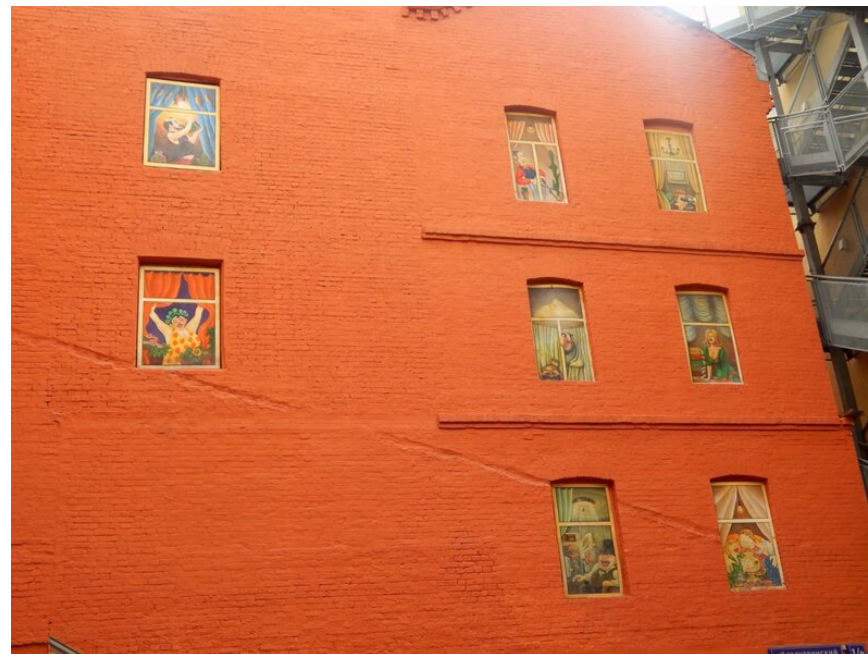
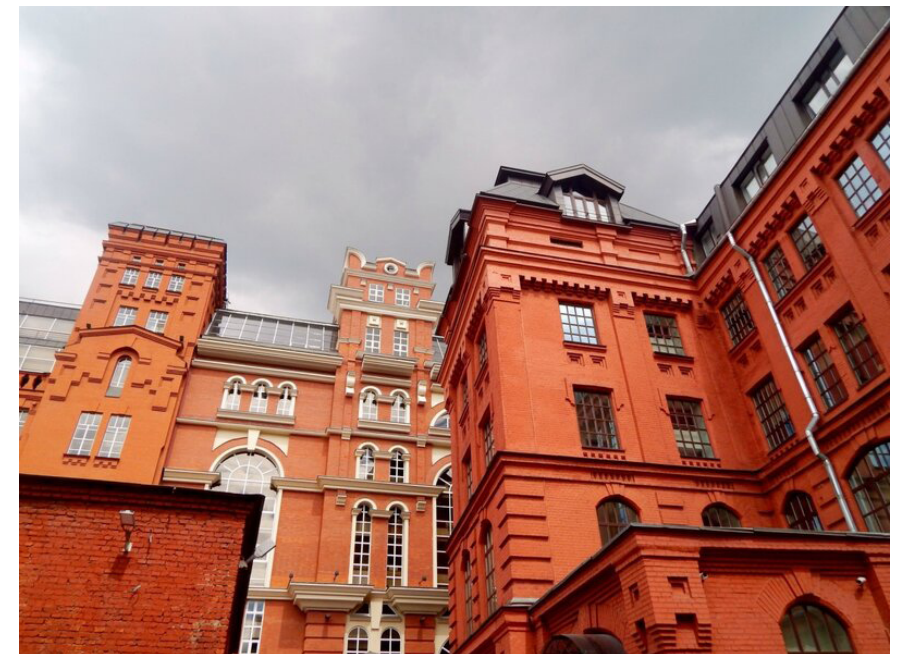
GOLUTVINSKAYA MANUFACTORY AND TRADING HOUSE, one of the largest textile factories and trading houses in Russia- XIX century

The factory belonged to the Istomins until the revolution, and they managed it even until 1919. Since 1921, the factory was called «Red Textile Workers», and in the 1990s it became one of the first (if not the first) object of the old industrial architecture, converted into a business center. It was redone, on the one hand, it was not so bad, on the other hand, due to the fact that the alteration was carried out in the 90s, the old details were practically not preserved inside the buildings.

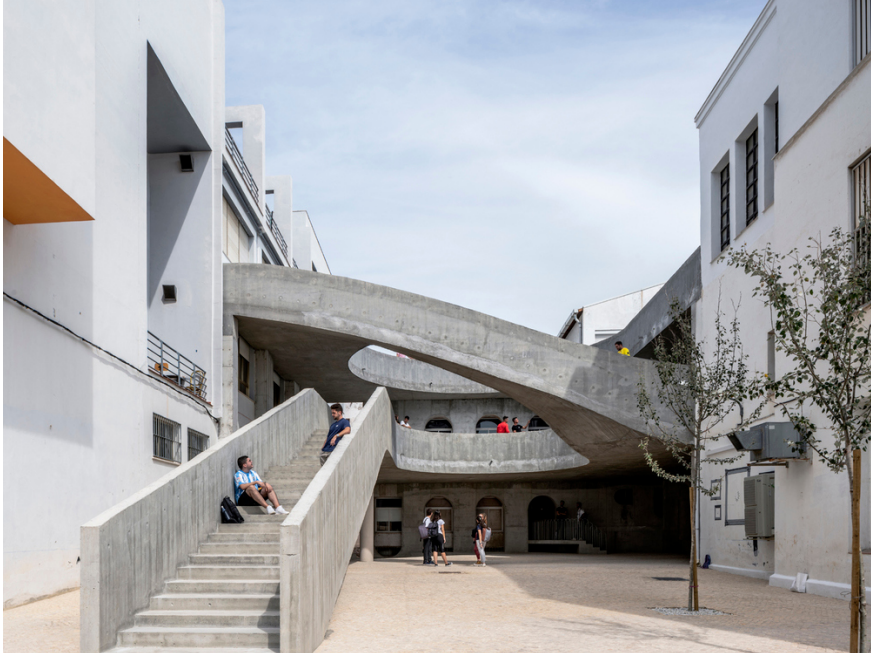
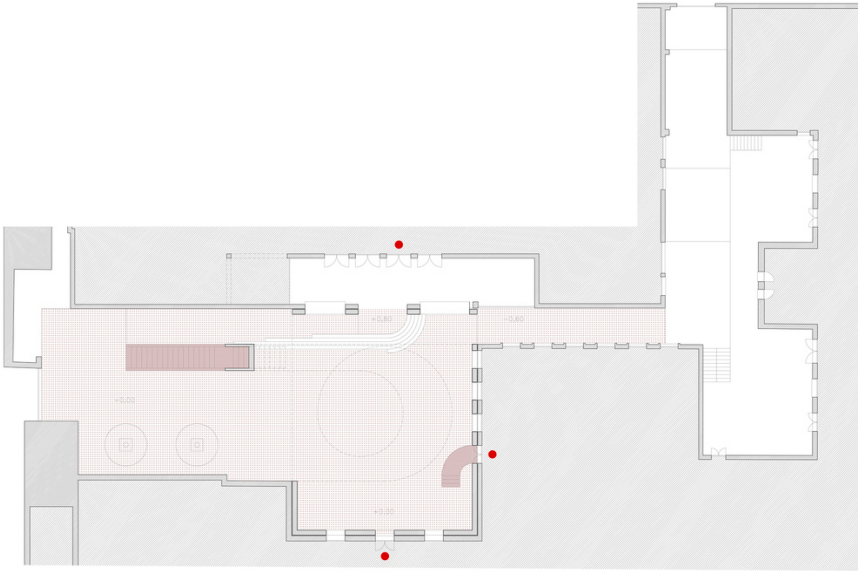
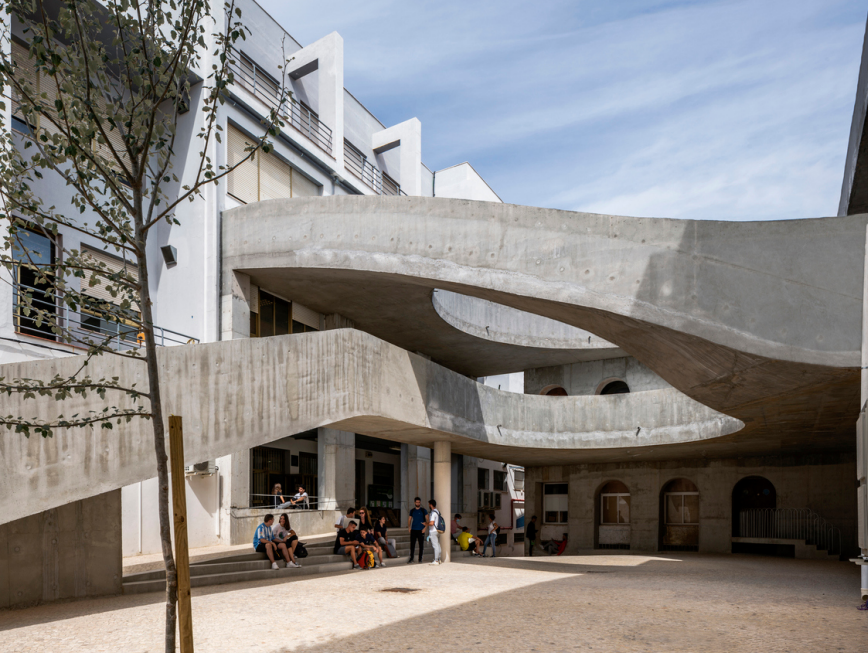
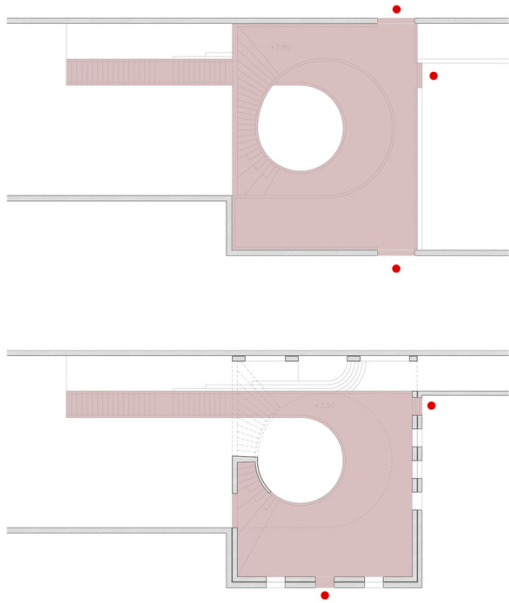
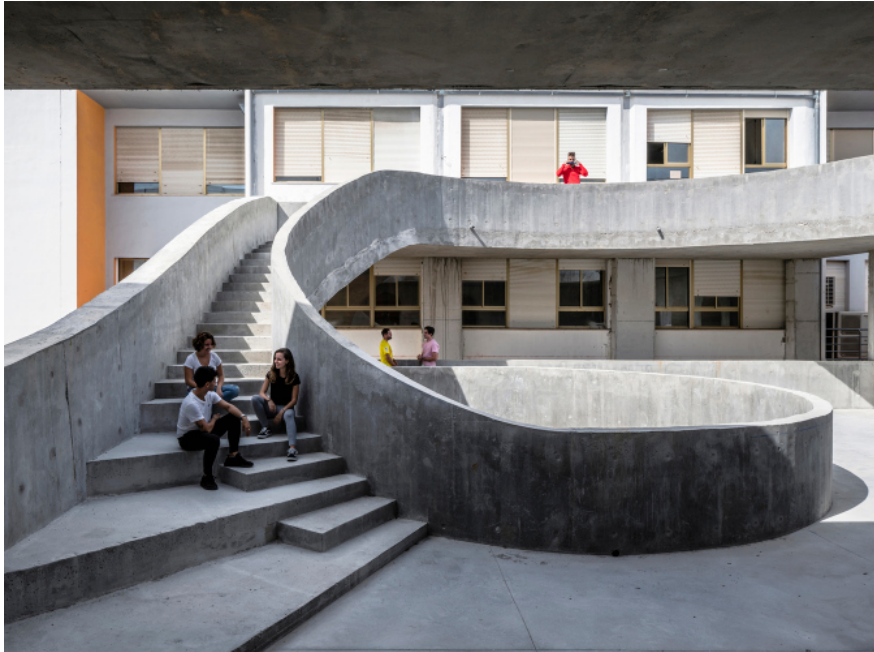
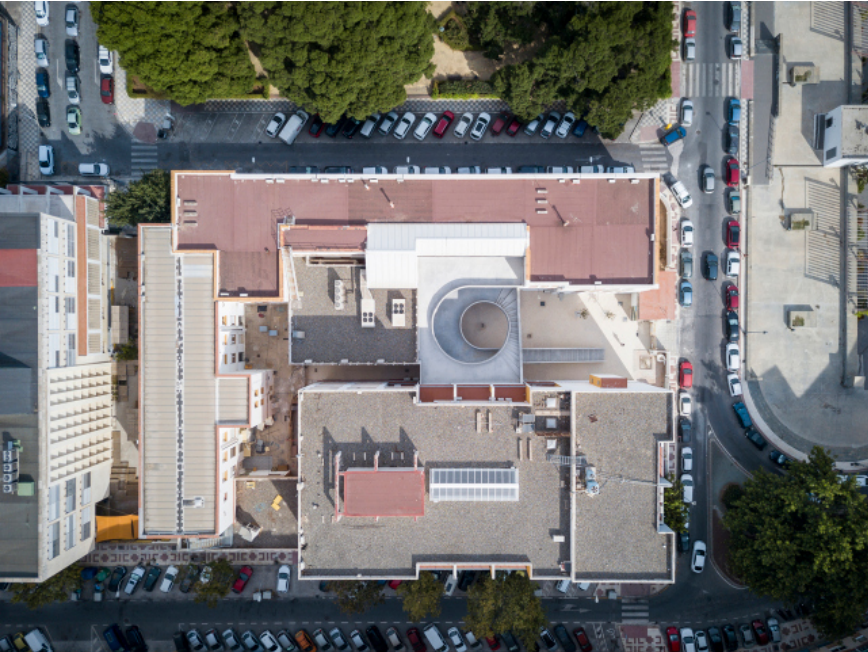
PUBLIC SPACE RENOVATION , Courtyard Reorganisation in Spain
