Department of Architecture:  
«Sustainable Architecture and Landscape Design»  
2022

*«Applying Sustainable Methods in Renovation of the Historical building in Tver, Russia.»*

*«How to apply sustainable renovation technique to a protected historical building?»*

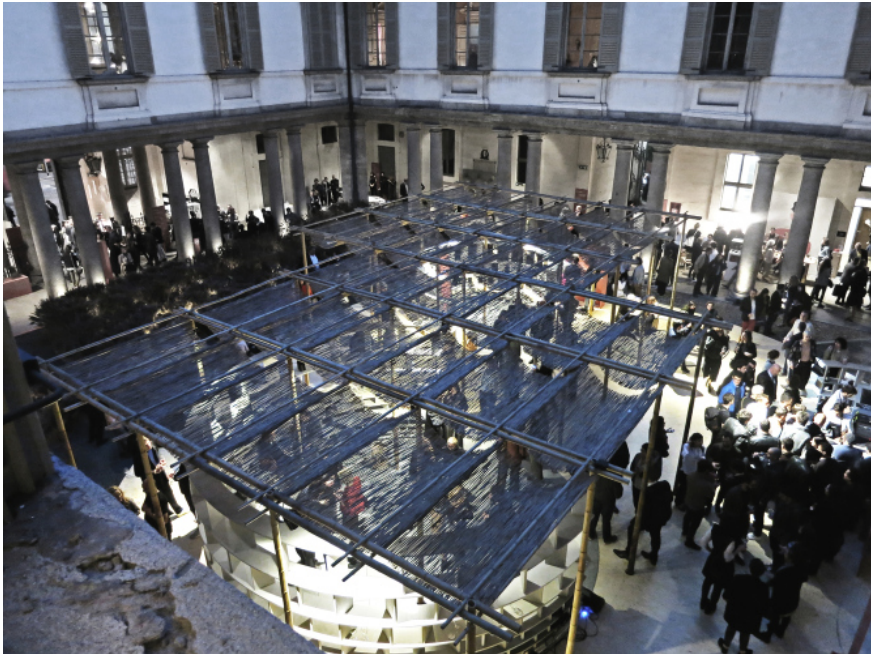
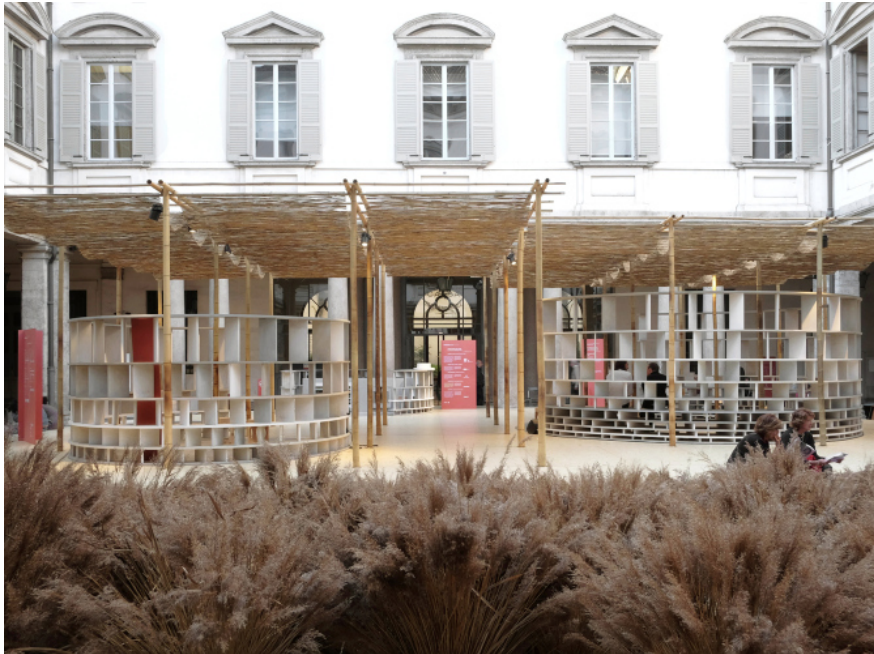
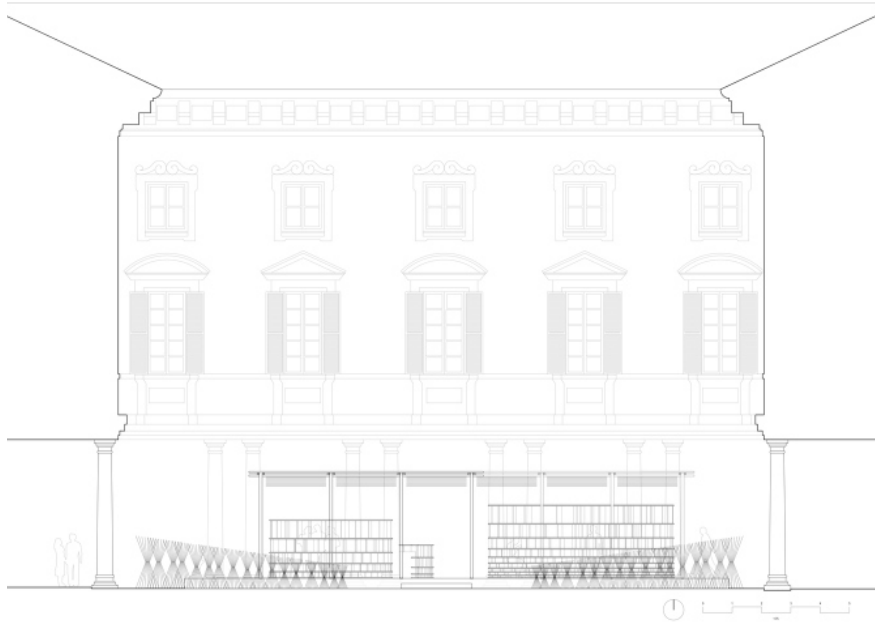
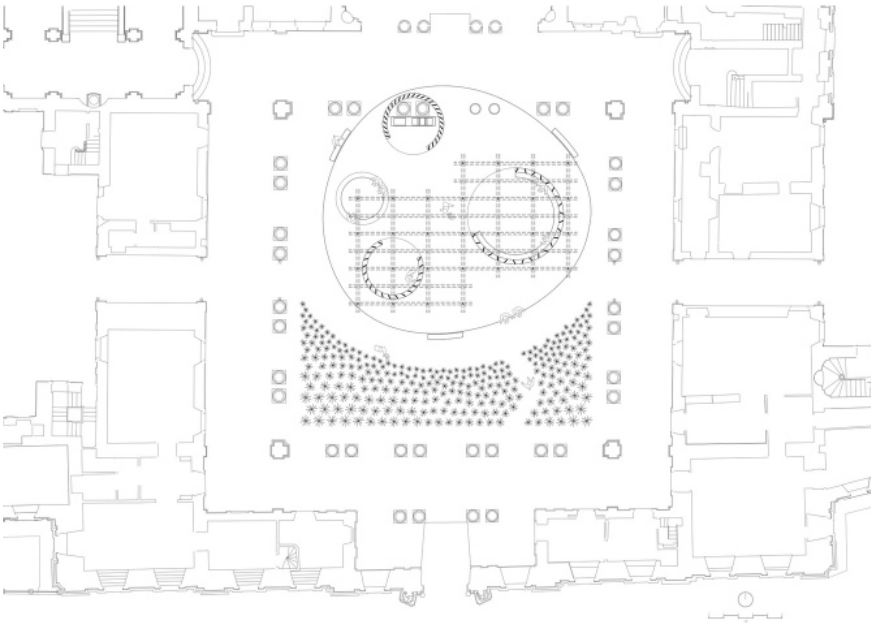
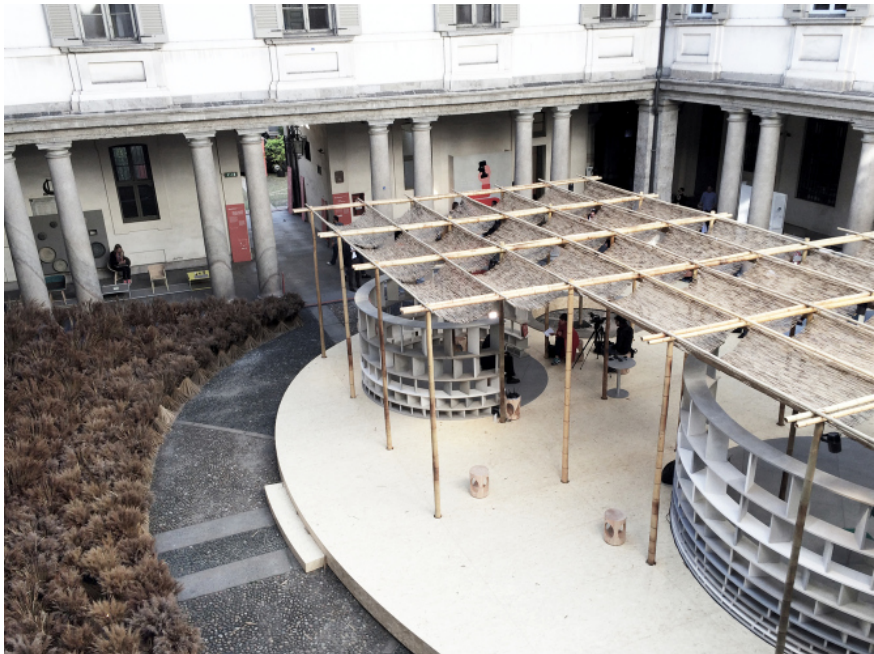
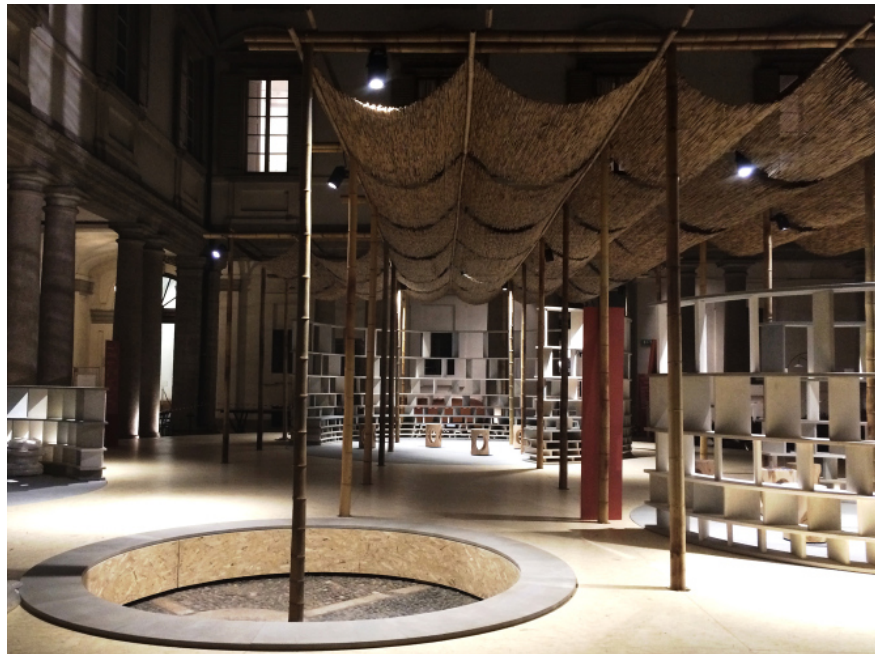
TEMPORARY COARTYARD INSTALATIONS , Courtyard Village in Milan

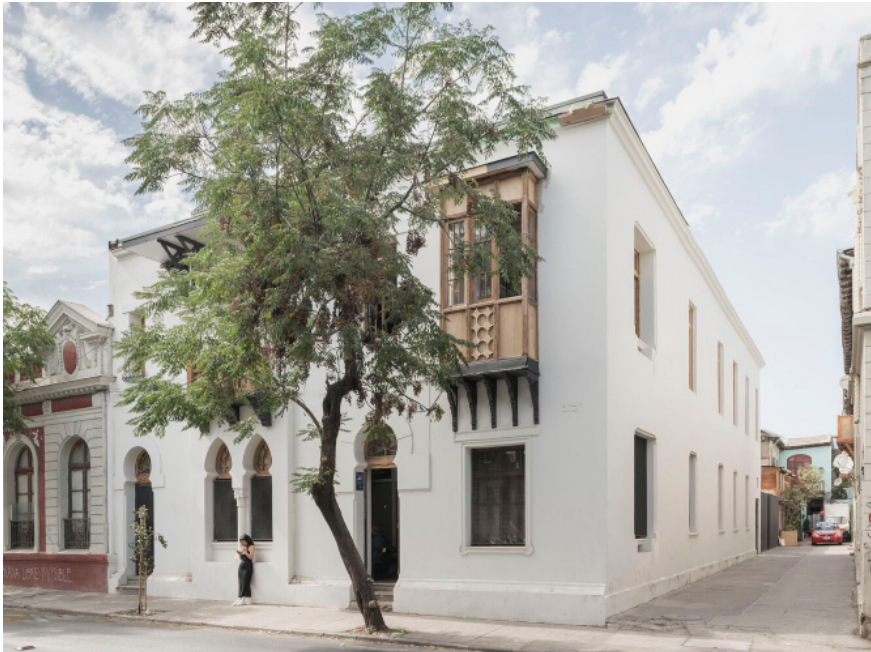
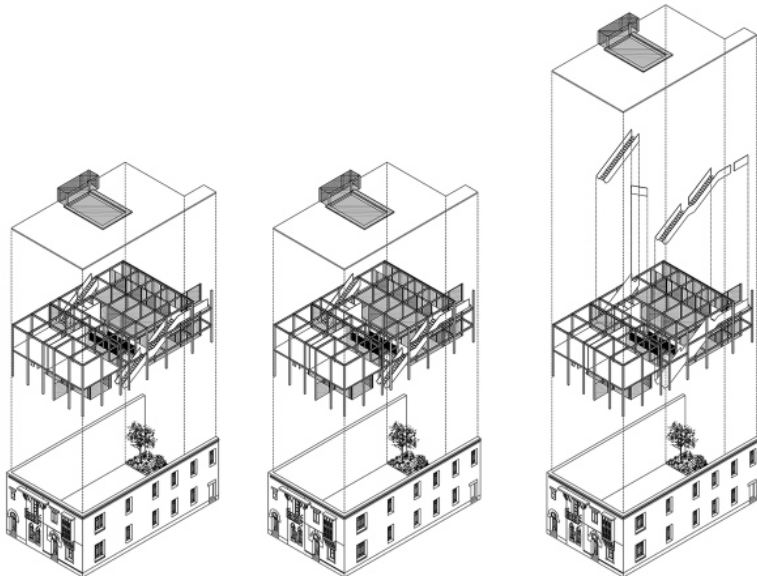
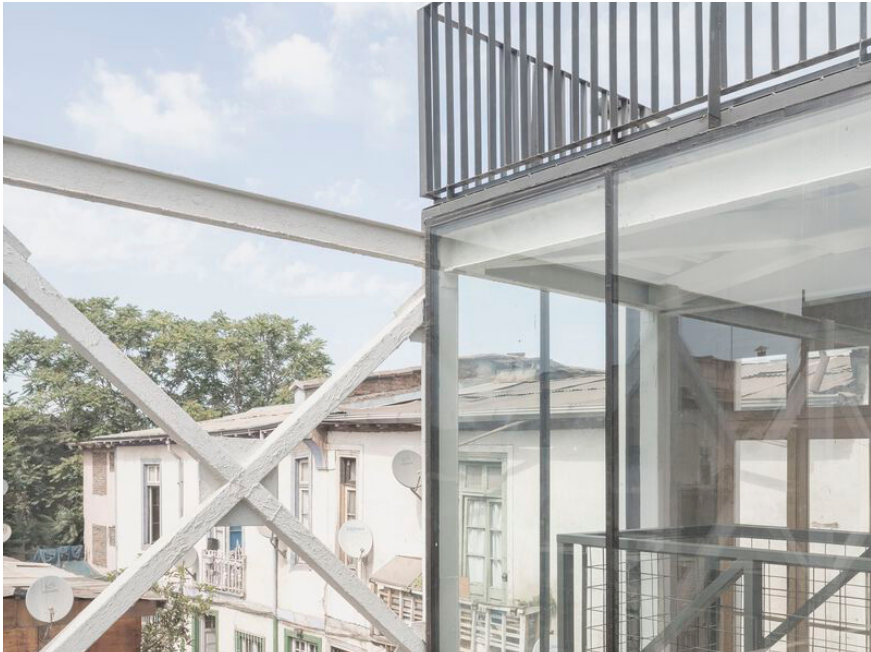
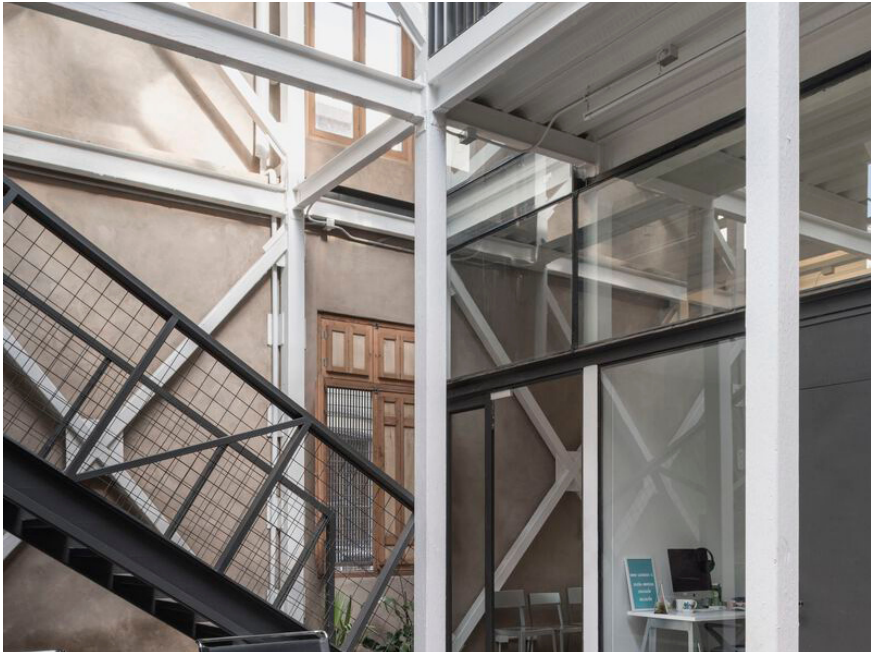
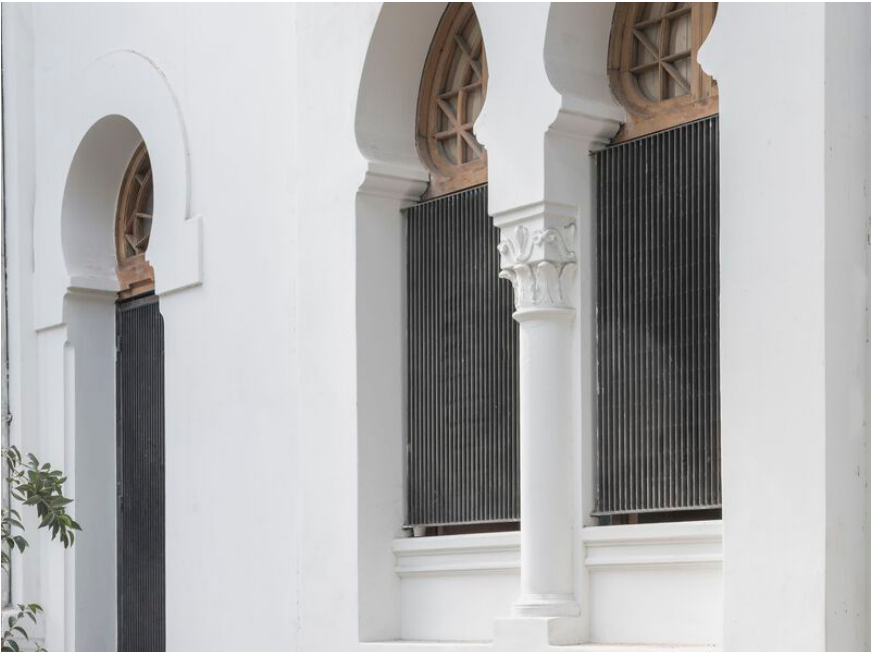
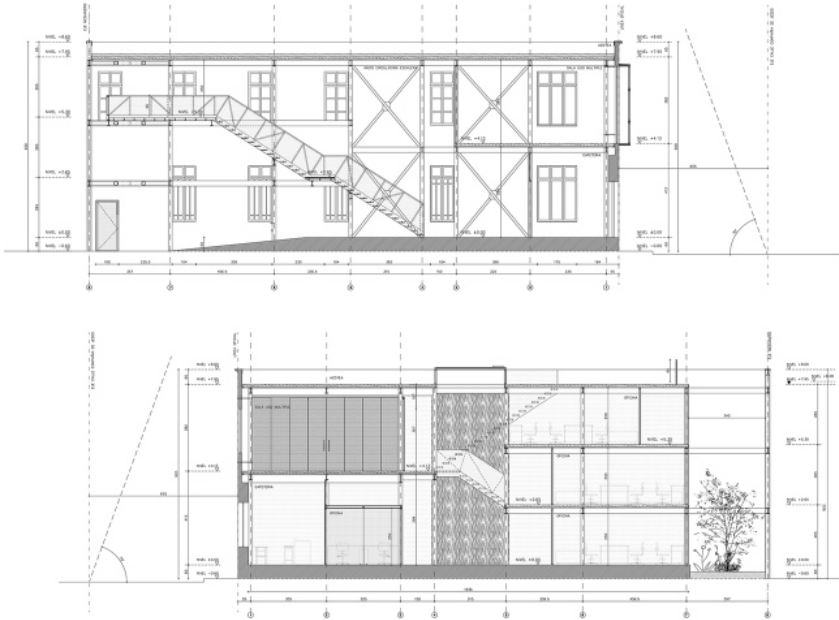
COWORK INTERIORS , Building restoration in Chile

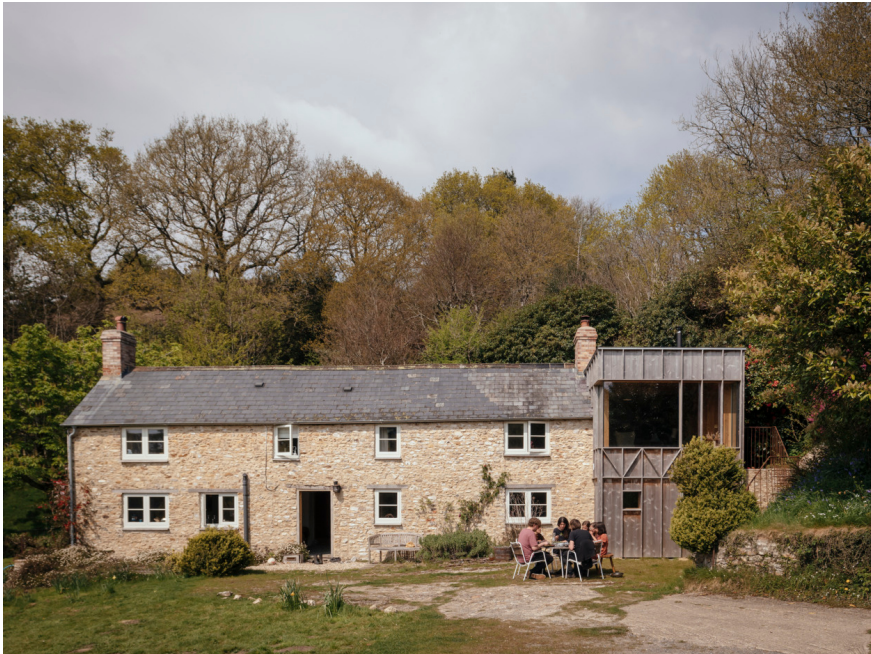
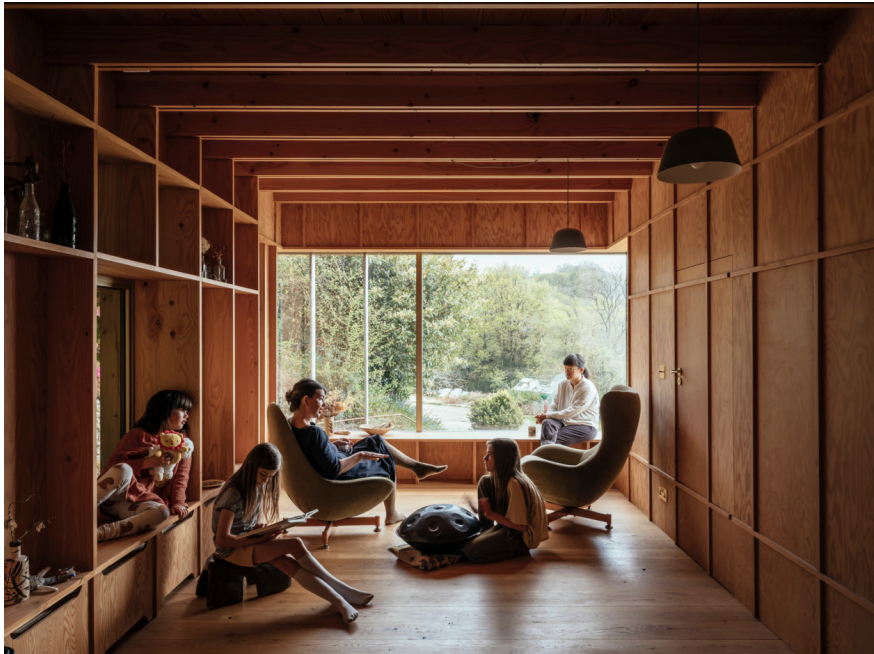
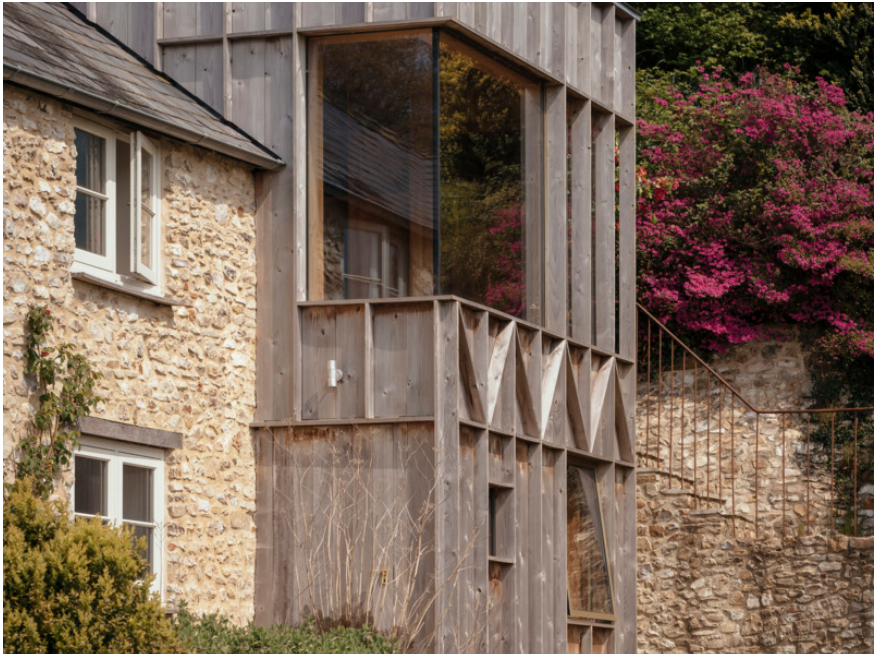
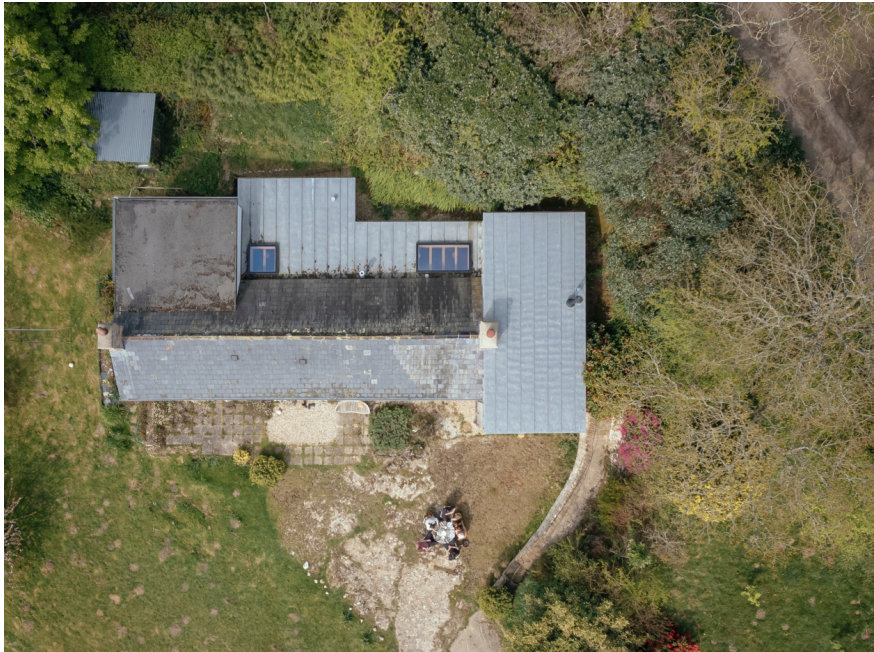
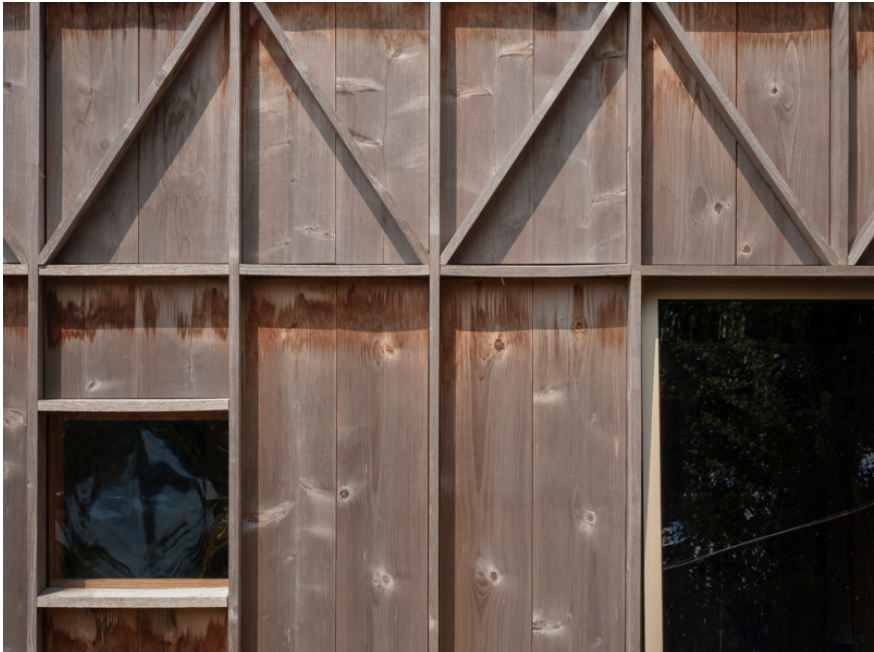
«MADE OF SAND» HOUSE EXTENTION , Building renovation in UK

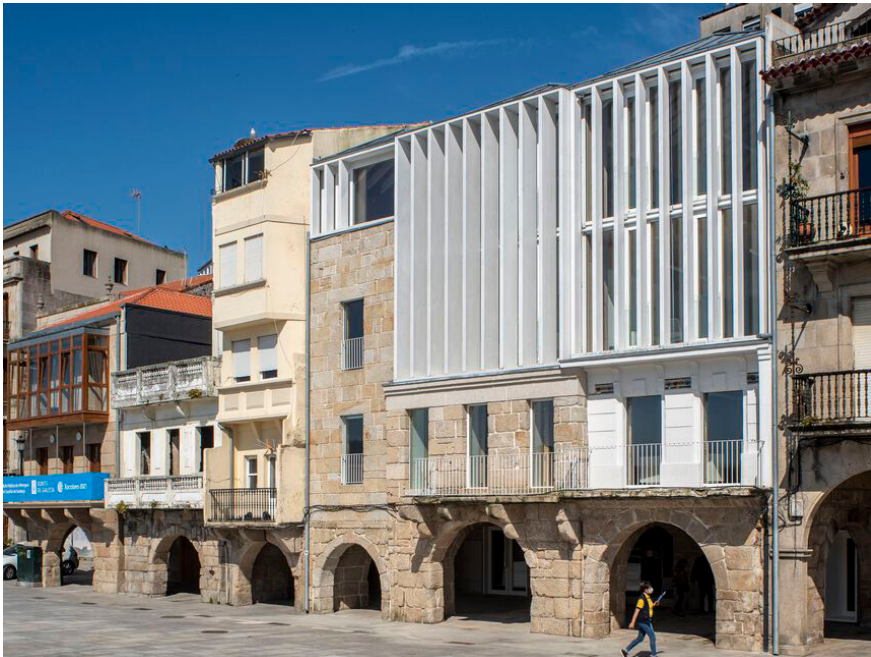
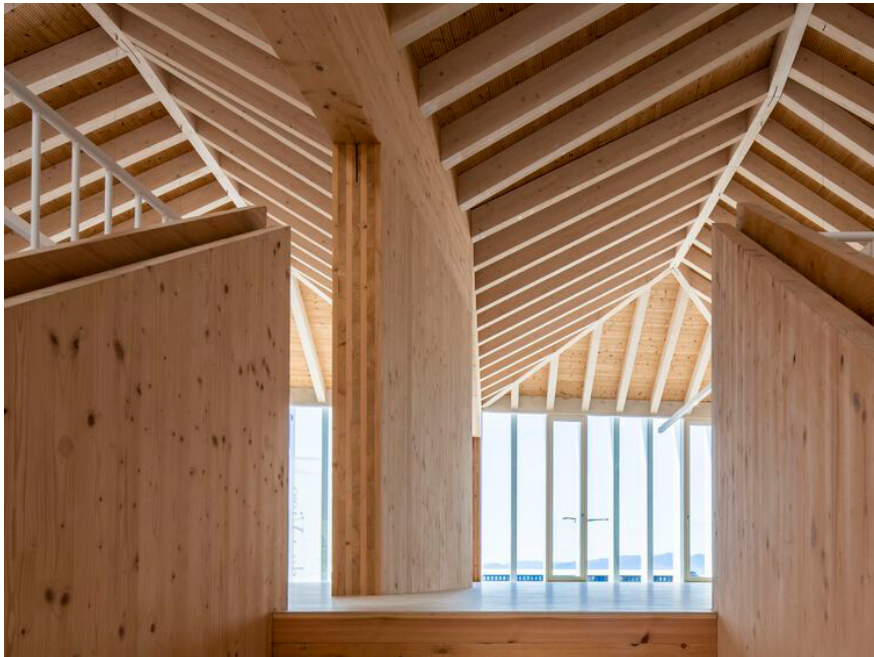
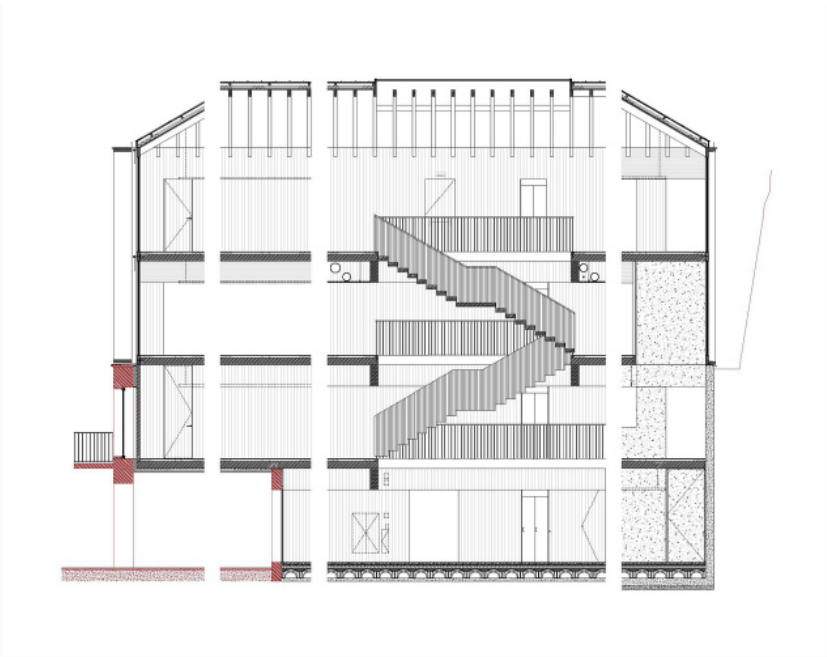
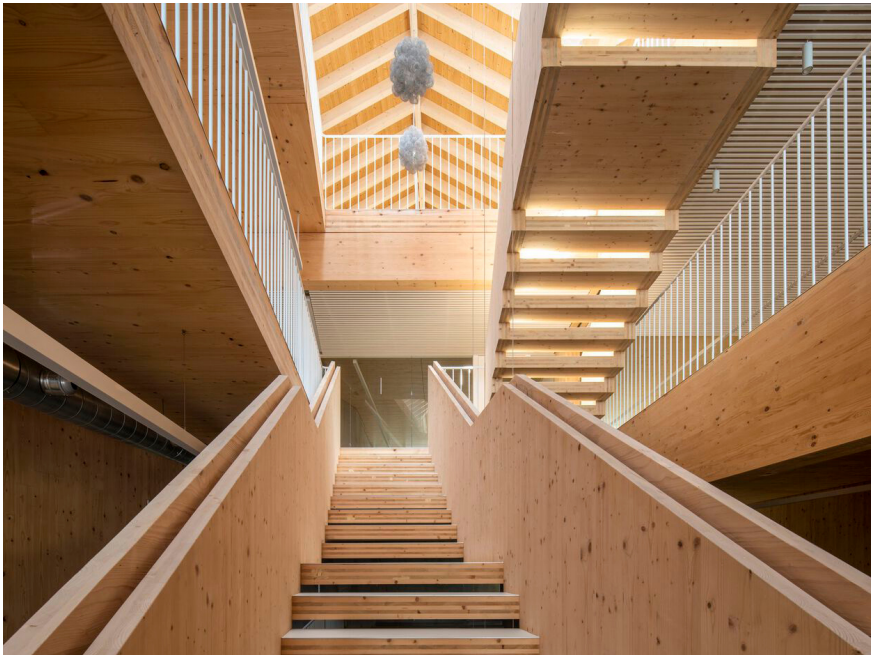
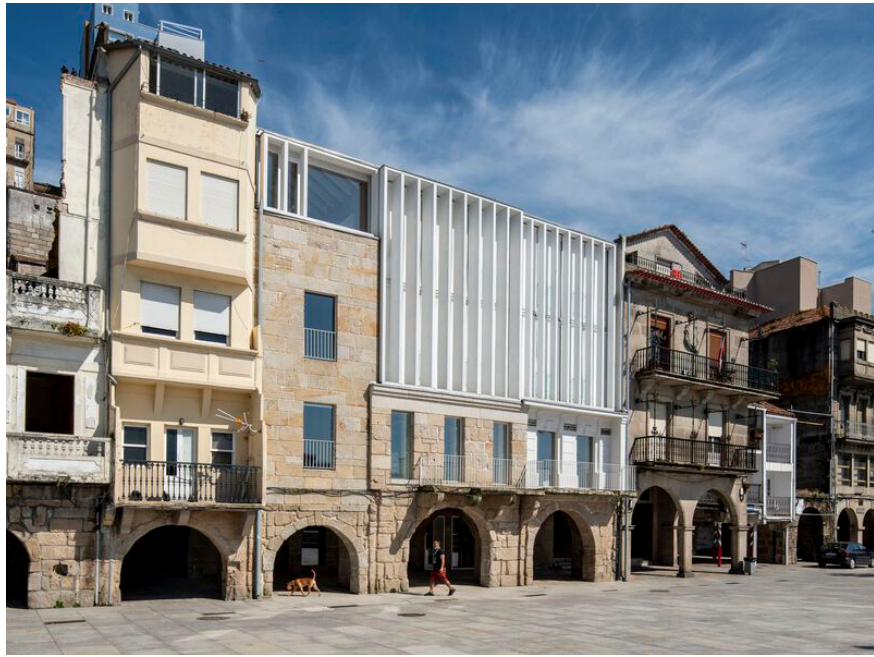
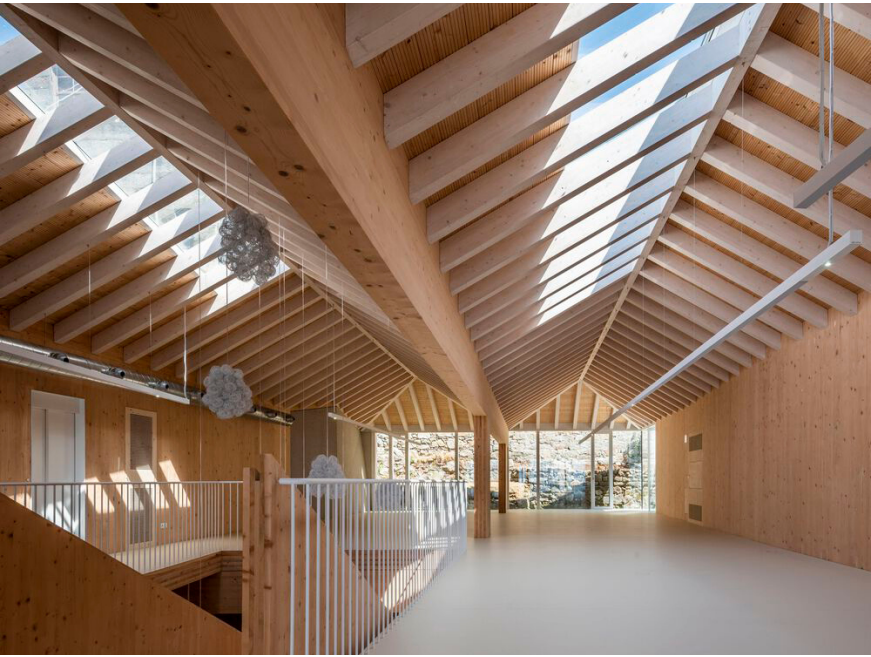
HEADQUARTERS REORGANISATION , Building of the University in Spain

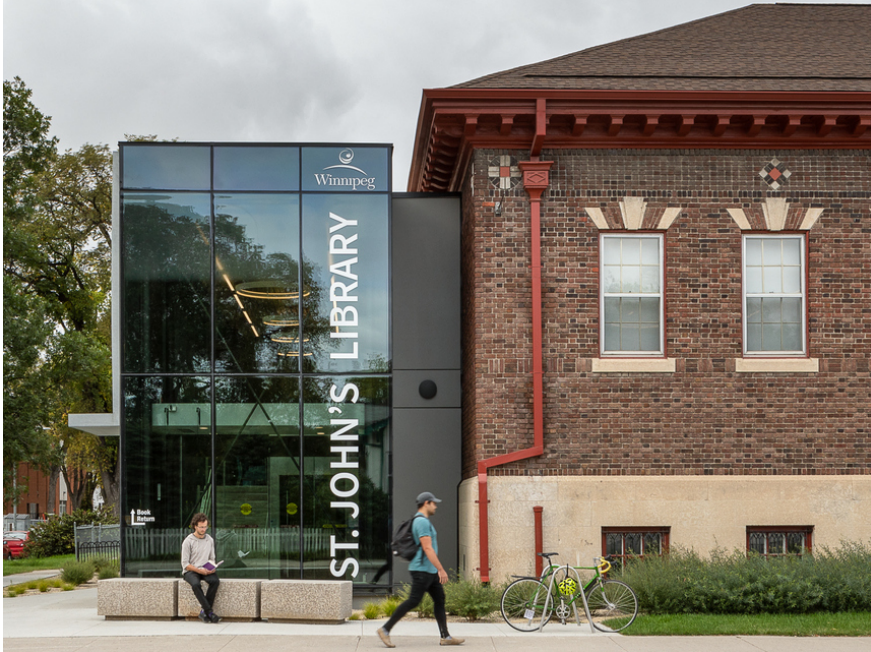
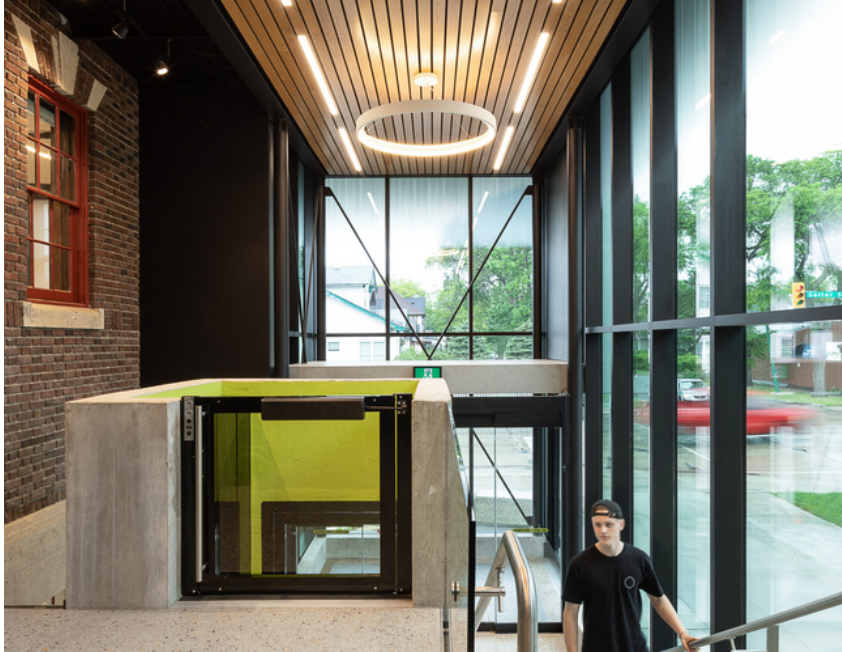
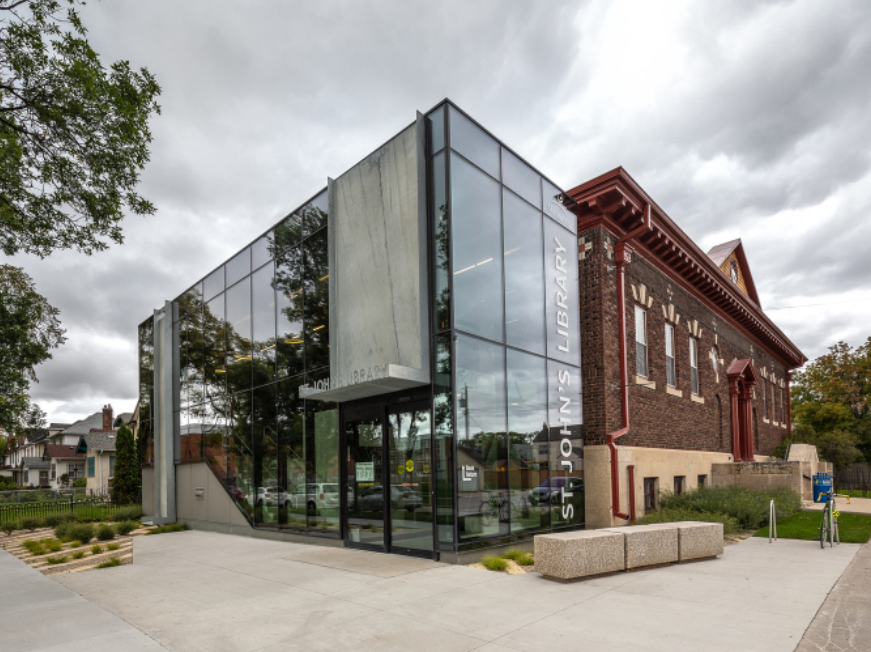
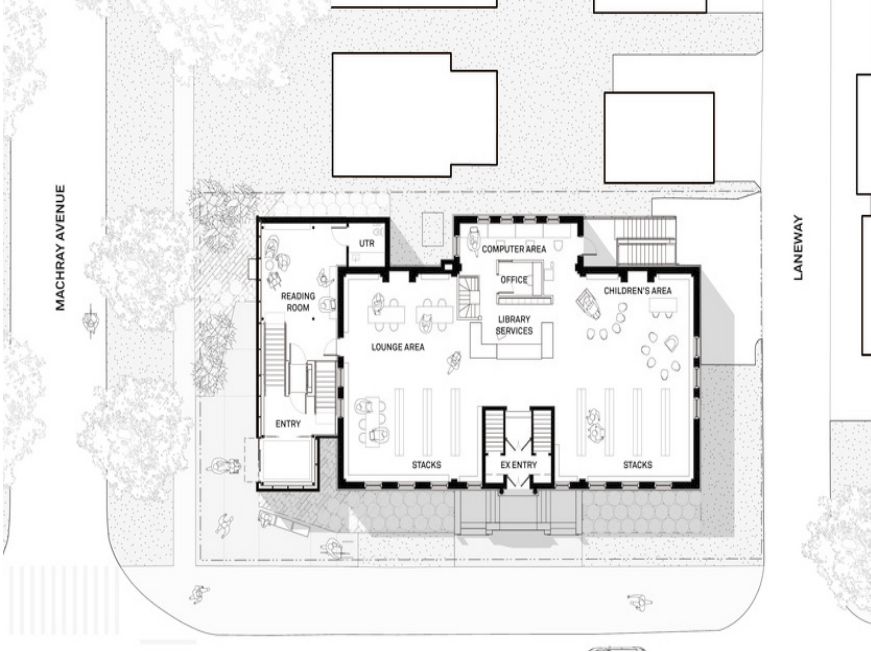
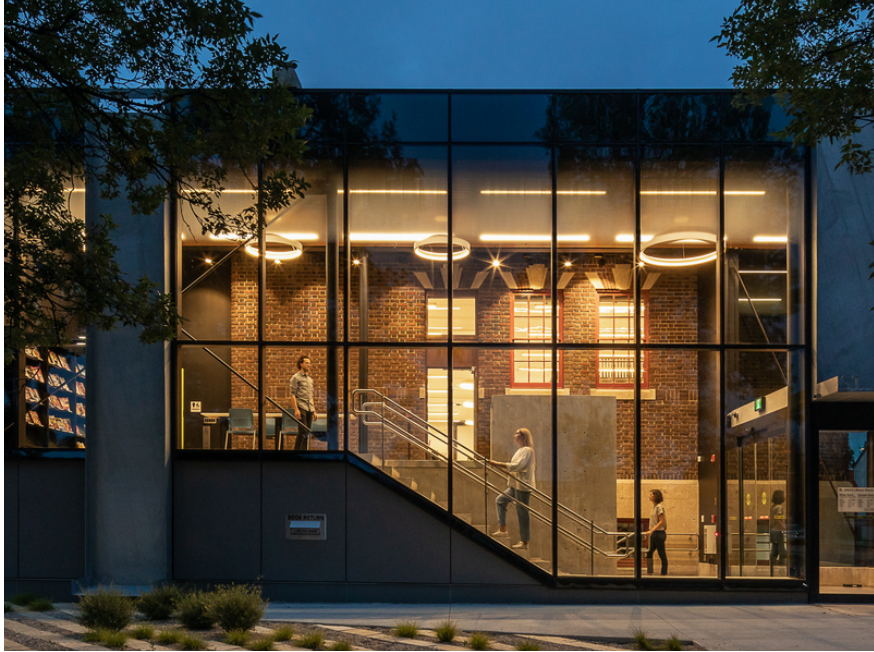
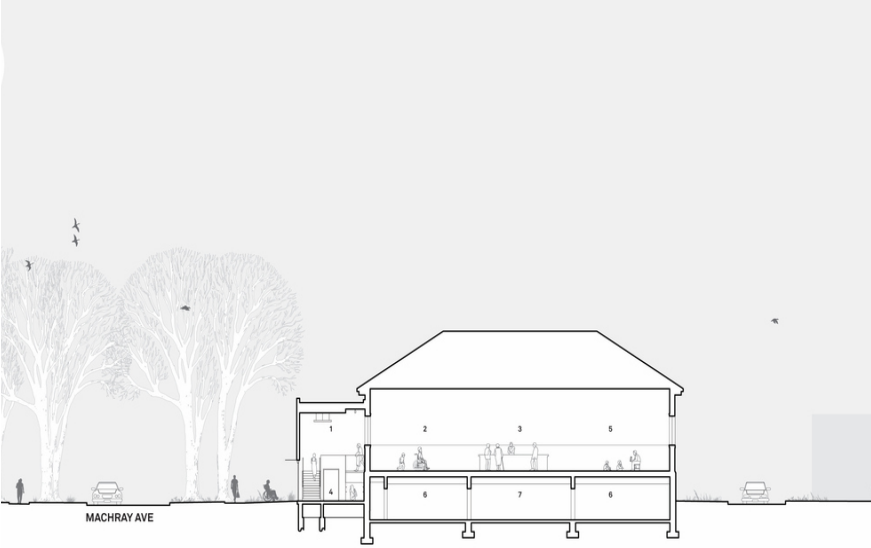
LIBRARY RESTORATION , Building upgrade in Canada

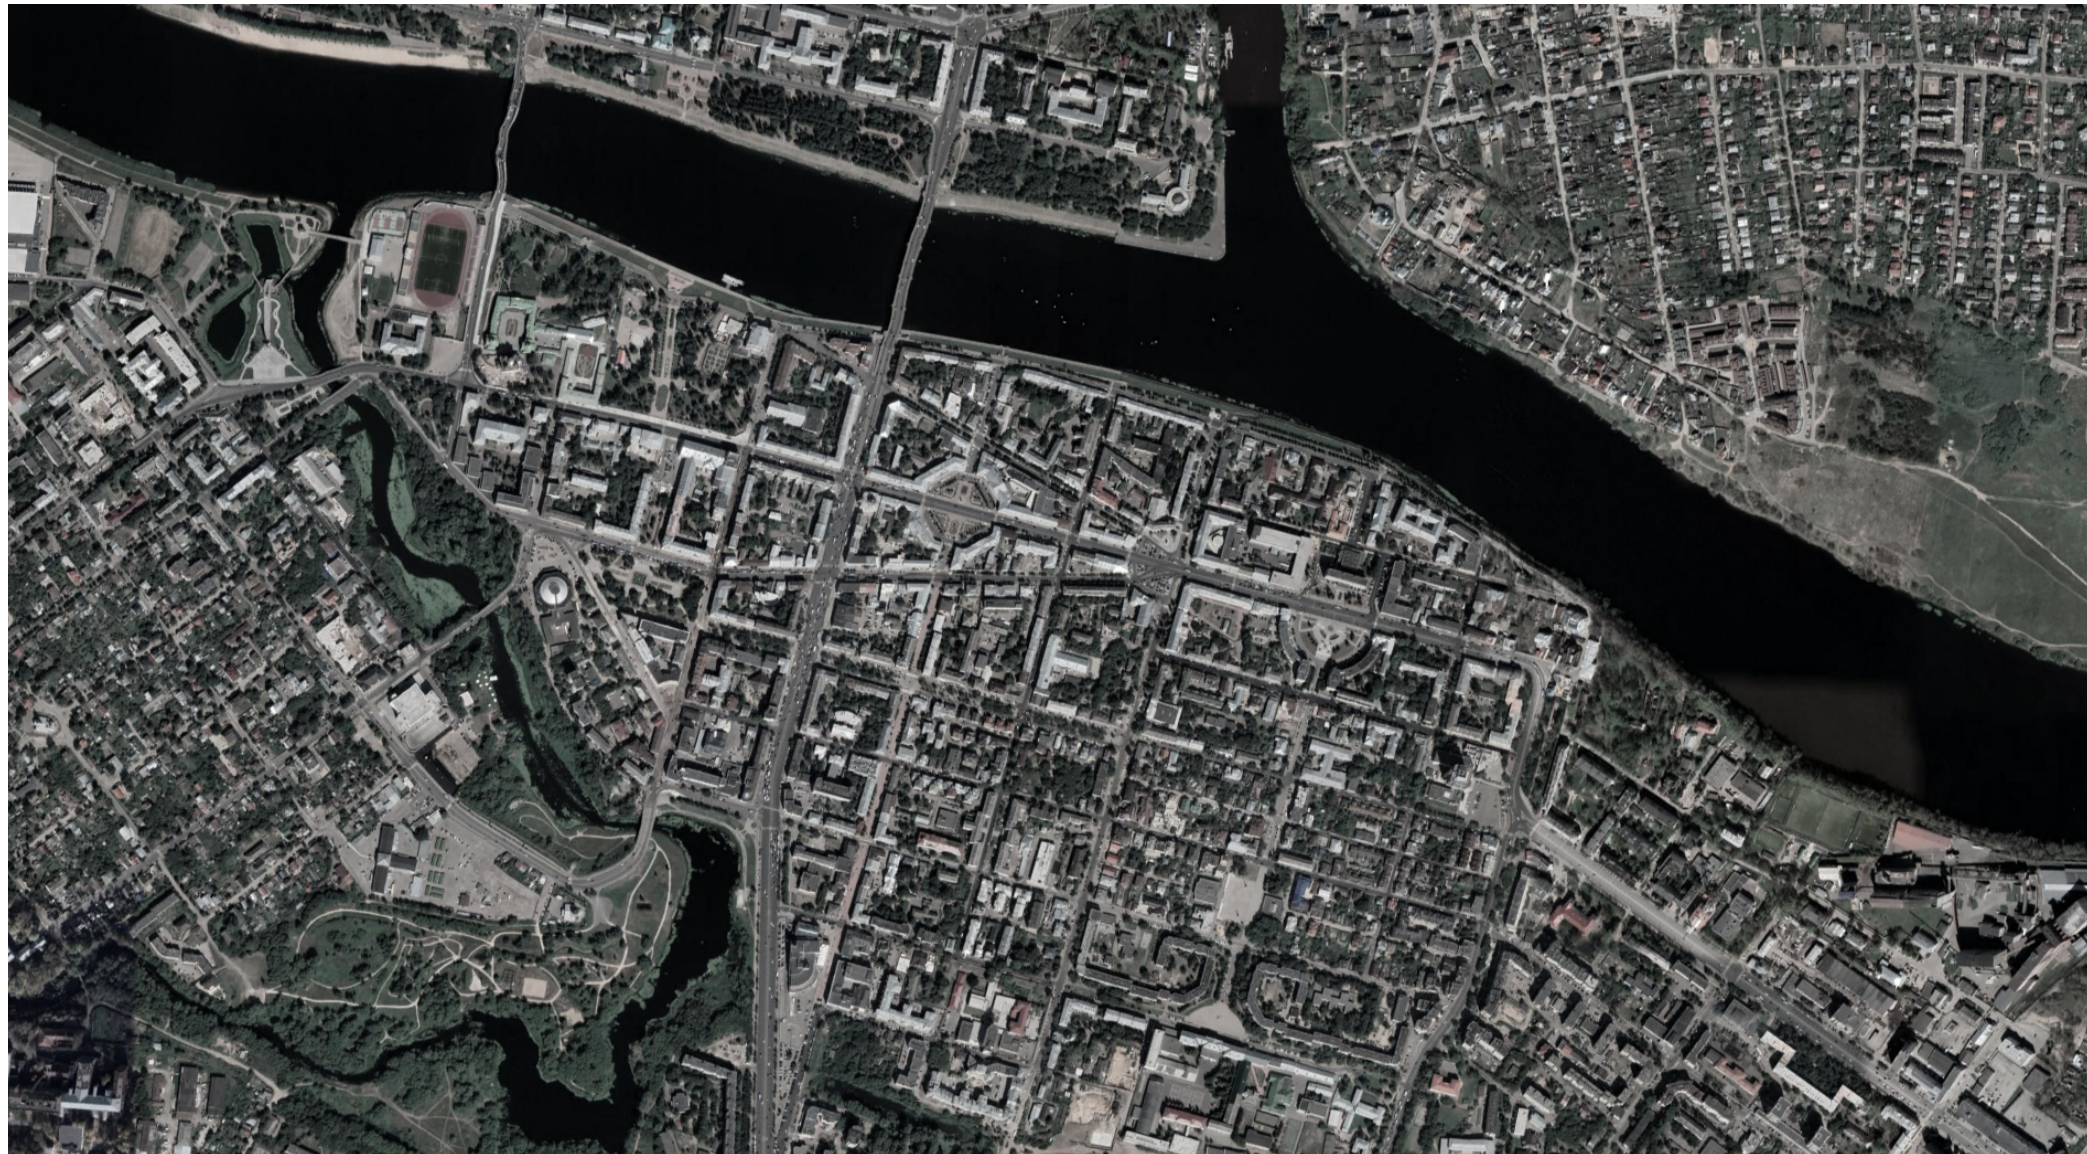
-   **CITY SENTIAL AREA:**  
HISTORIC PART OF THE CITY
-   **RAILWAY LINE:**  
REGIONAL RAILWAY CONNECTION
-   **SOCIAL AND CULTURAL PLACES:**  
MUSEUMS, EXEBITIONS, HISTORICAL BUILDINGS,  
MONUMENTS and etc
-   **DESIGN AREA:**  
NOVOTORGSKAYA STREET, 12/5

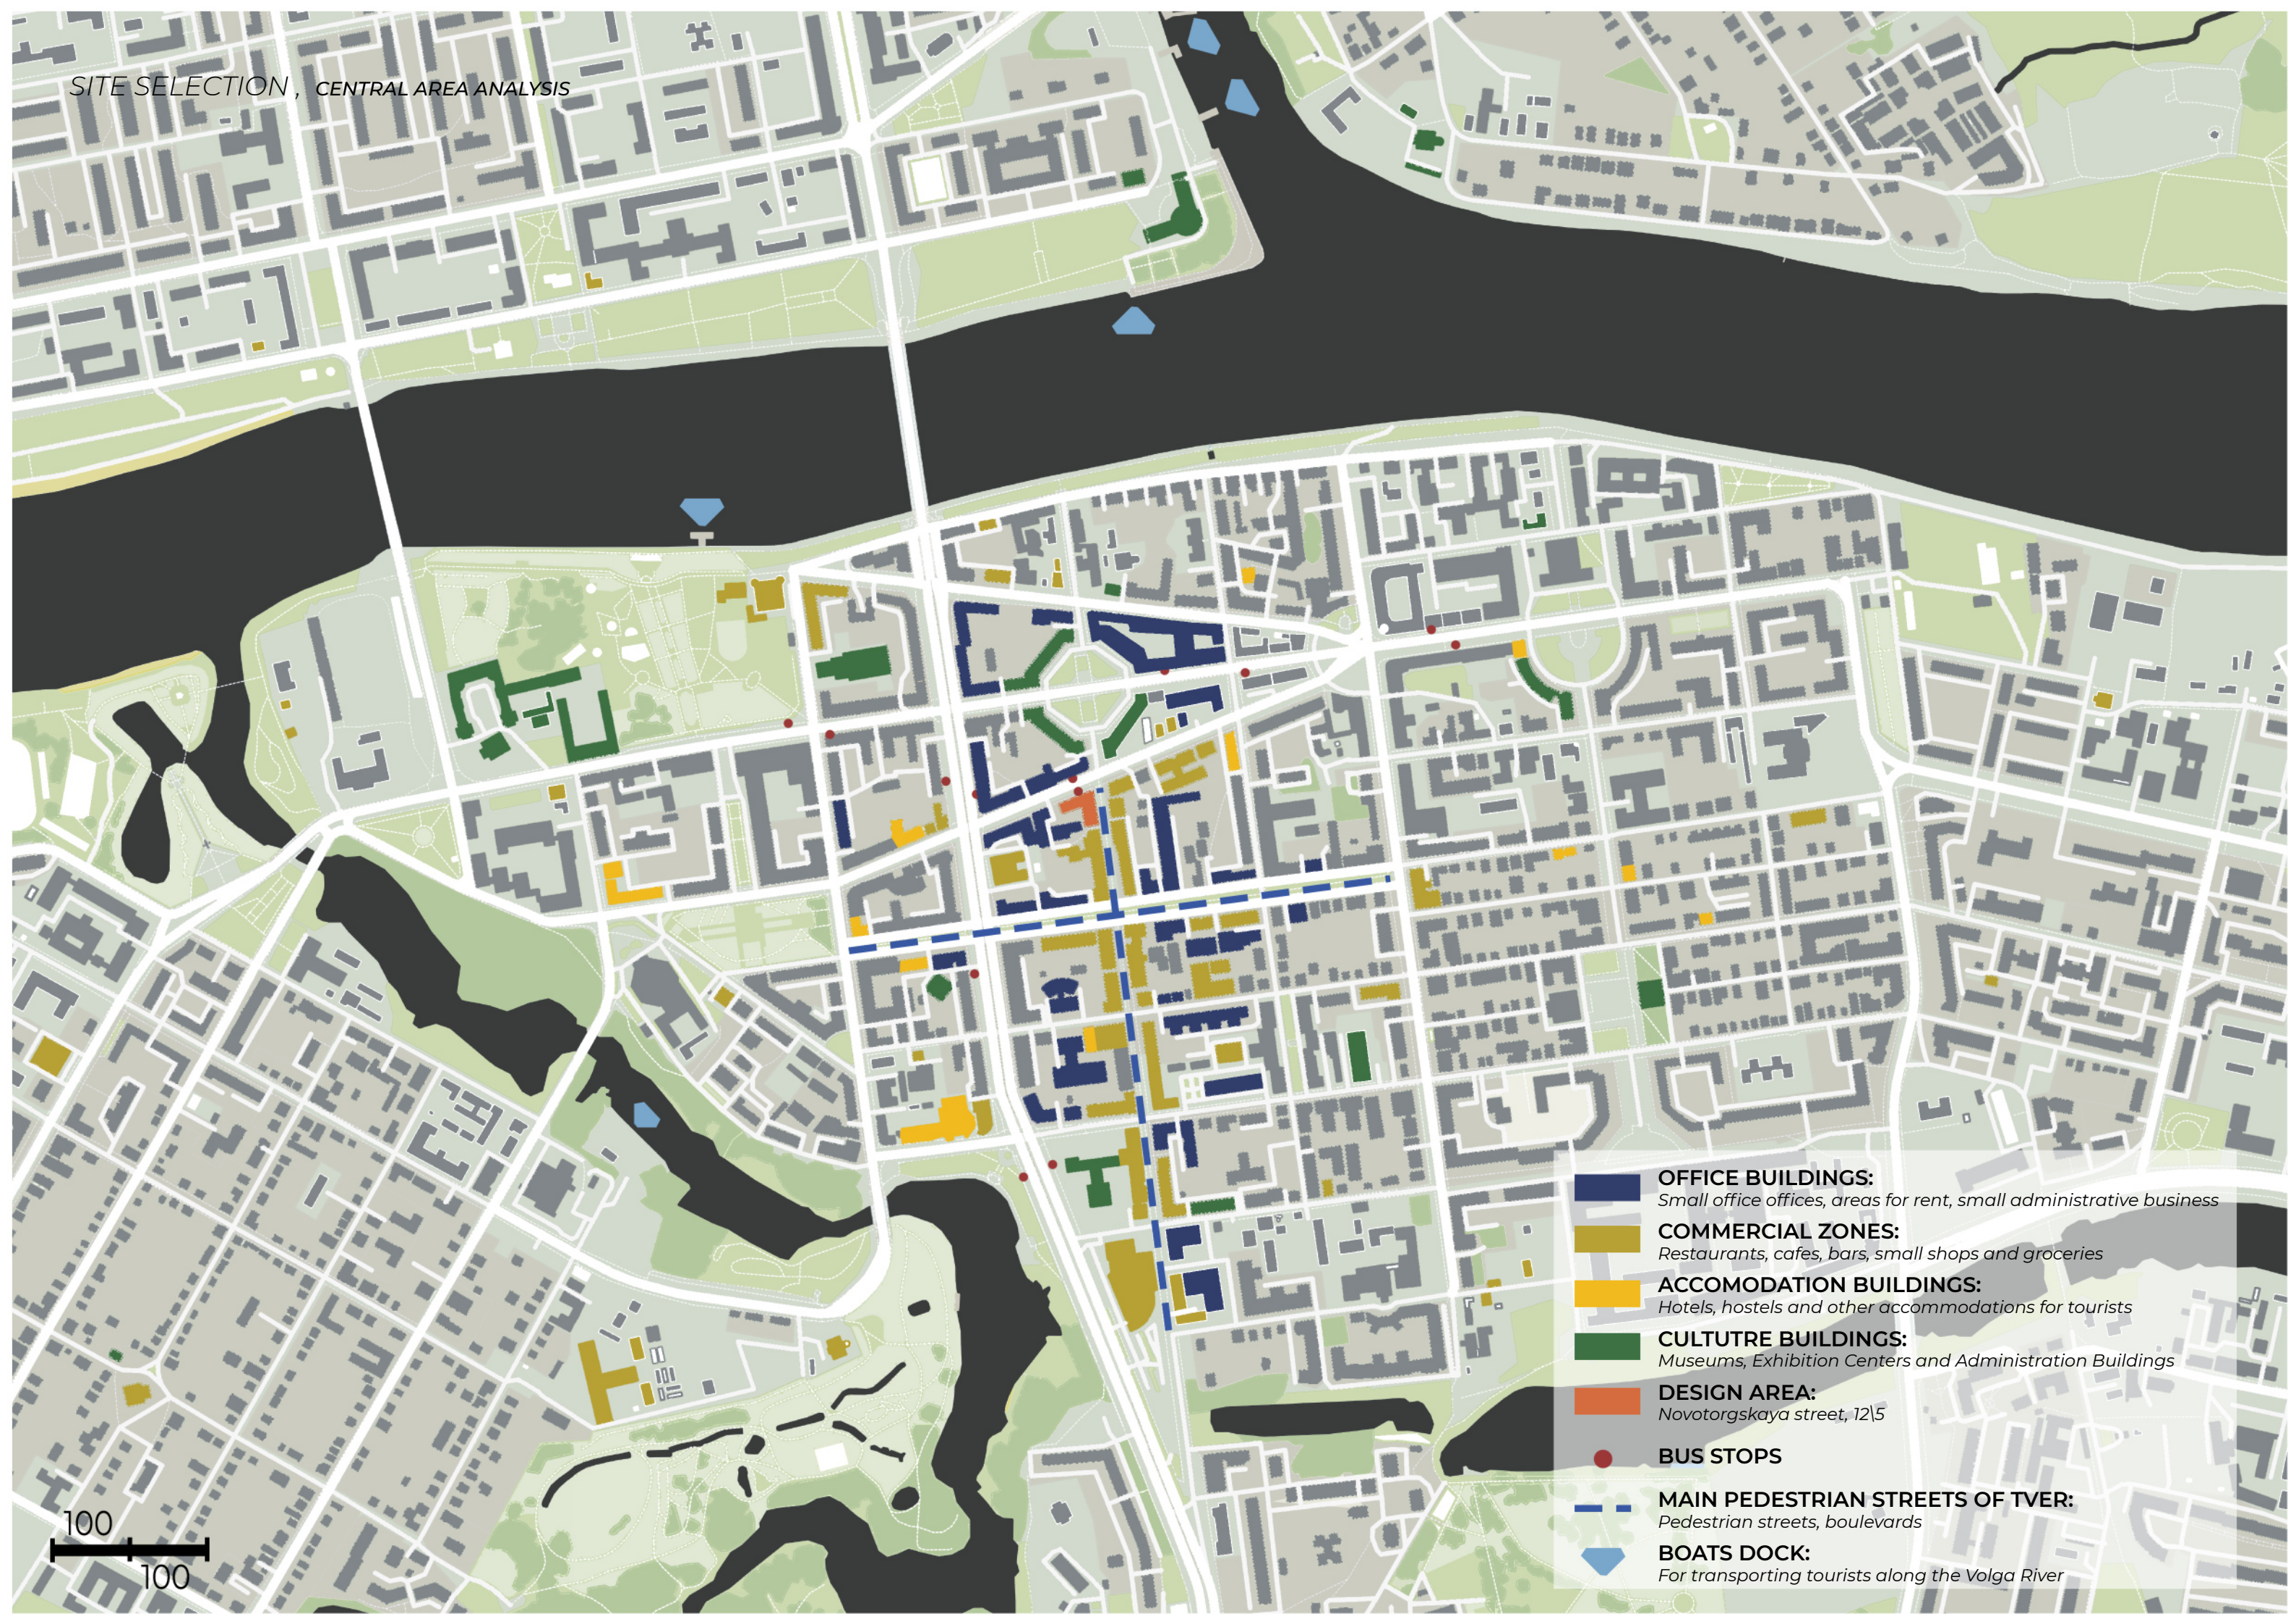
*The historical center of the city of Tver, the layout of which was designed at the end of the 17th century.*

- OFFICE BUILDINGS:**  
*Small office offices, areas for rent, small administrative business*
- COMMERCIAL ZONES:**  
*Restaurants, cafes, bars, small shops and groceries*
- ACCOMODATION BUILDINGS:**  
*Hotels, hostels and other accommodations for tourists*
- CULTUTRE BUILDINGS:**  
*Museums, Exhibition Centers and Administration Buildings*
- DESIGN AREA:**  
*Novotorgskaya street, 12/5*
- BUS STOPS**
- MAIN PEDESTRIAN STREETS OF TVER:**  
*Pedestrian streets, boulevards*
- BOATS DOCK:**  
*For transporting tourists along the Volga River*
