Department of Architecture:  
«Sustainable Architecture and Landscape Design»  
2022

*«Applying Sustainable Methods in Renovation of the Historical building in Tver, Russia.»*

*«How to apply sustainable renovation technique to a protected historical building?»*

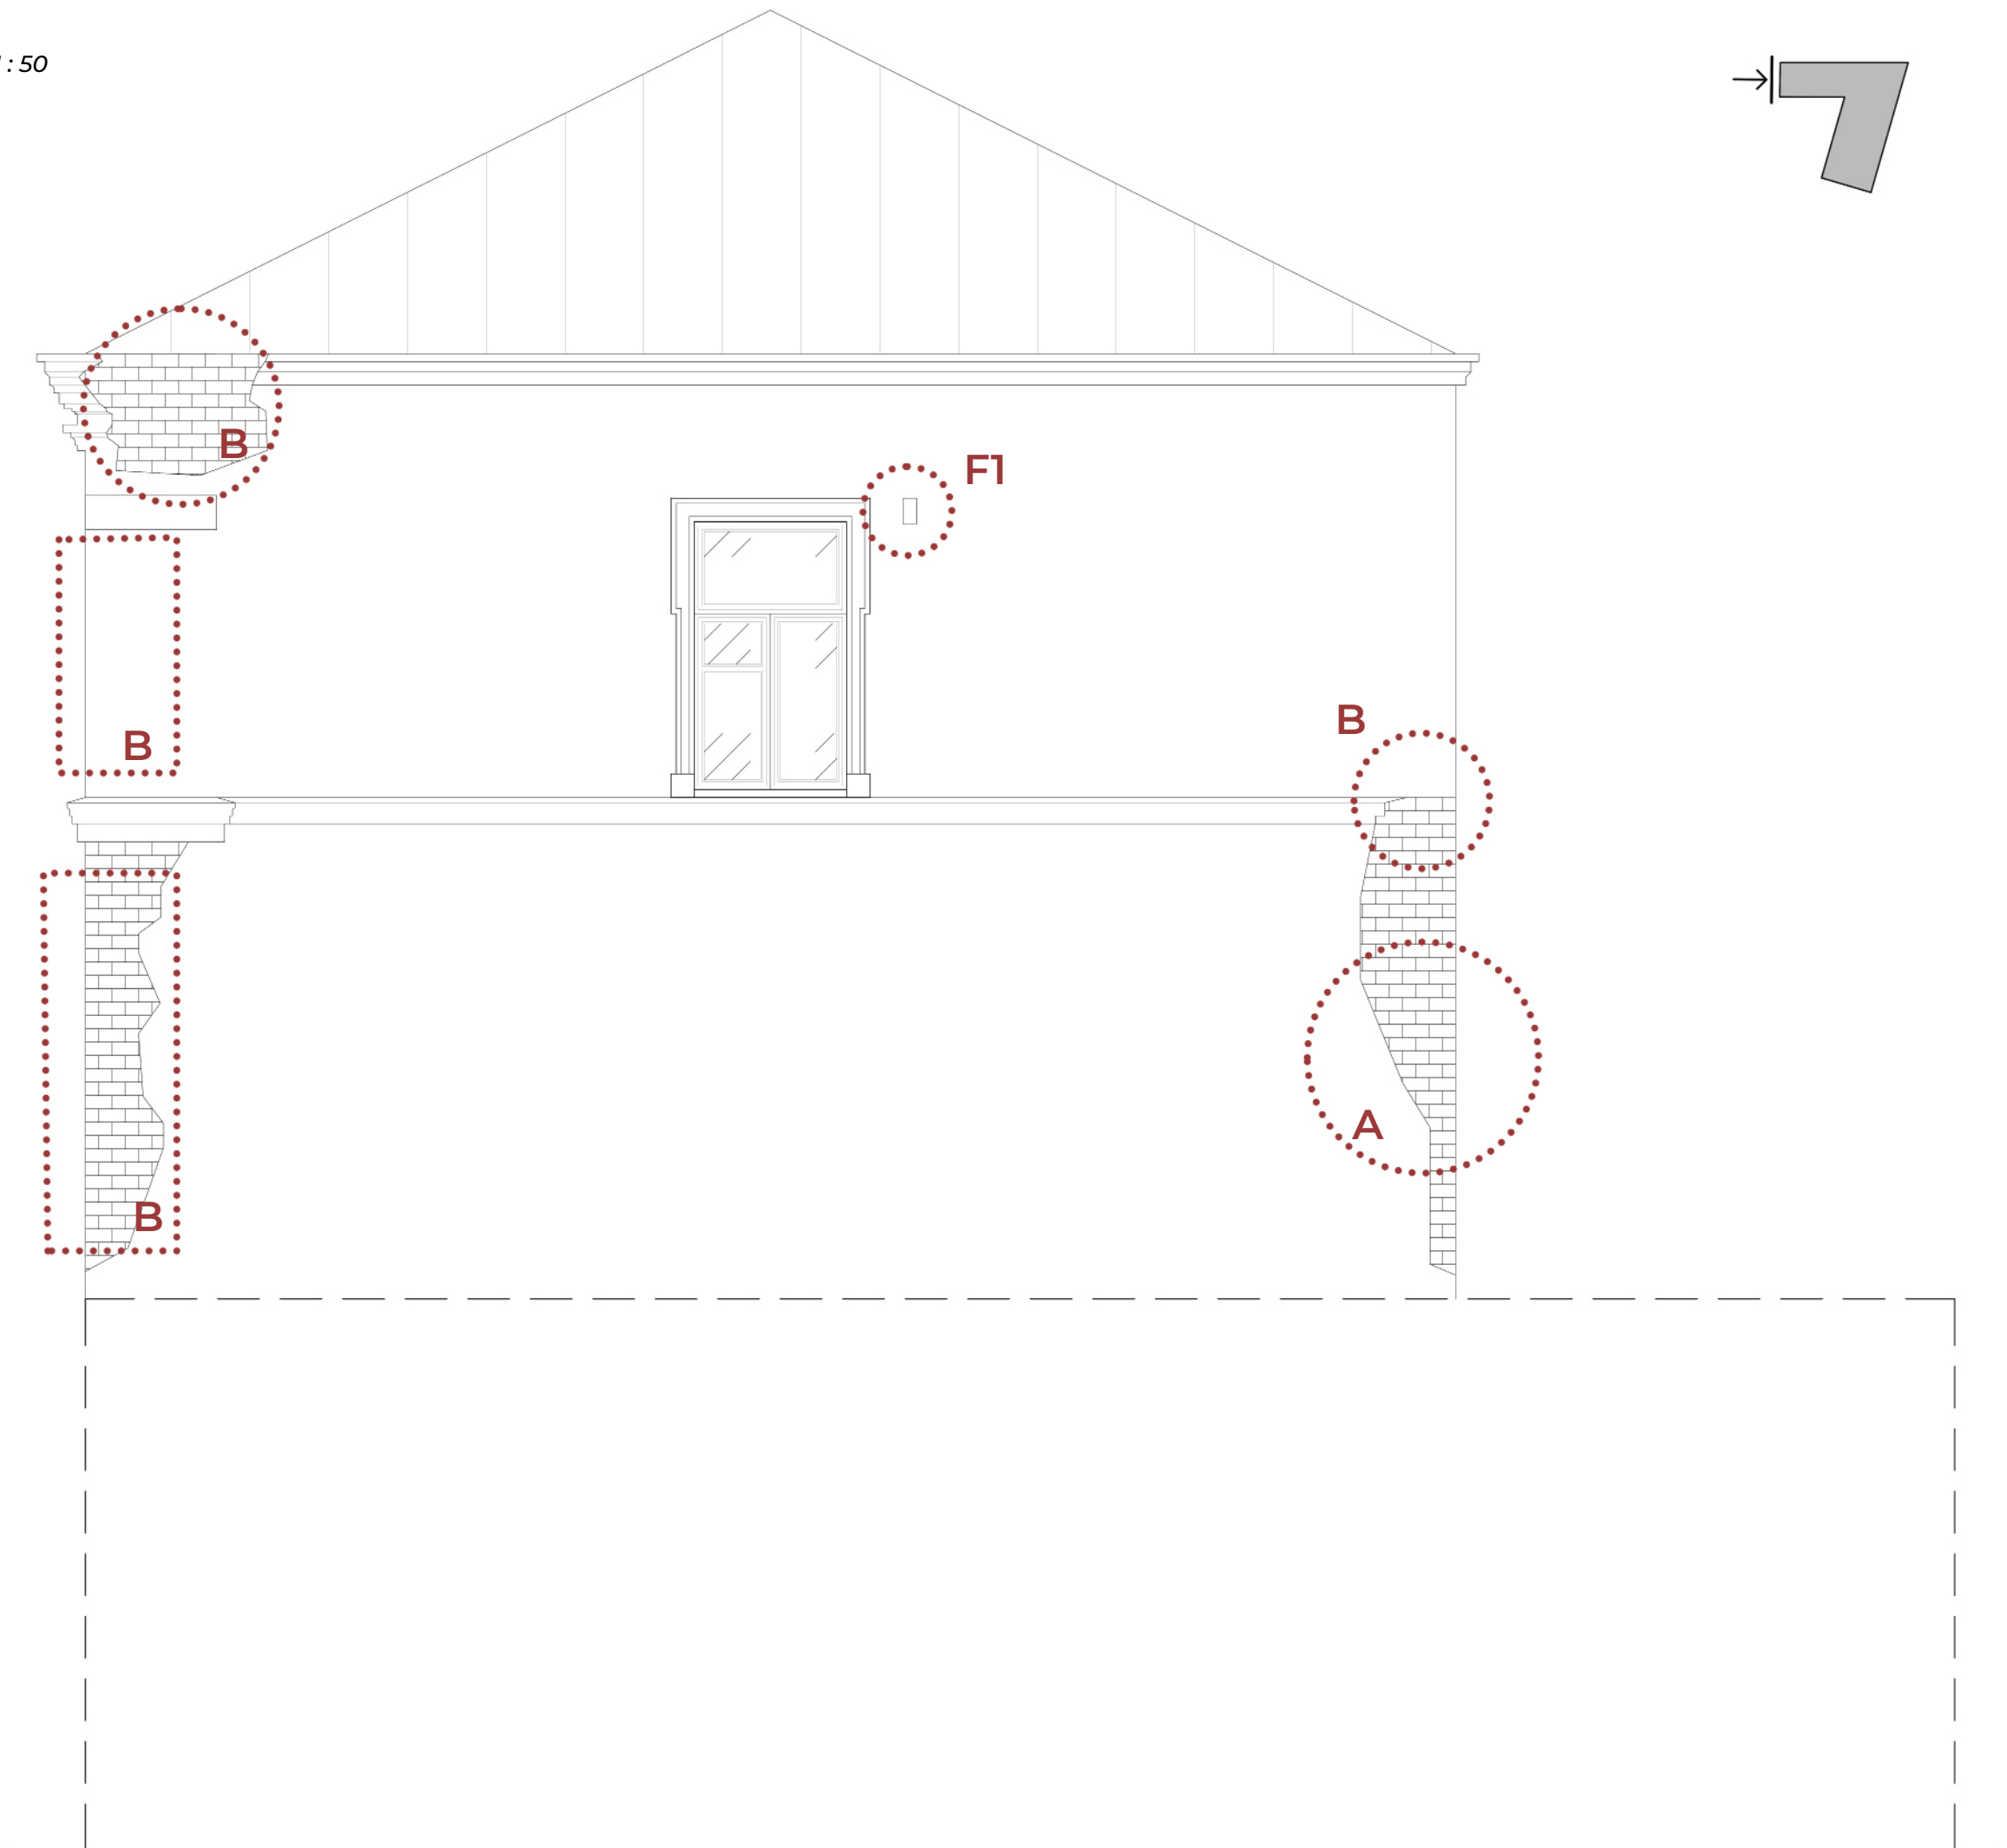
BUILDING CONDITION, WEST FACADE M 1:50

**F1**  
*A hole in the wall, not according to  
the project (from previous temporary  
structures or supports).*

**F2**  
*Traces of former brick outbuildings (lost  
over time).*

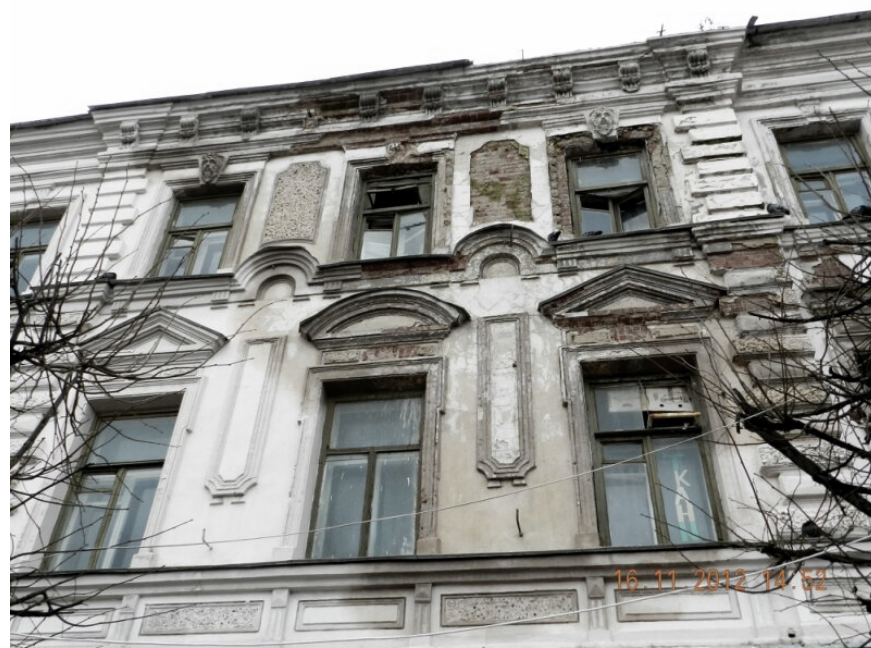
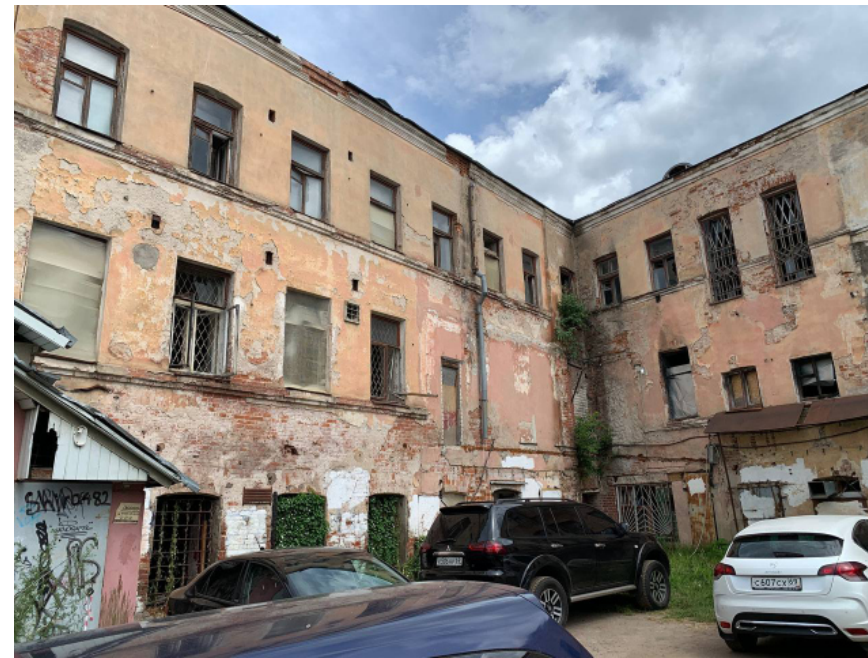
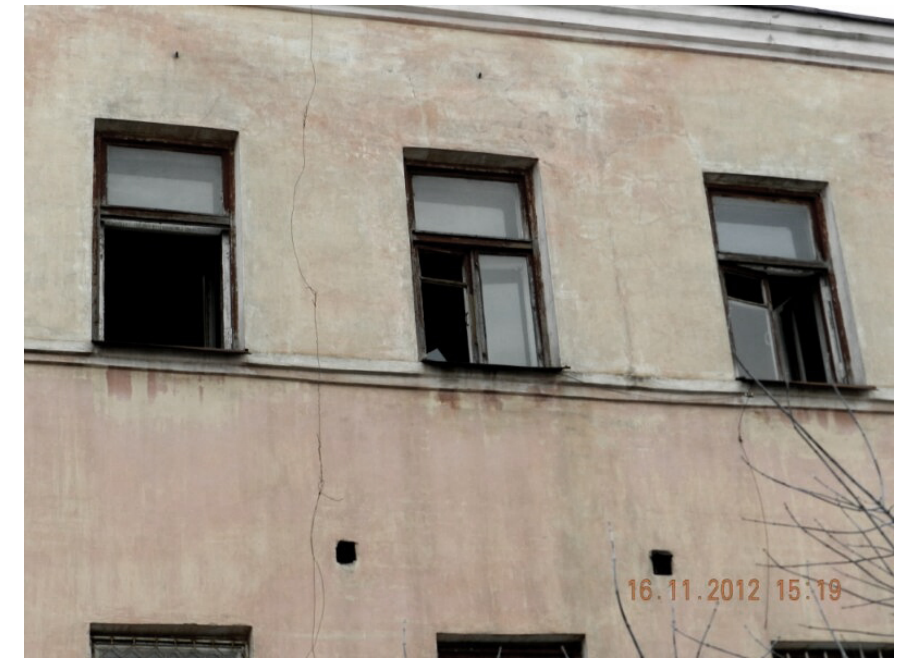
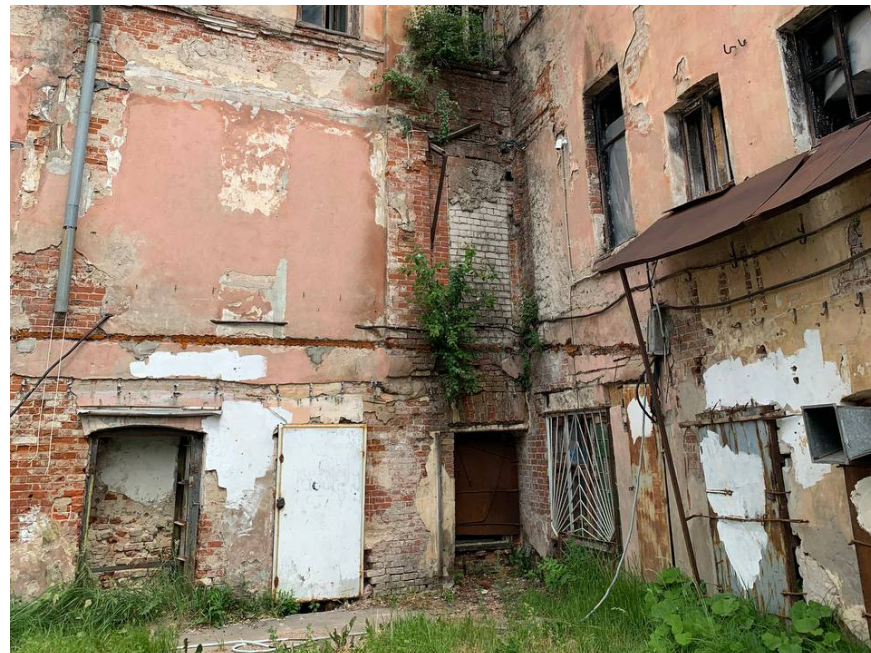
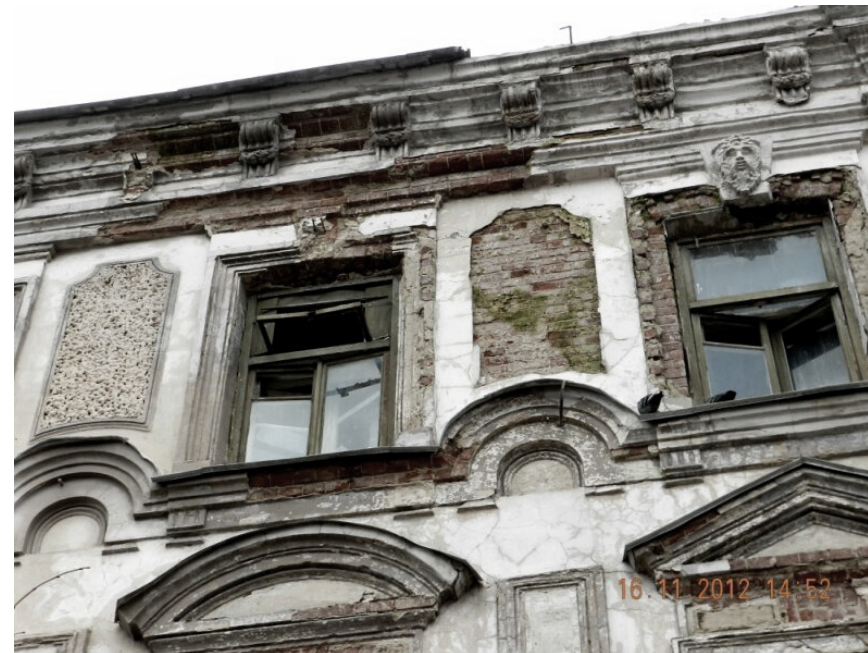
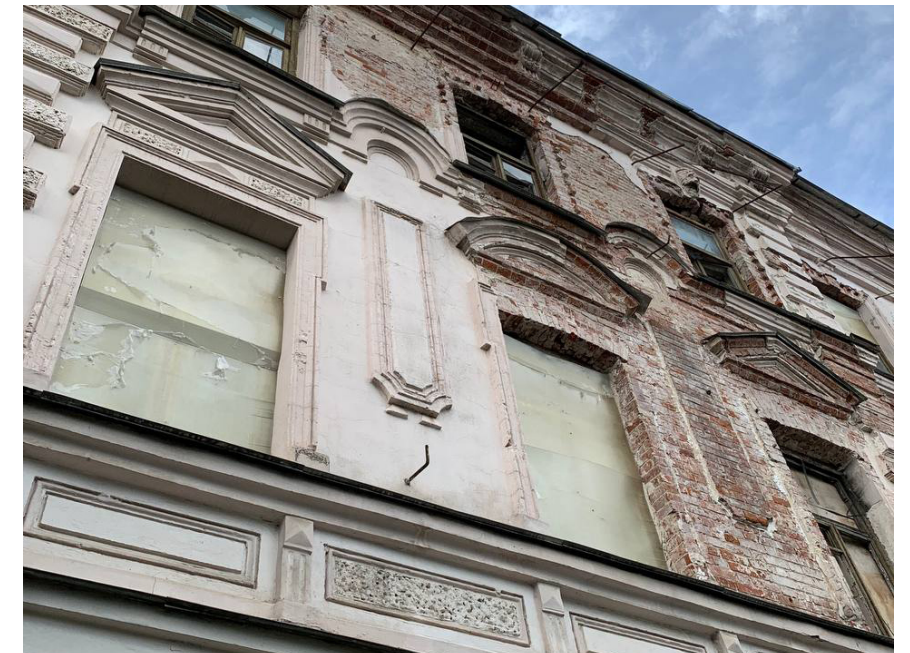
PHOTO ARCHIVE, PRESENT CONDITION

/ 2022 year, outside photoes condition

2012, the building burned down twice already. Empty areas incide, emergency condition. The building is actually abandoned. 2012, the building burned down twice already. Empty premises, emergency condition. The building is actually abandoned. Mold covers a significant part of the walls both inside and out. Facade elements of the building are crumbling.

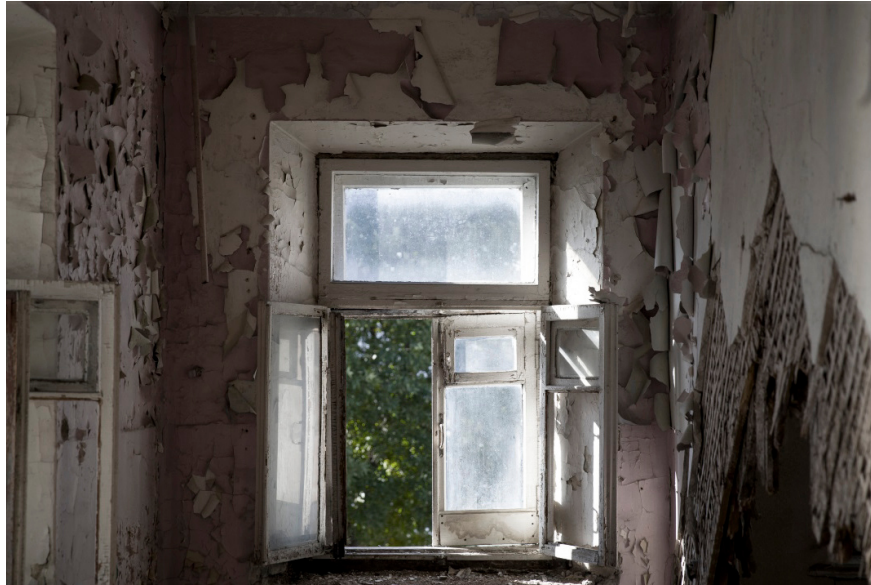
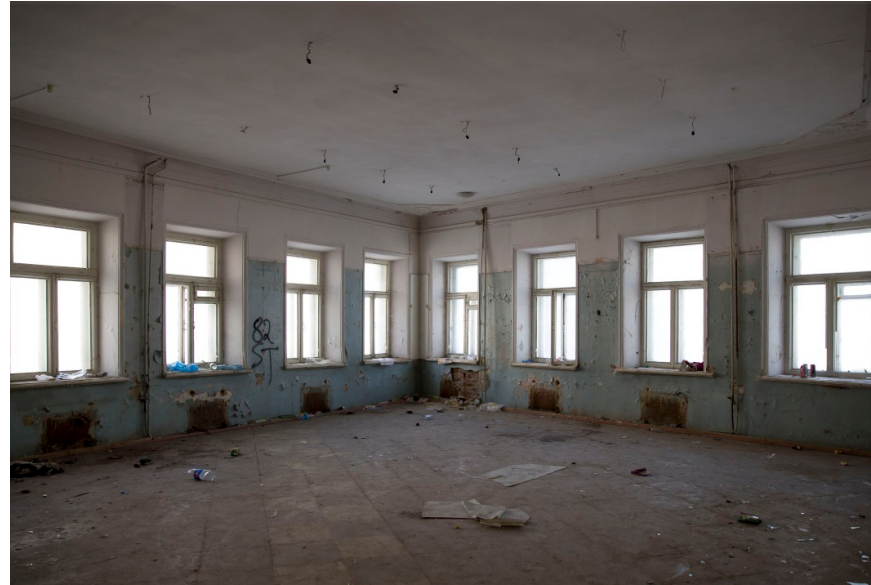
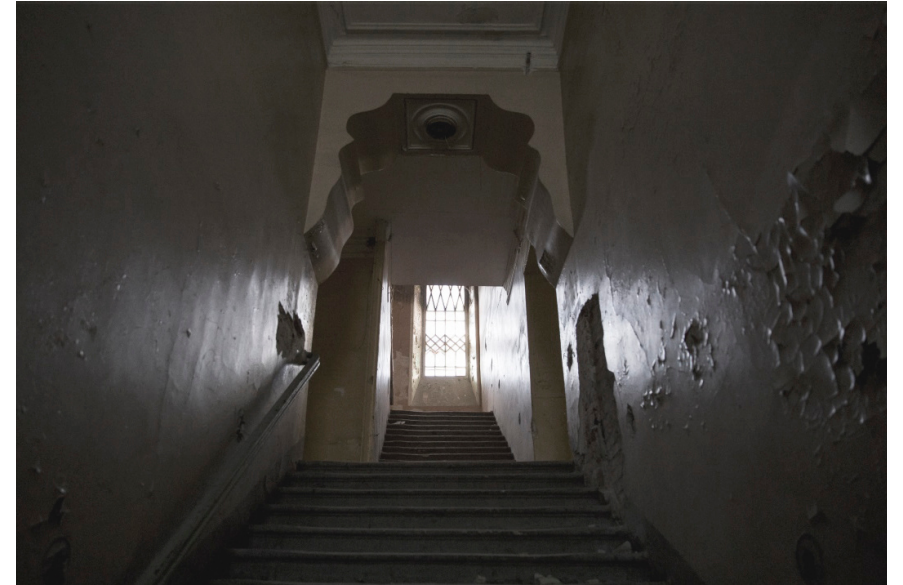
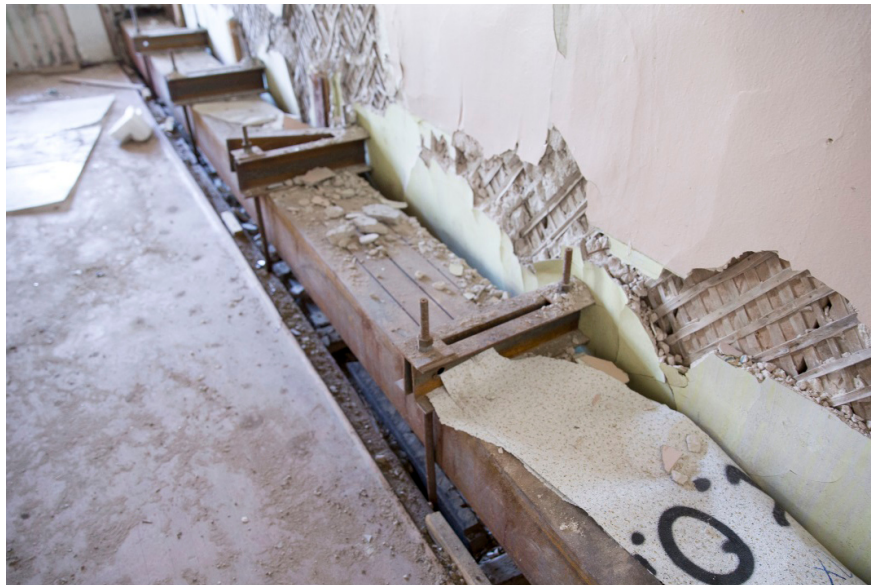
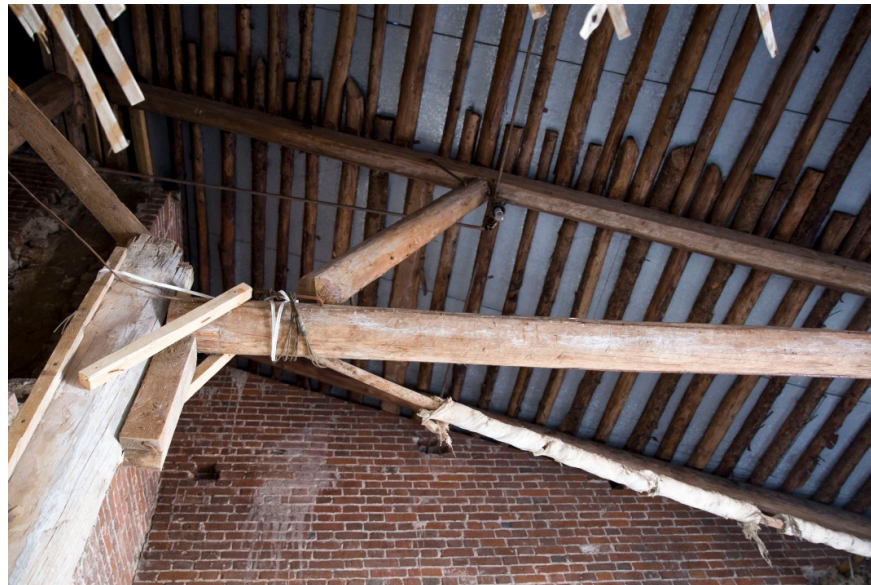
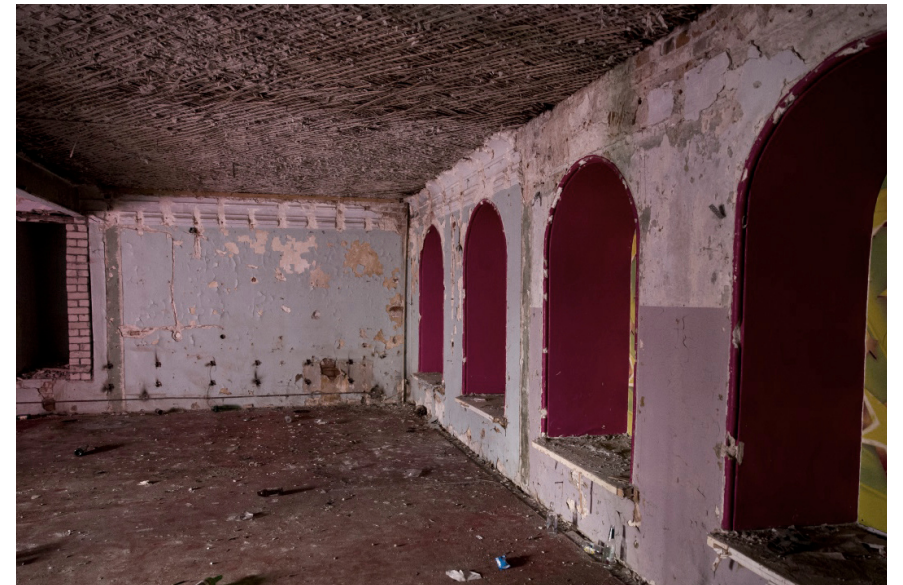
*PHOTO ARCHIVE, PRESENT CONDITION*

*/ 2012 year, incide photoes condition*

*The interior has been redone many times. The walls have a thick layer of previous finishes that have completely lost the original design and appearance of the interior of the building. The floor structures are dilapidated. There is a great need for reconstruction and complete renovation of some structural elements.*

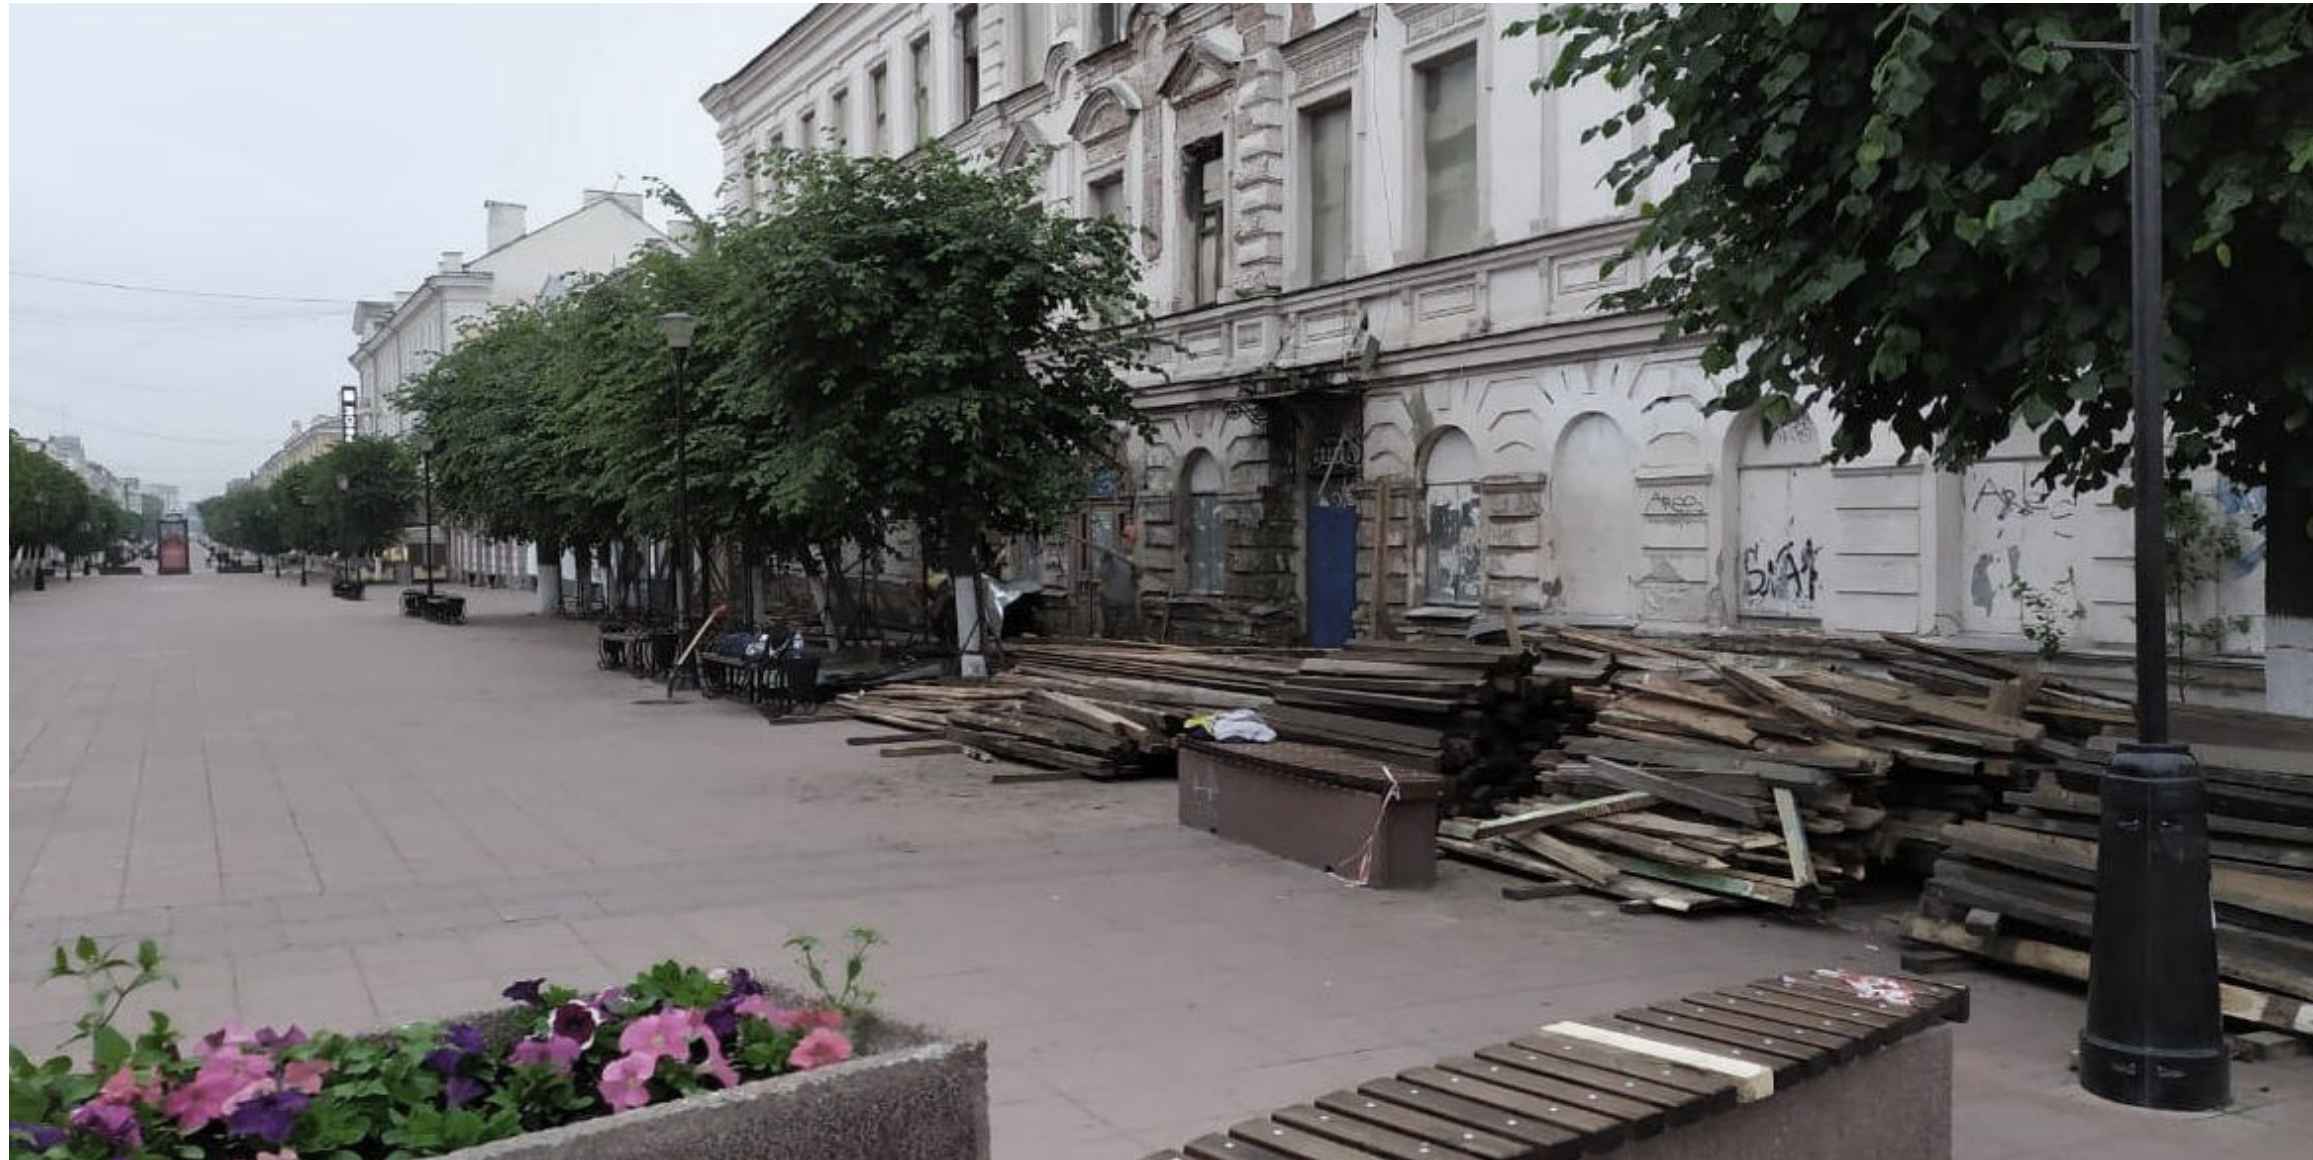
/ 2020 year

*View from the side of the central pedestrian boulevard. The constructions protecting the first floor emergency rooms from penetration have been dismantled, 2020.*

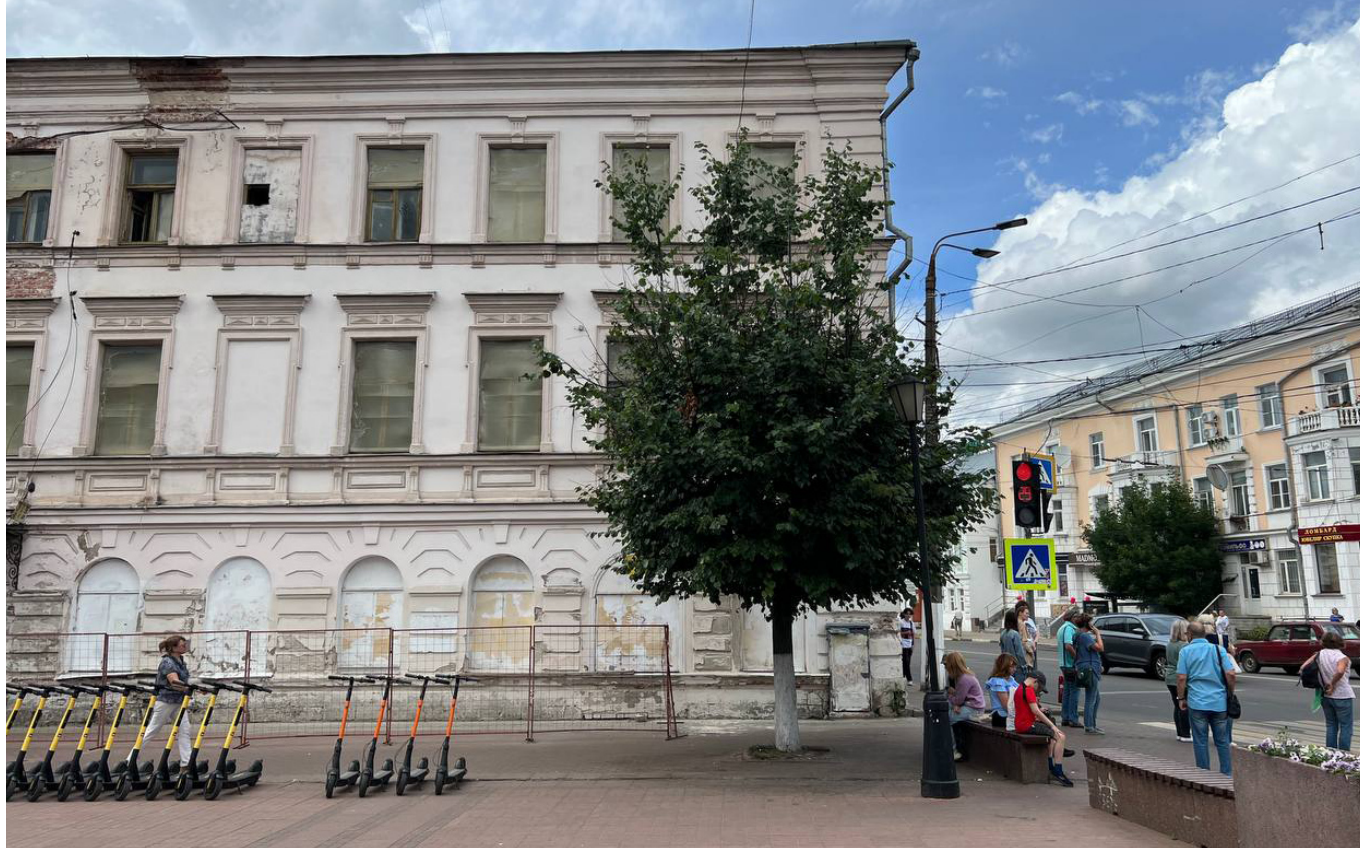
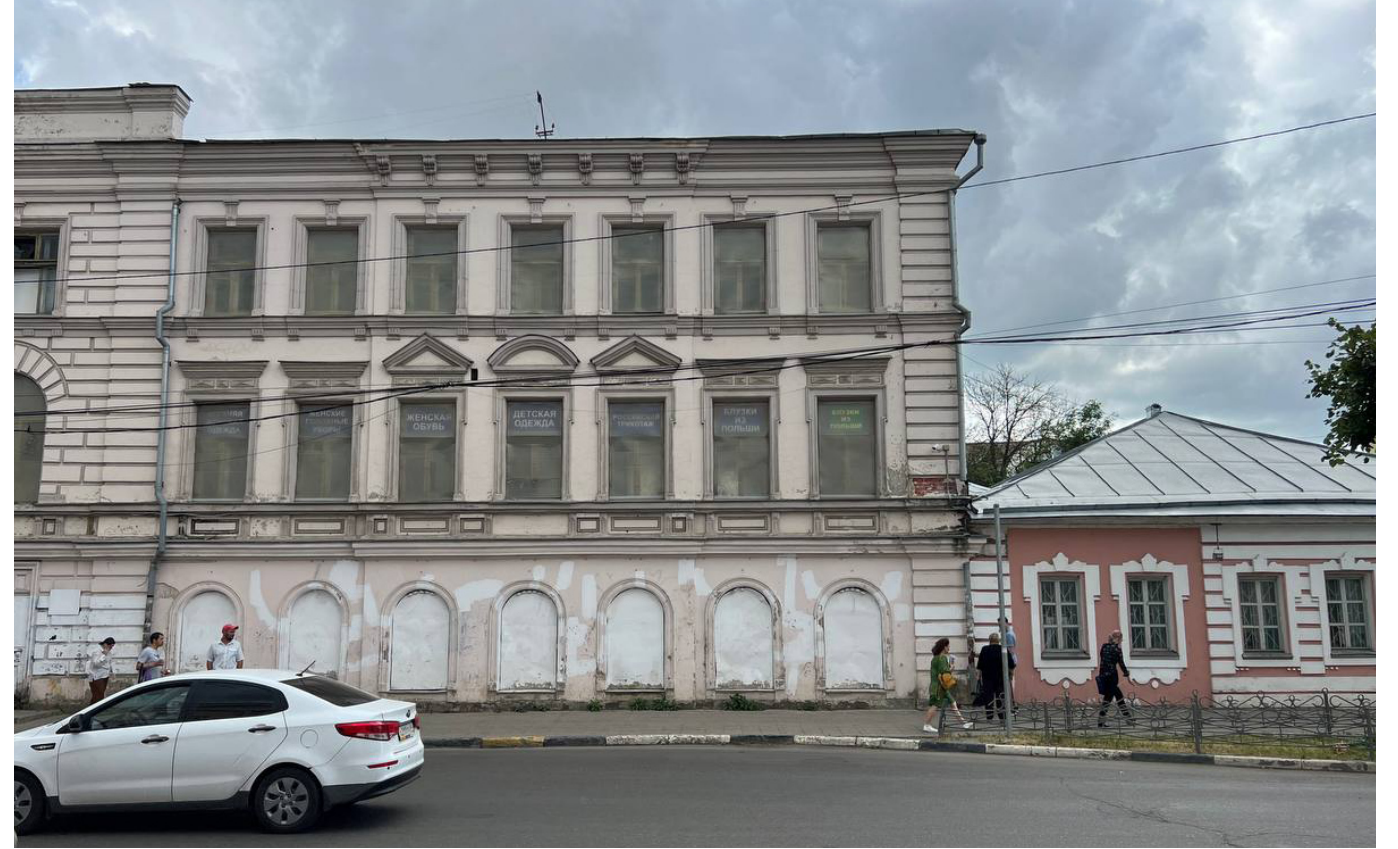
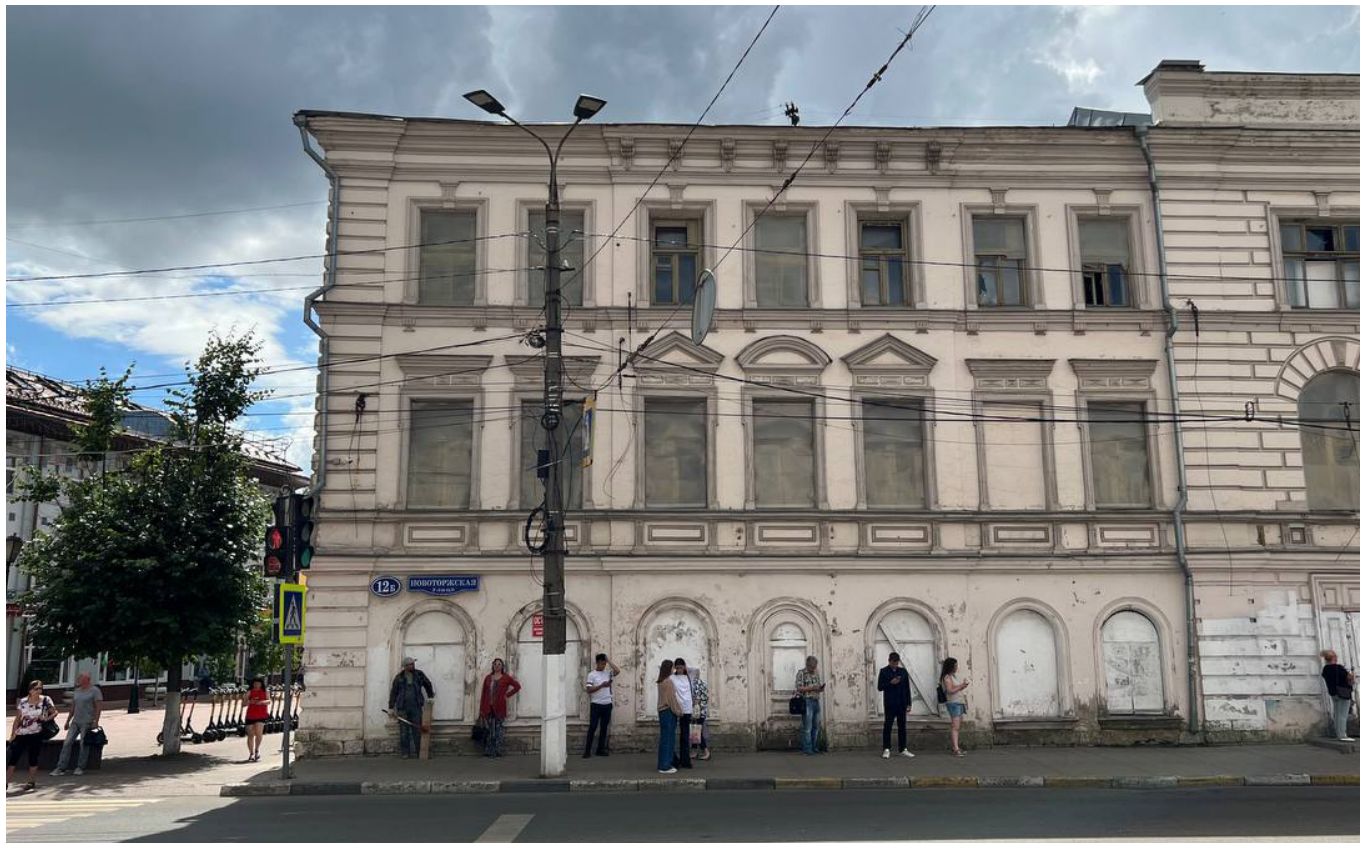
/ 2022 year

*The state of the building today. Boarded up windows, screened the façade to disguise it in the streetscape. The same deplorable state of the building's structures. Masking the facade with trees, from the side of the pedestrian boulevard. Fences preventing passage near the emergency facade.*

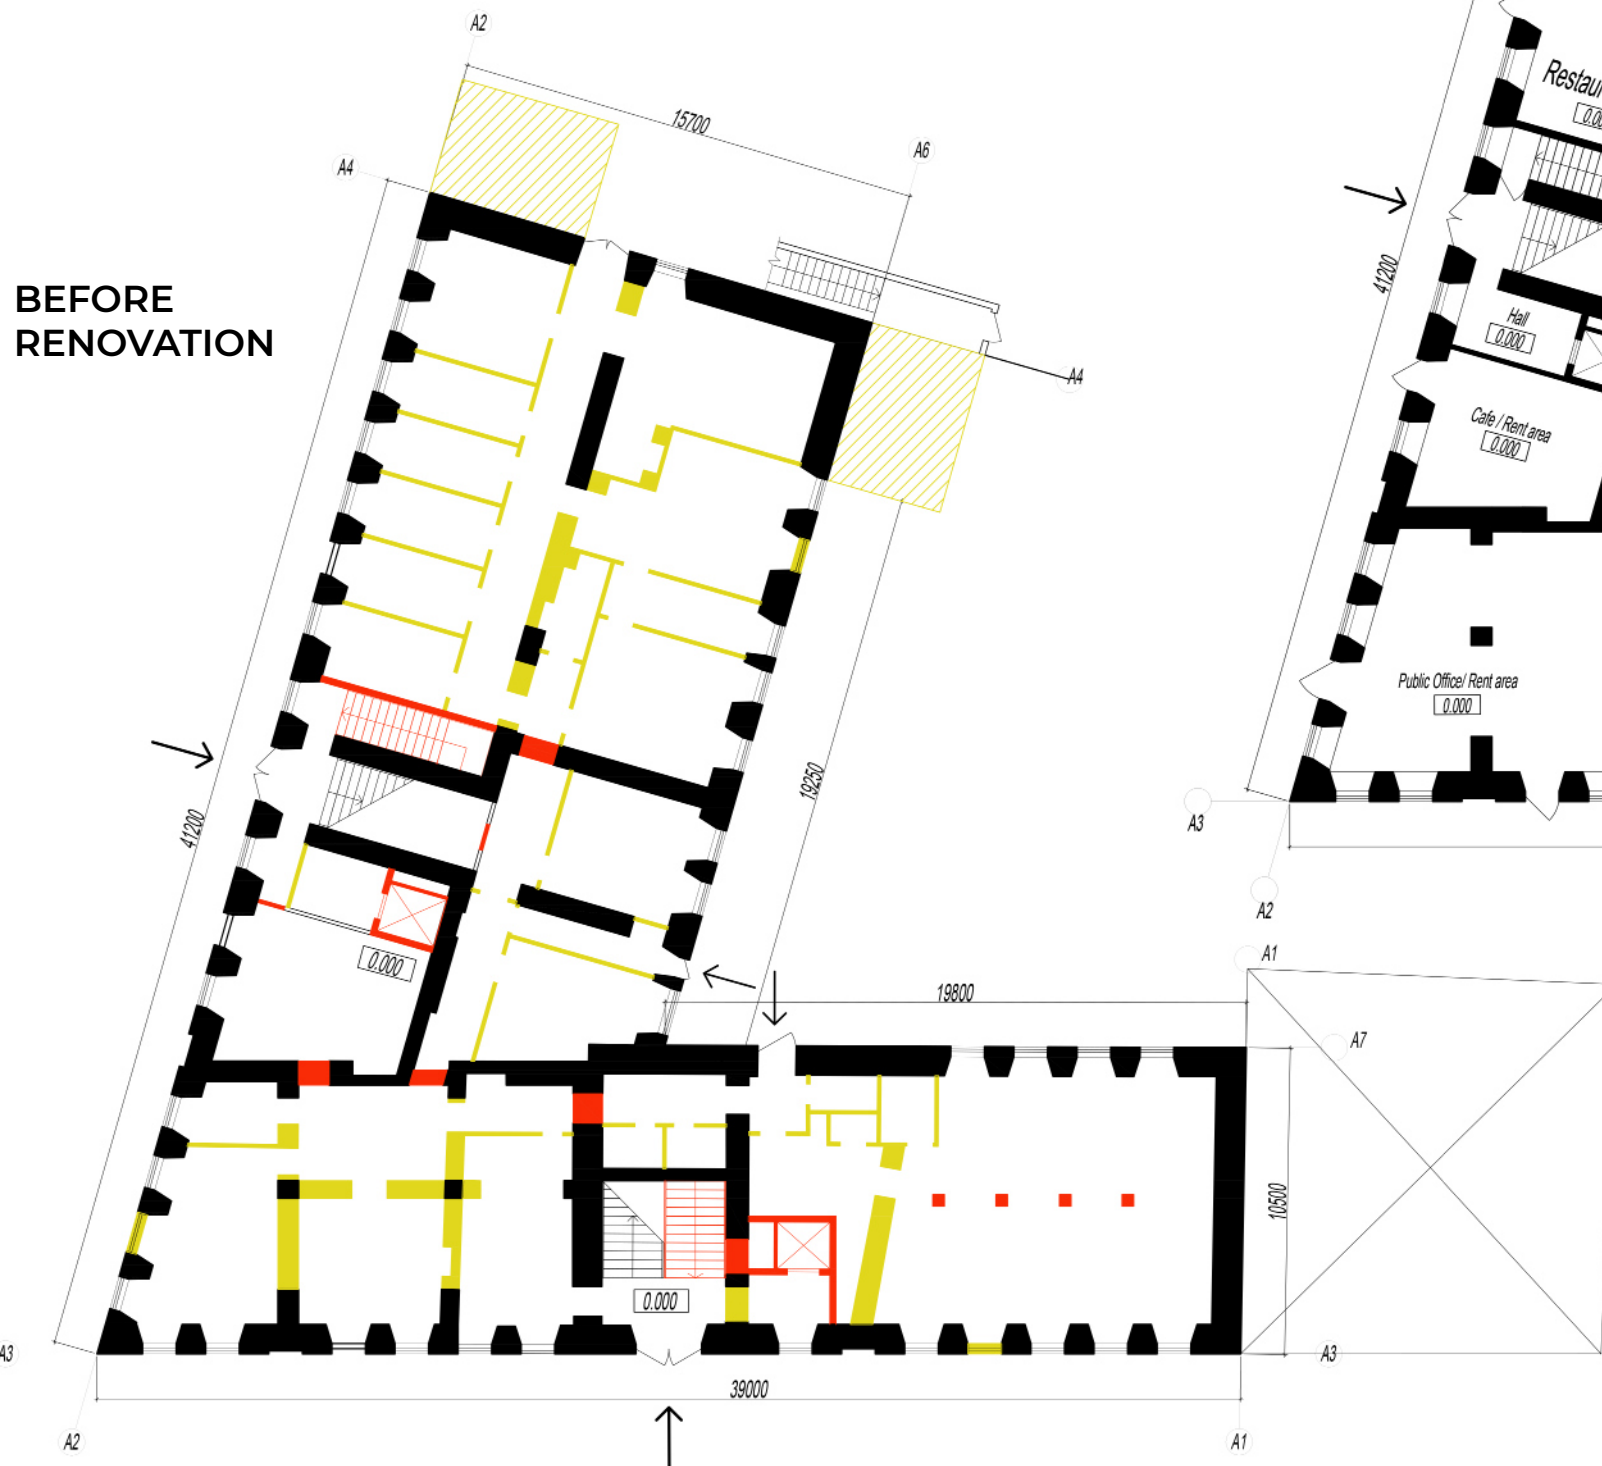
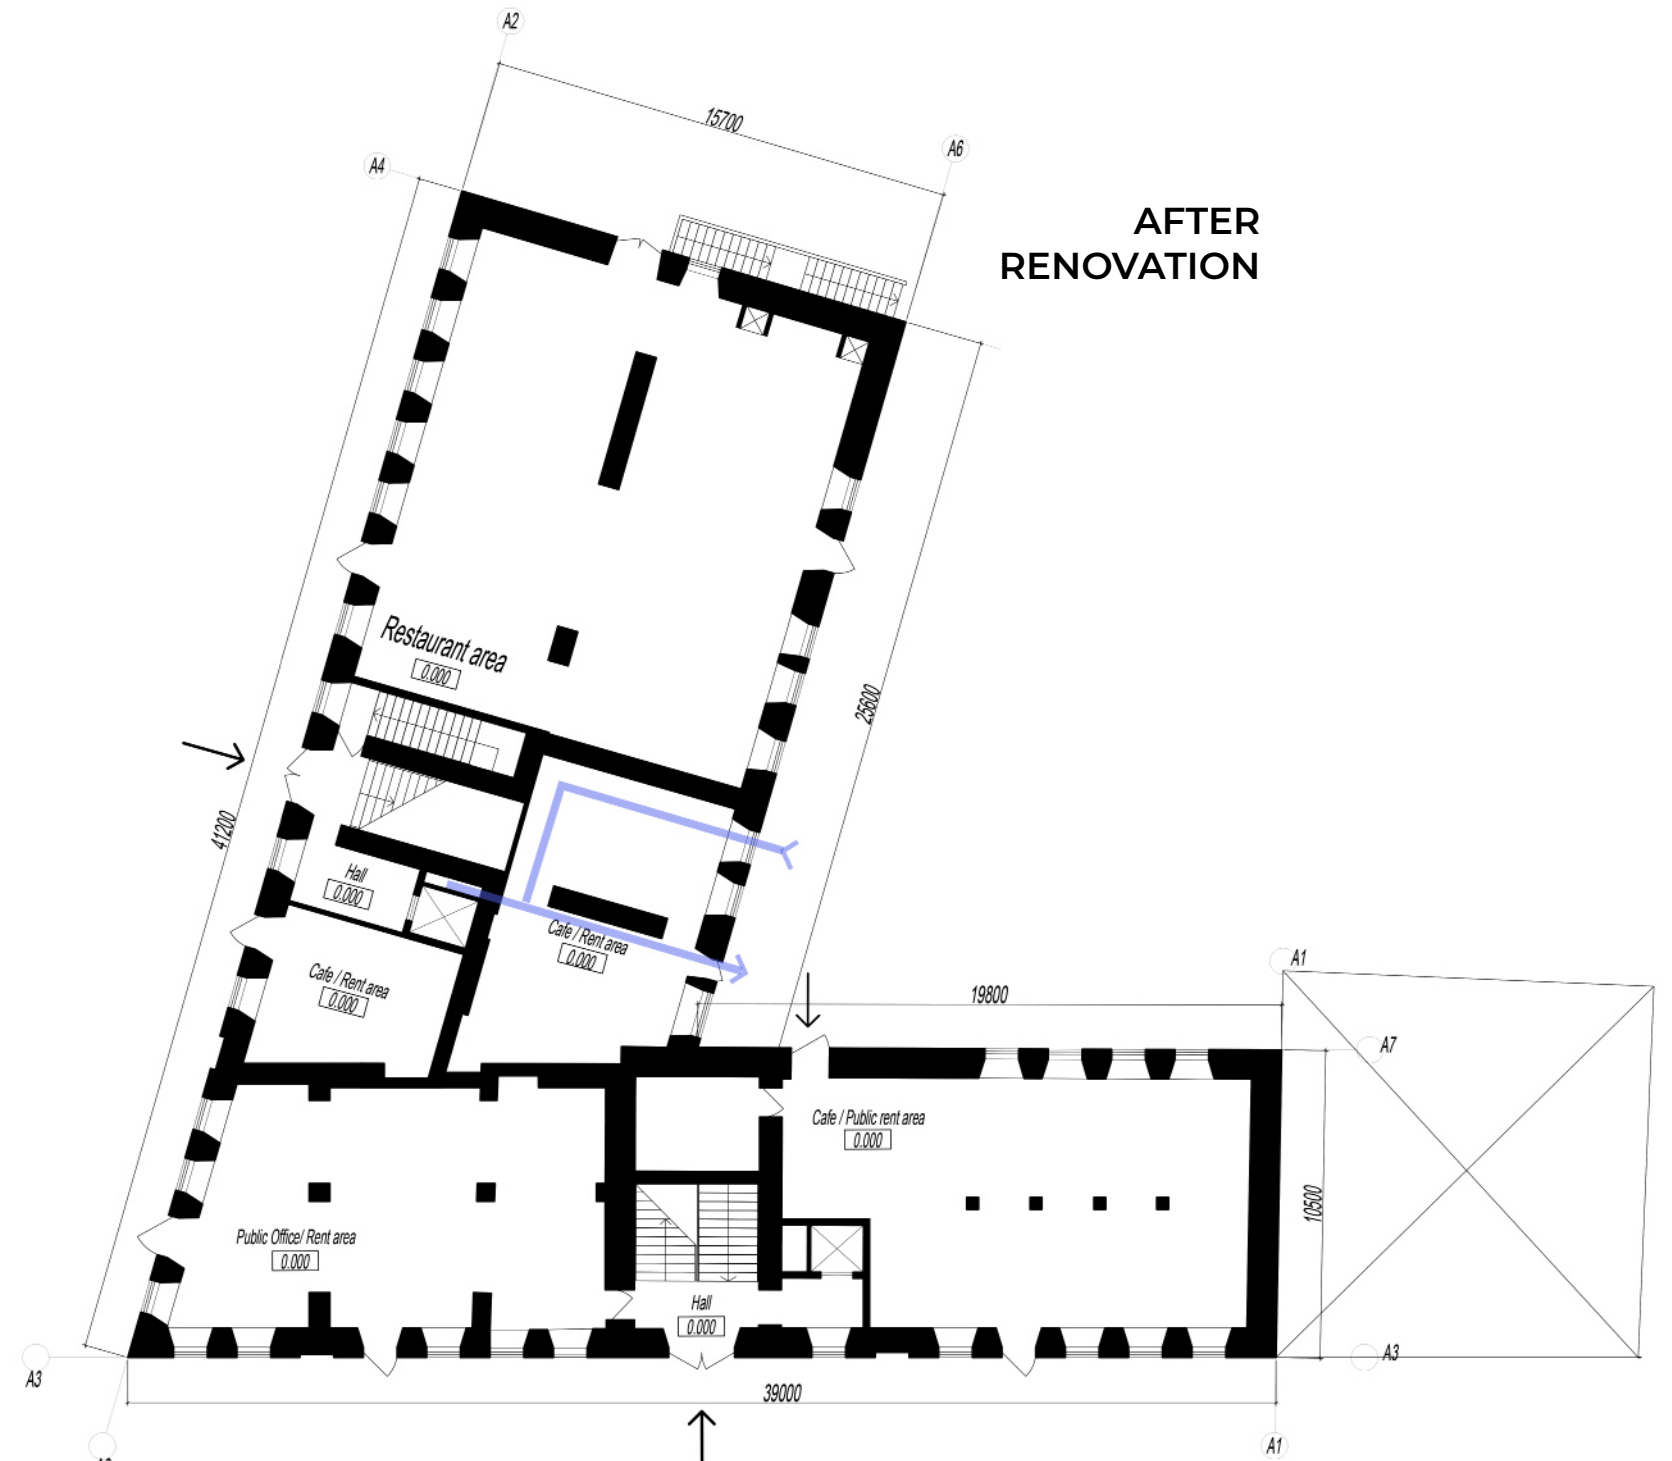
DESIGN PROPOSAL, GROUND FLOOR

- Demolished parts of interior
- New parts of interior after renovation

**AFTER RENOVATION**

**DEMOLISHED:**

1. Brick walls (partially).
2. Wooden frame partitions.
3. Laying of some openings in load-bearing brick walls.

**CONSTRUCTED:**

1. Column system.
2. Stairs system to basement floor.
3. Elevator system from -1 to 3 floor (roof).
4. New ventilation system combined with courtyard outside area and intire building.
5. Floor water pipe heating system for hotel apartments area. Connected through new vertical passage system and finishing incide of courtyard ground. (minimal temreture > 30 celsius degree)
6. New floor construction system.
