Department of Architecture:  
«Sustainable Architecture and Landscape Design»  
2022

*«Applying Sustainable Methods in Renovation of the Historical building in Tver, Russia.»*

*«How to apply sustainable renovation technique to a protected historical building?»*

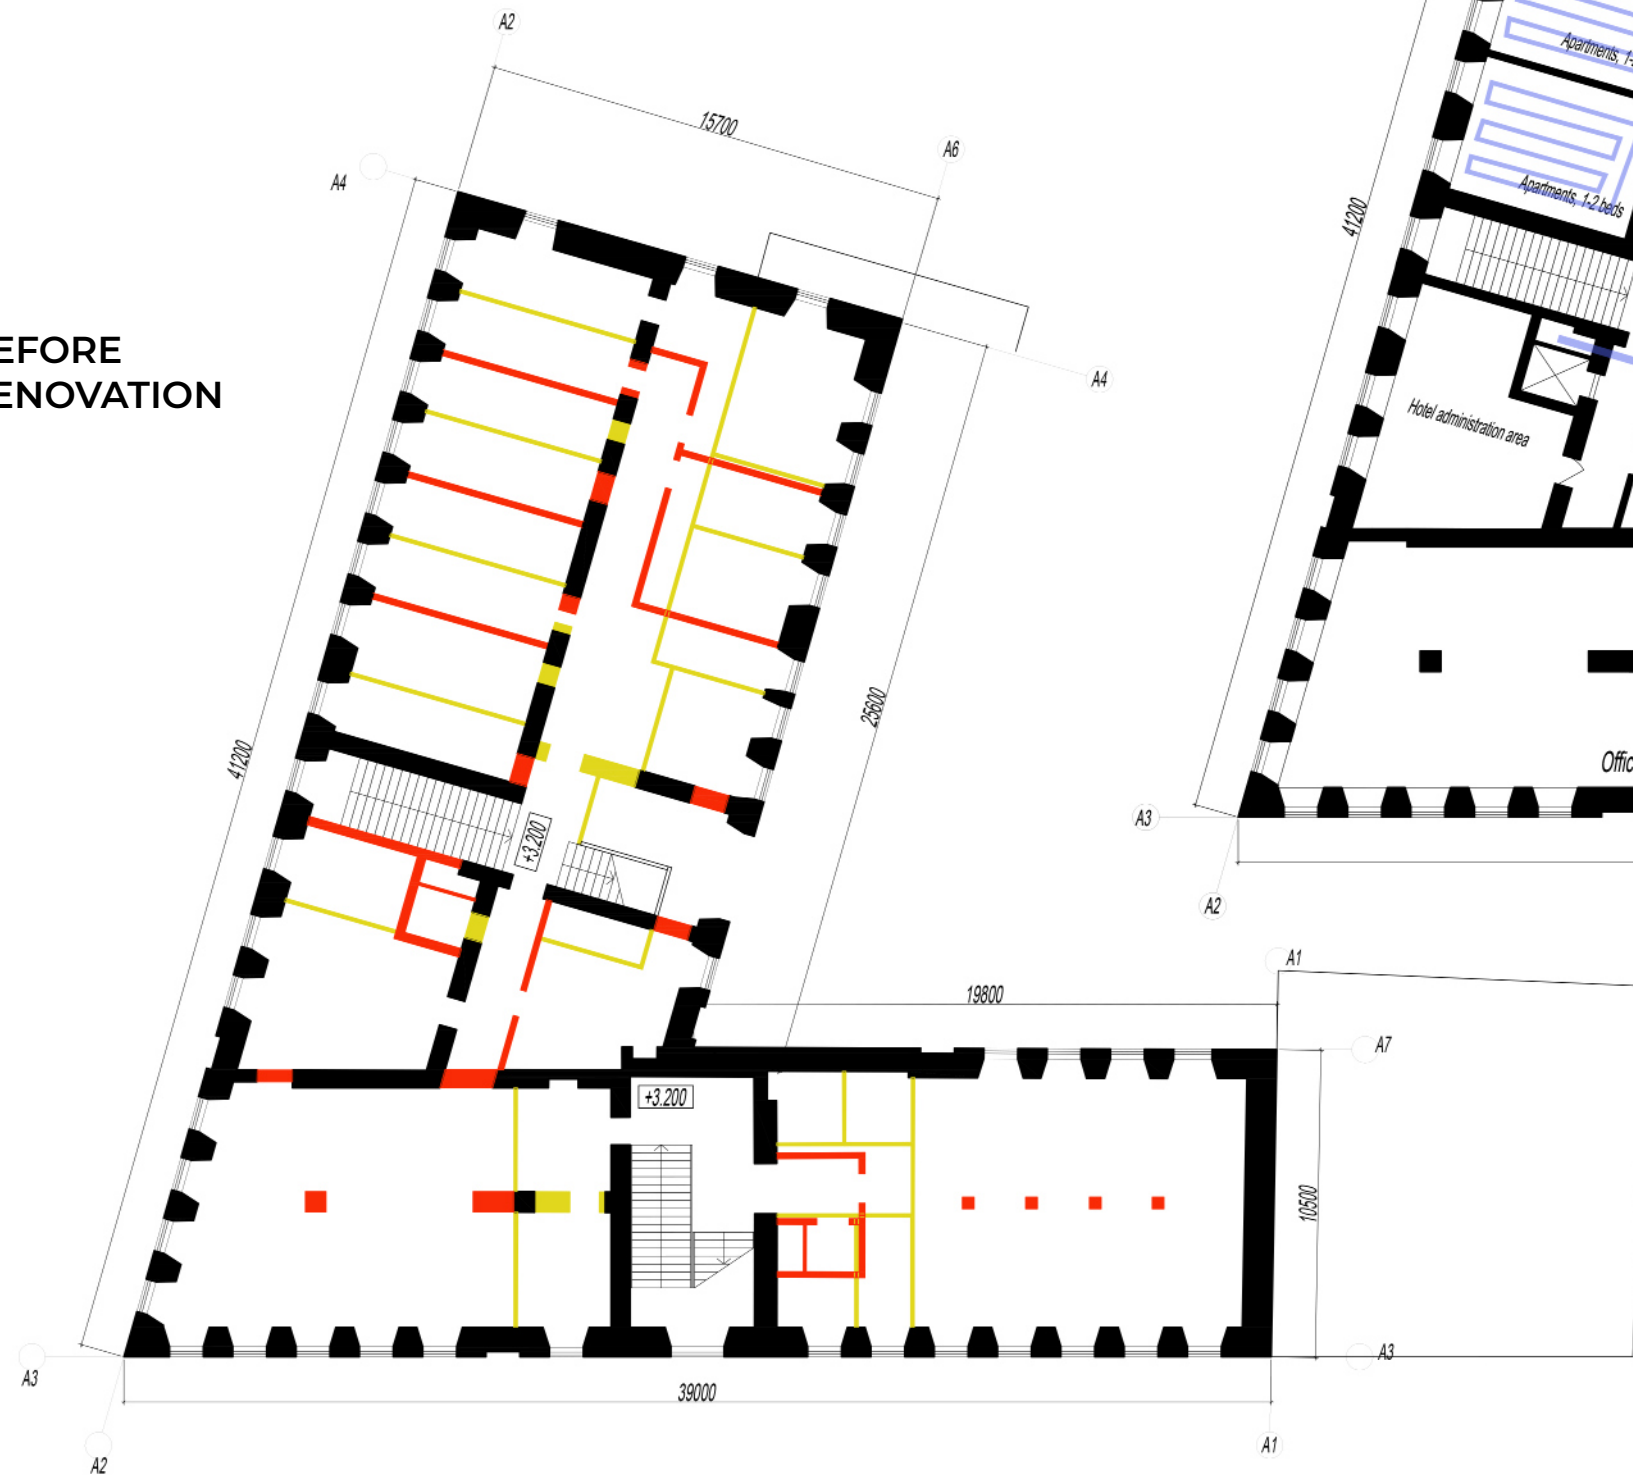
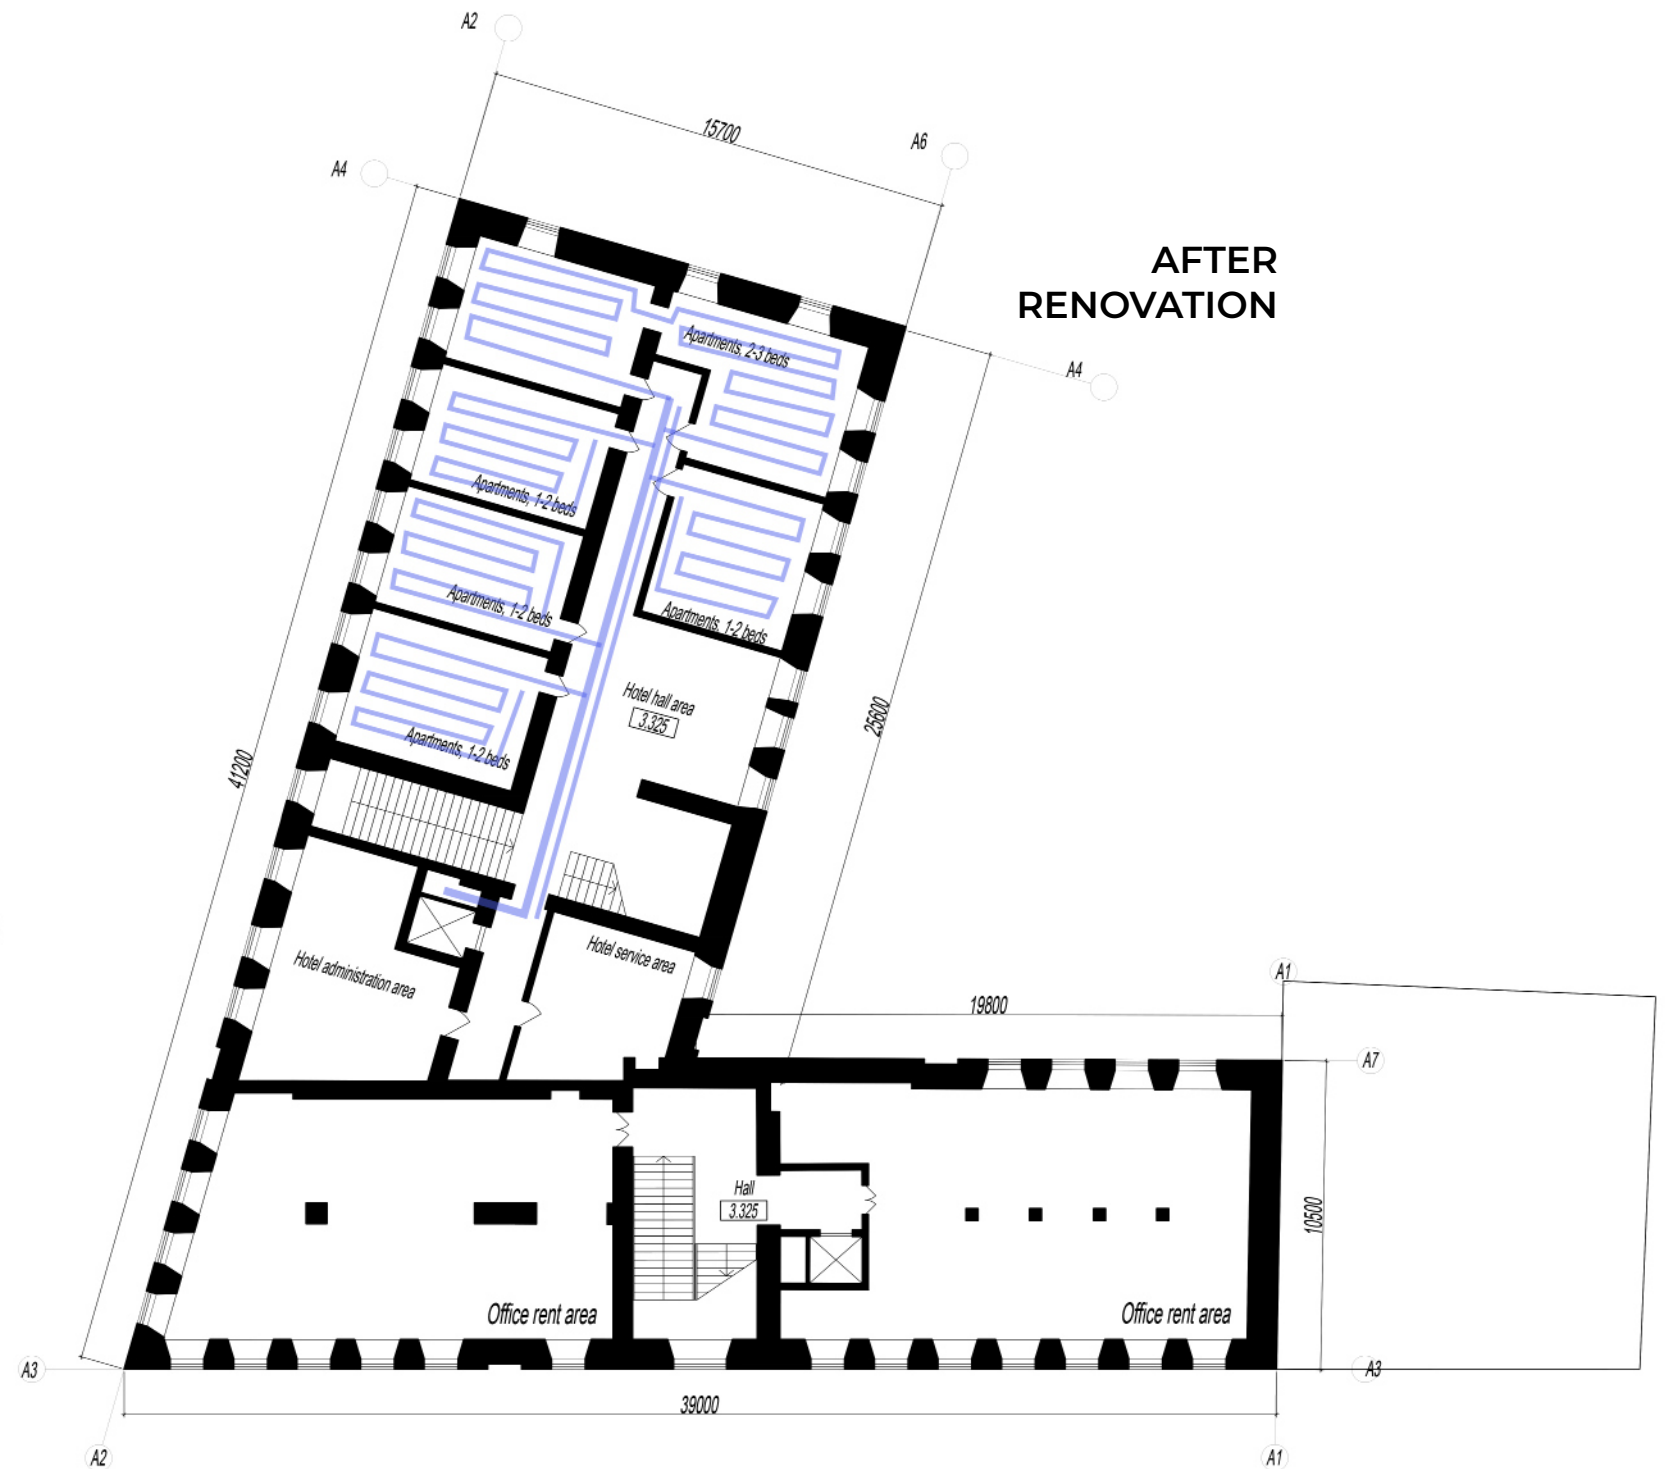
- Demolished parts of interior
- New parts of interior after renovation

BEFORE  
RENOVATION

AFTER  
RENOVATION

**DEMOLISHED:**

1. Brick walls (partially).
2. Wooden frame partitions.
3. Laying of some openings in load-bearing brick walls.

**CONSTRUCTED:**

1. Column system.
2. Elevator system from -1 to 3 floor (roof).
3. New ventilation system combined with courtyard outside area and intire building.
4. Floor water pipe heating system for hotel apartments area. Connected through new vertical passage system and finishing incide of courtyard ground. (minimal temreture > 30 celsius degree)
5. New floor constuction system.

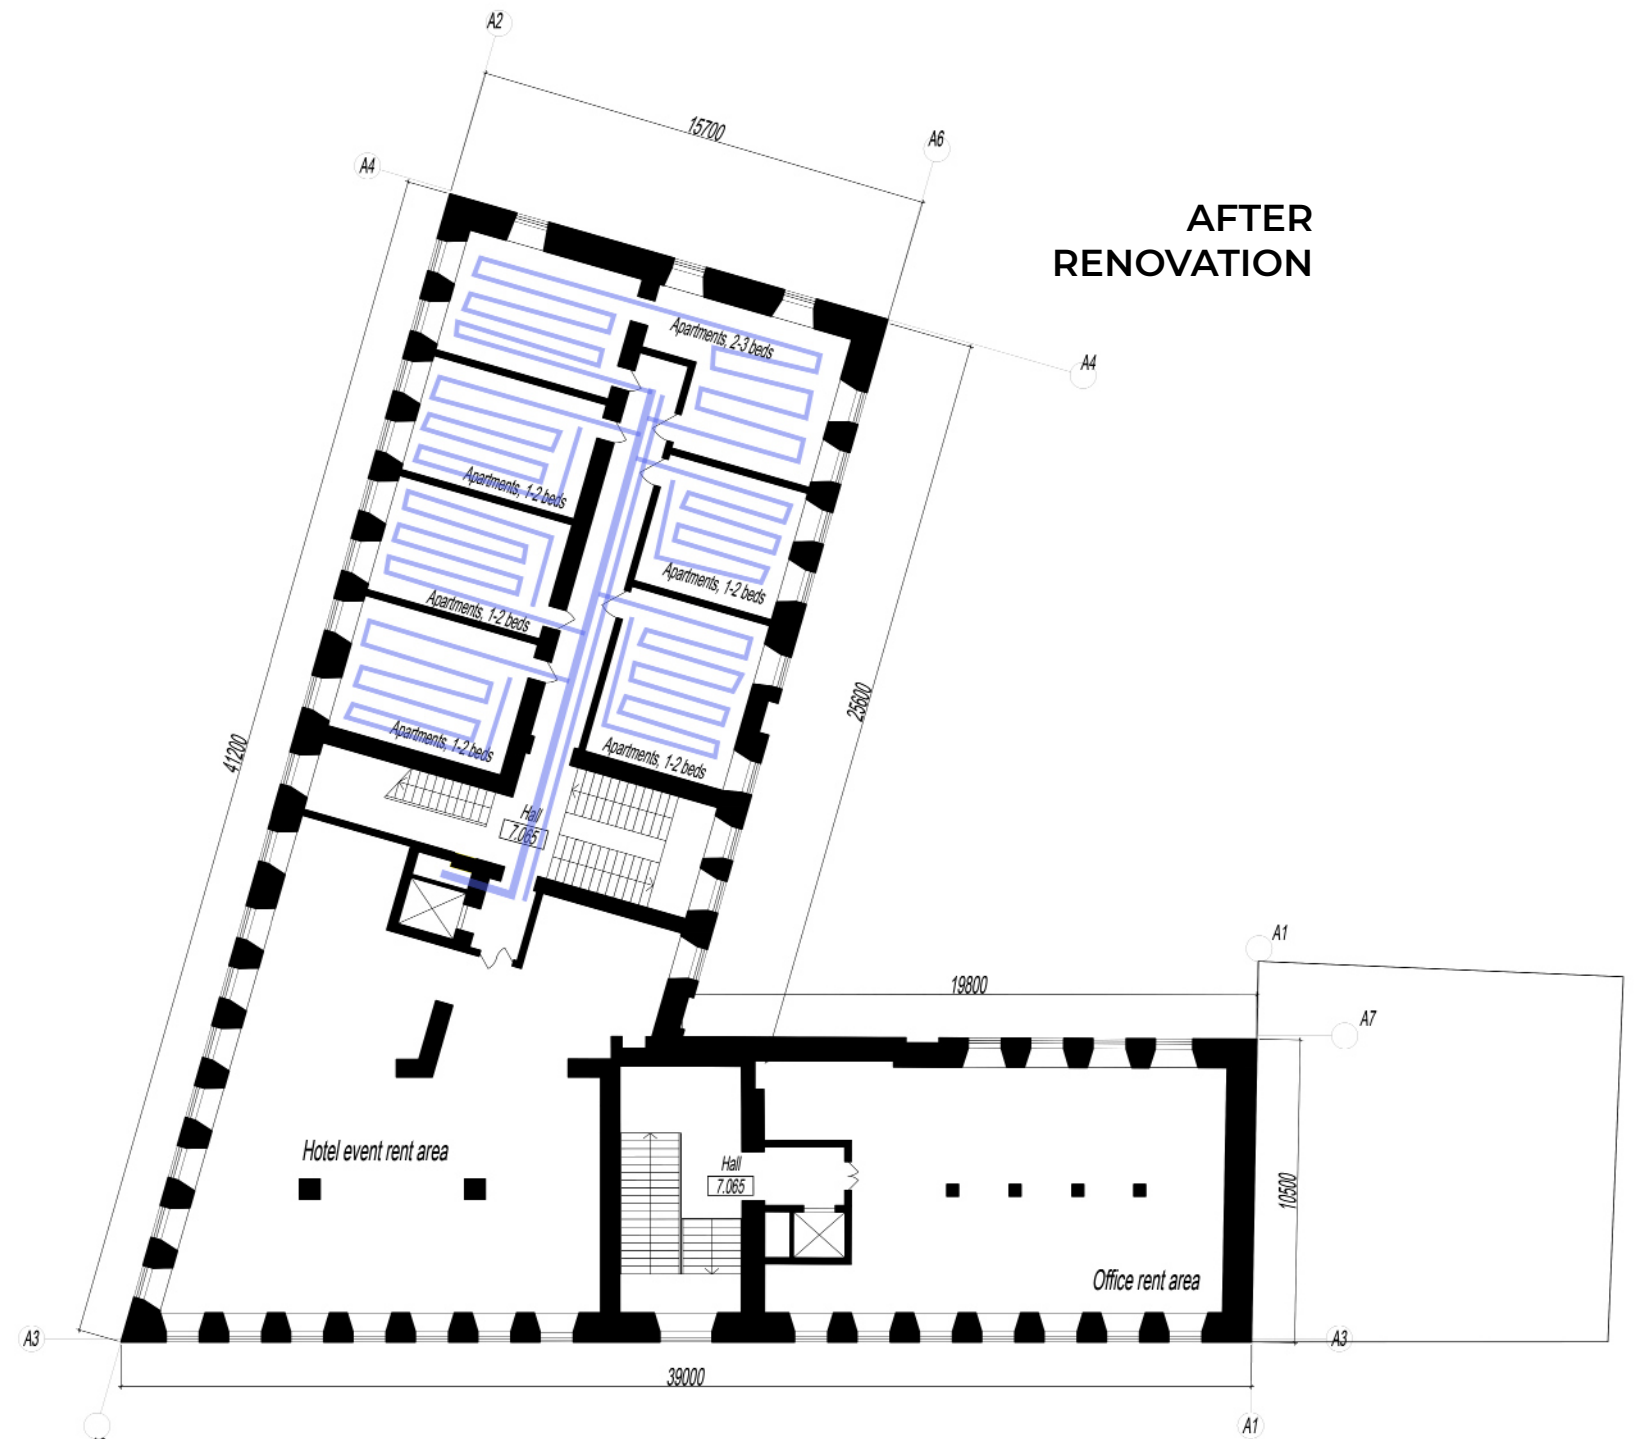
- Demolished parts of interior
- New parts of interior after renovation

**DEMOLISHED:**

1. Brick walls (partially).
2. Wooden frame partitions.
3. Laying of some openings in load-bearing brick walls.

**CONSTRUCTED:**

1. Column sistem.
2. Elevator system from -1 to 3 floor (roof).
3. New ventilation system combined with coartyard outside area and intire building.
4. Floor water pipe heating system for hotel apartments area. Connected through new vertical passage system and finishing incide of courtyard ground. (minimal temreture > 30 celsius degree)
5. Stairs system to roof floor.
6. New floor construction system.

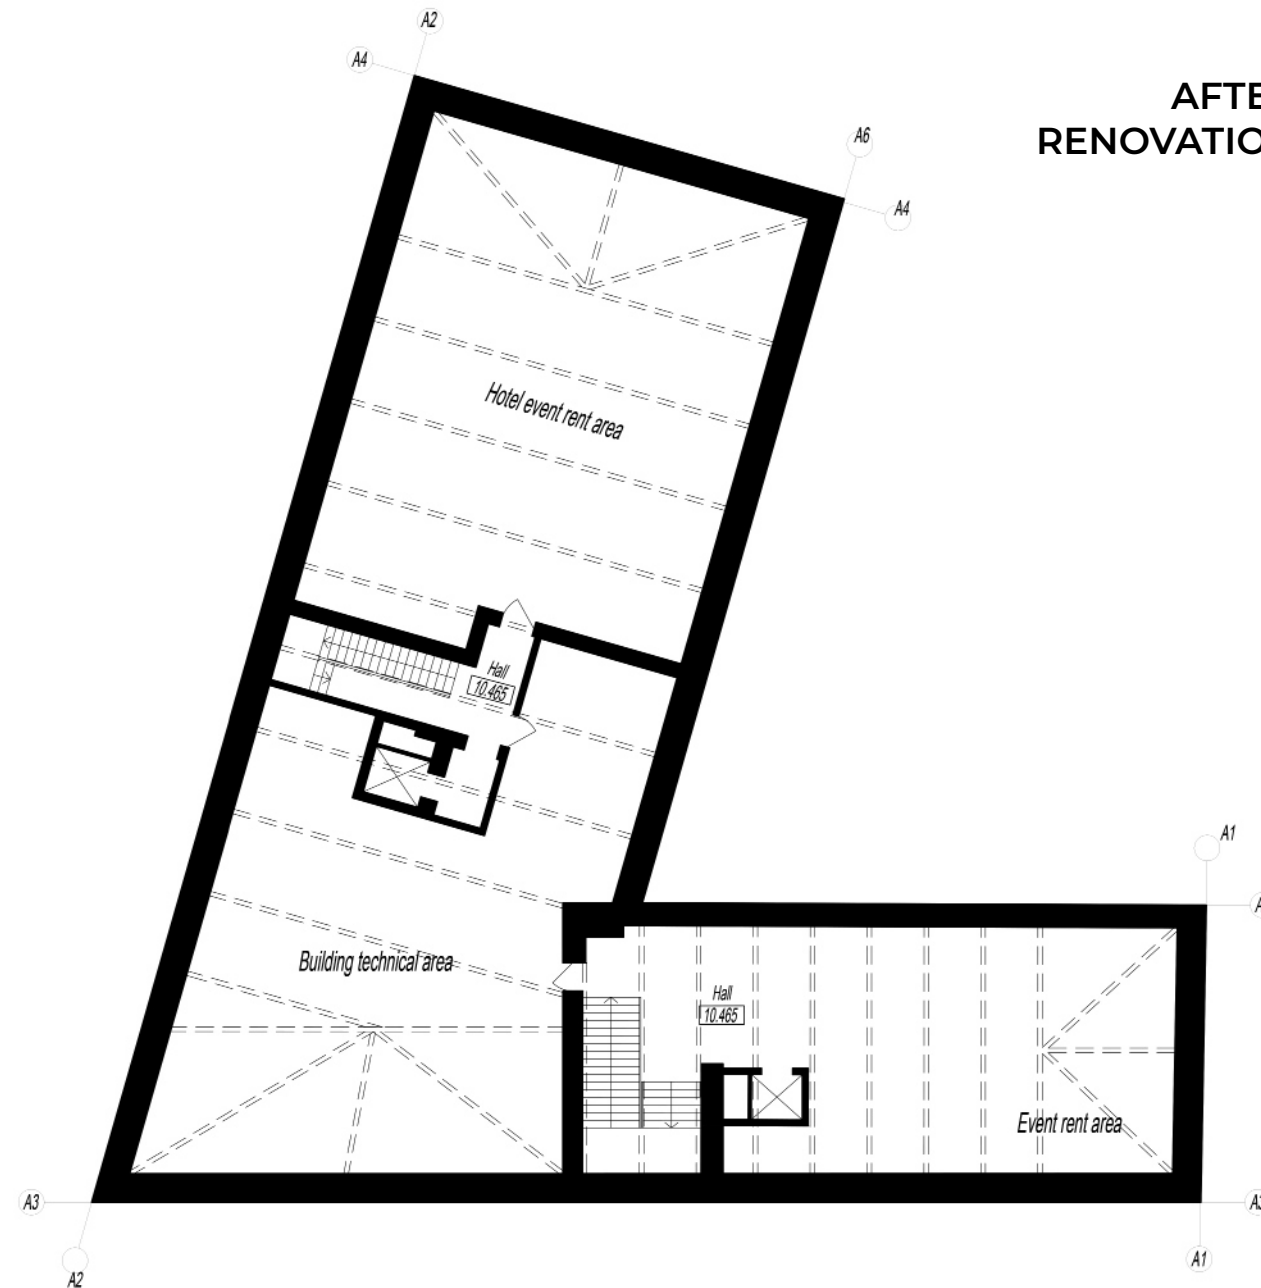
- Demolished parts of interior
- New parts of interior after renovation

BEFORE  
RENOVATION

AFTER  
RENOVATION

**DEMOLISHED:**

1. Brick walls (partially).
2. Laying of some openings in load-bearing brick walls.

**CONSTRUCTED:**

1. Elevator system from -1 to 3 floor (roof).
2. New ventilation system combined with coartyard outside area and intire building.
3. New entire floor, which can be used and be economy positive for building.
4. New floor construction system.

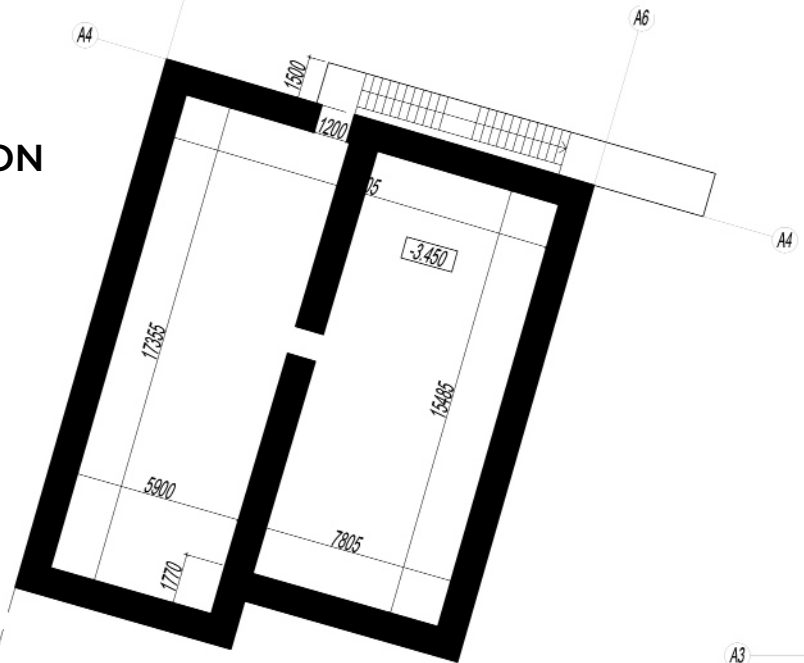
**BEFORE  
RENOVATION**

**AFTER  
RENOVATION**

**DEMOLISHED:**

1. Brick walls (partially).
2. Laying of some openings in load-bearing brick walls.

**CONSTRUCTED:**

1. Elevator system from -1 to 3 floor (roof).
2. New ventilation system combined with coartyard outside area and intire building.
3. New entire renovated basement floor, which can be used and be economy positive for building. (Resturant working area for kithcen and sto raging products)
4. New floor construction system.
5. Parking spots (16) and new garage system with car elevators (2), integrated into side building.
6. Additional high windows. New working areas with direct sunlight.

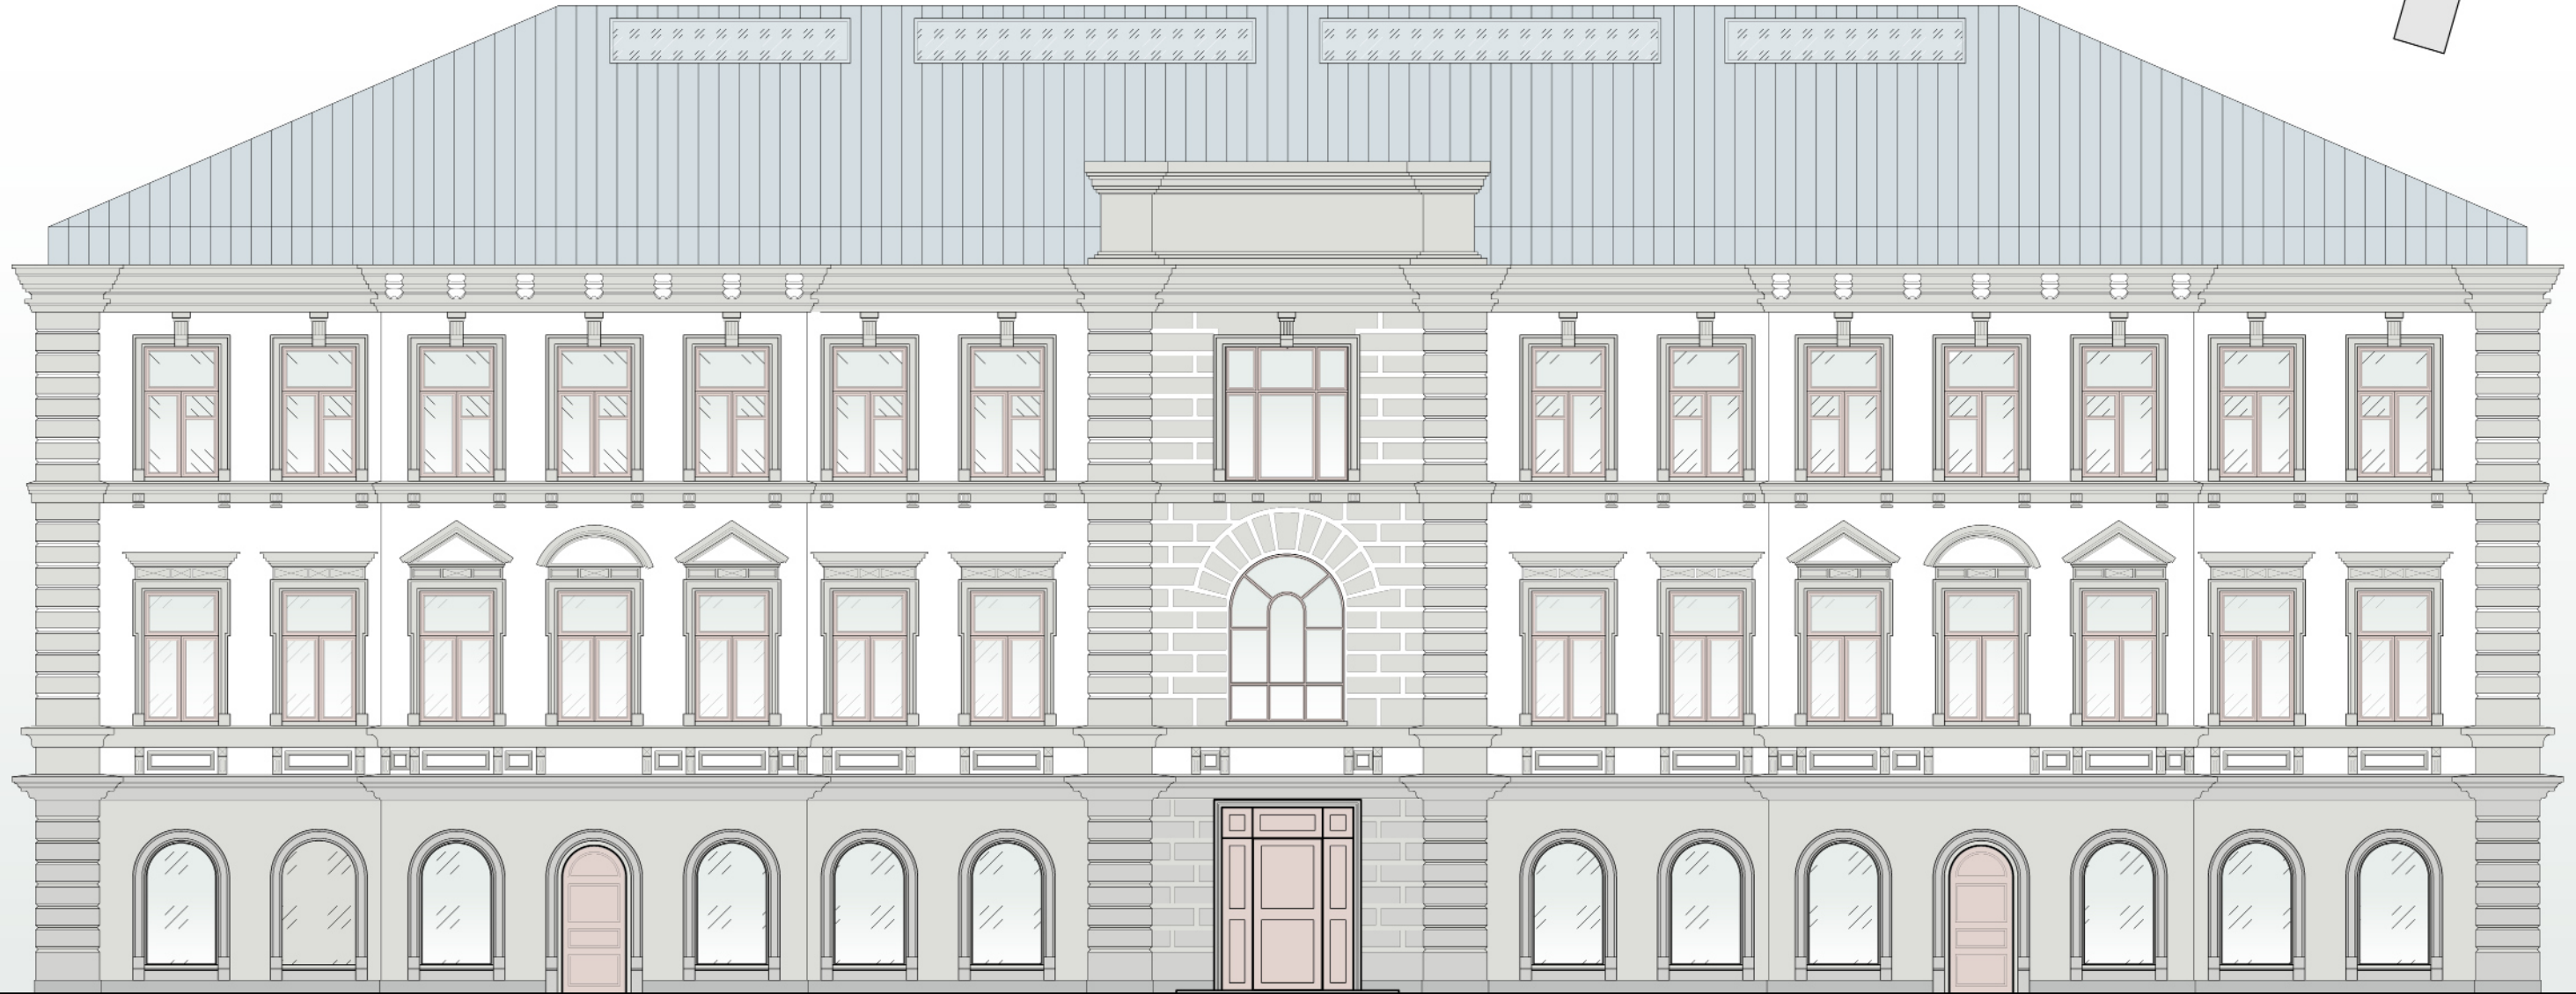
The color scheme of the facade is made by a coloristic design project. These recommendations indicate the required contrast of the hue of the tone (within the same color). \*Corresponds to archival records and historical documents.

**NORTH FACADE DESCRIPTION:**

5. Window frames restored from preserved original wooden frames. Without the possibility of opening after reconstruction. (The building is fully provided with centralized ventilation, air intakes through the roof)

6. Existing doorways have been retained to maintain the historical influence on the architecture and life of the building.

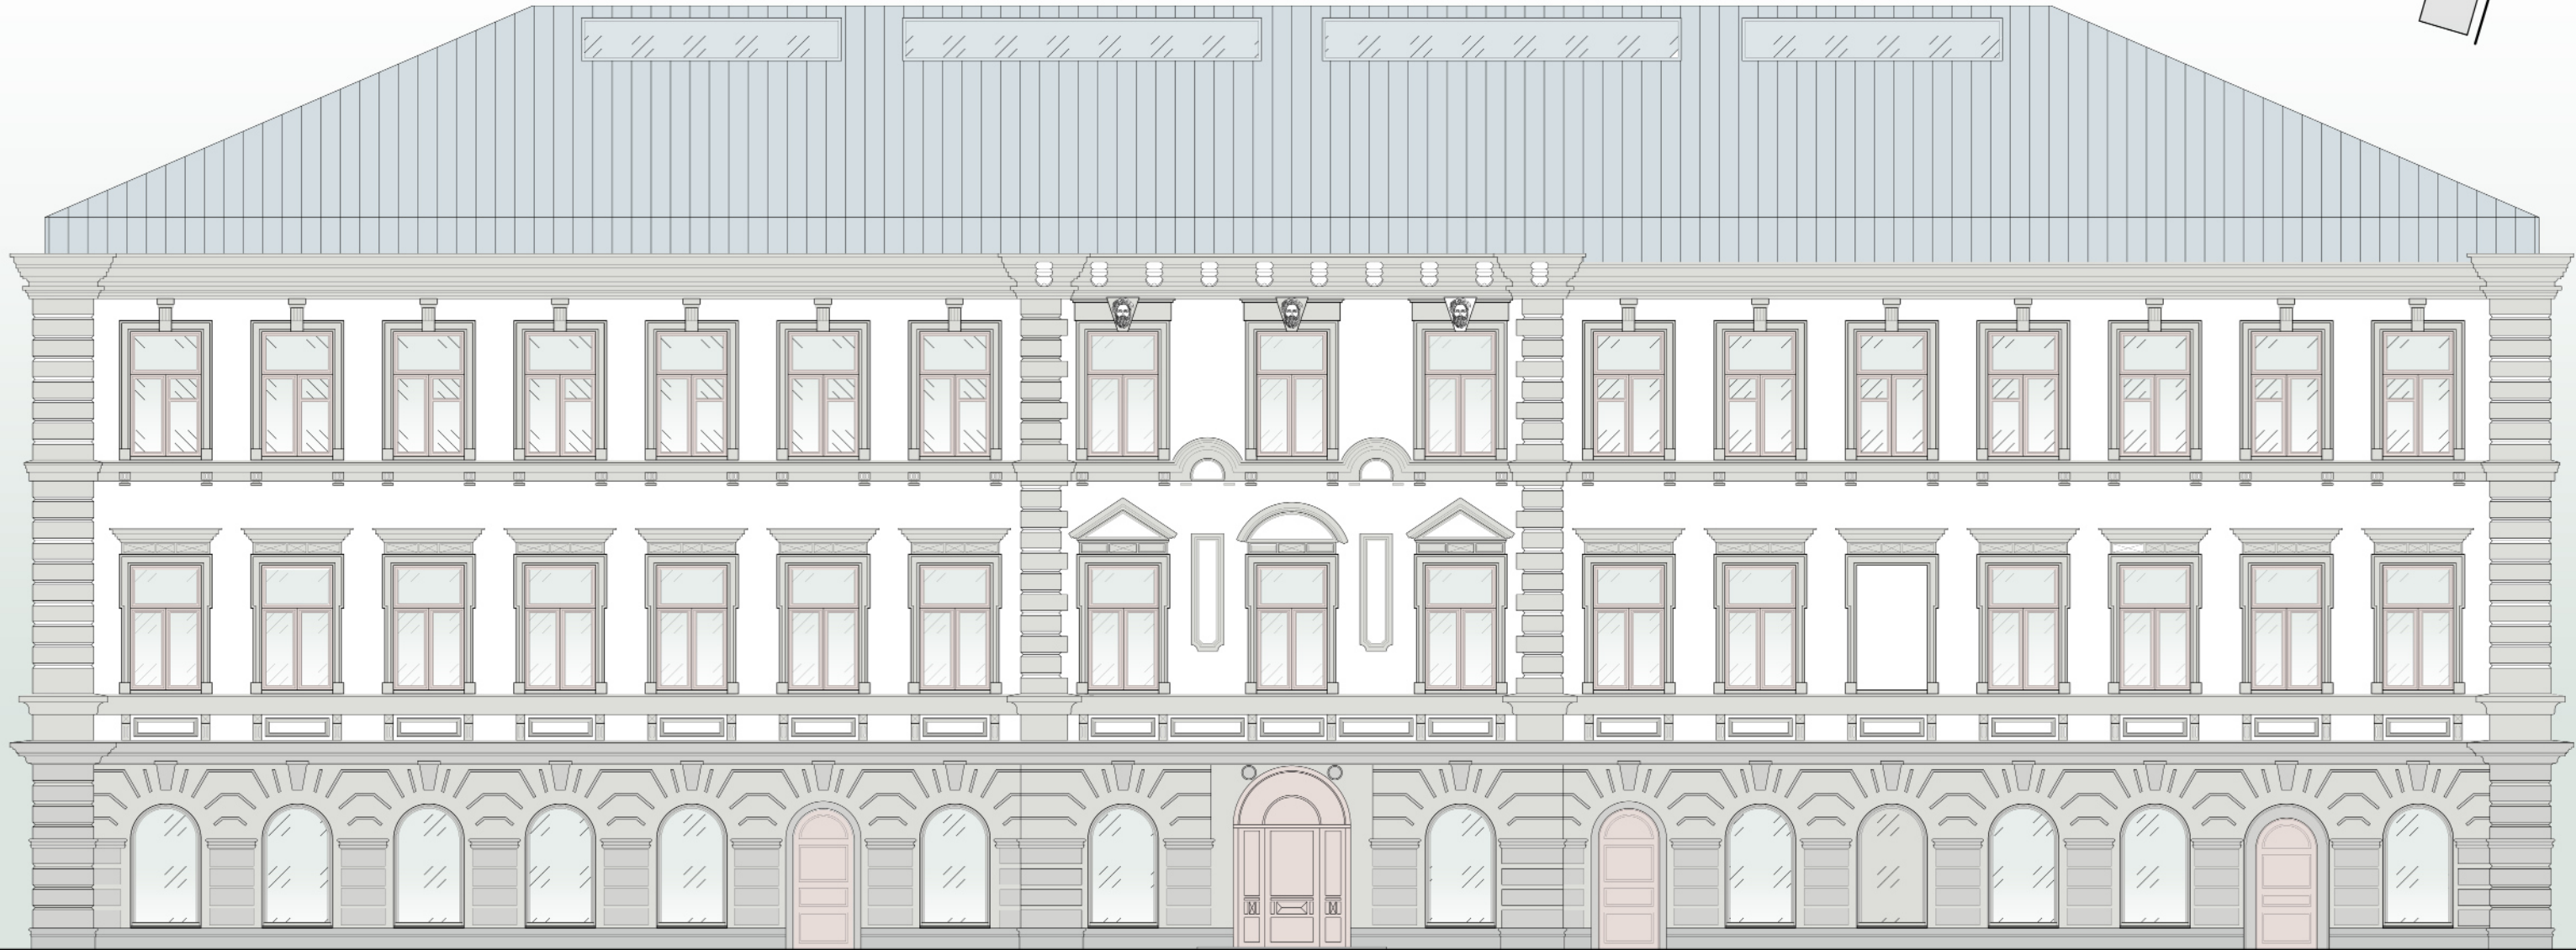
The color scheme of the facade is made by a coloristic design project. These recommendations indicate the required contrast of the hue of the tone (within the same color). \*Corresponds to archival records and historical documents.

5. Window frames restored from preserved original wooden frames. Without the possibility of opening after reconstruction. (The building is fully provided with centralized ventilation, air intakes through the roof)

6. Existing doorways have been retained to maintain the historical influence on the architecture and life of the building.

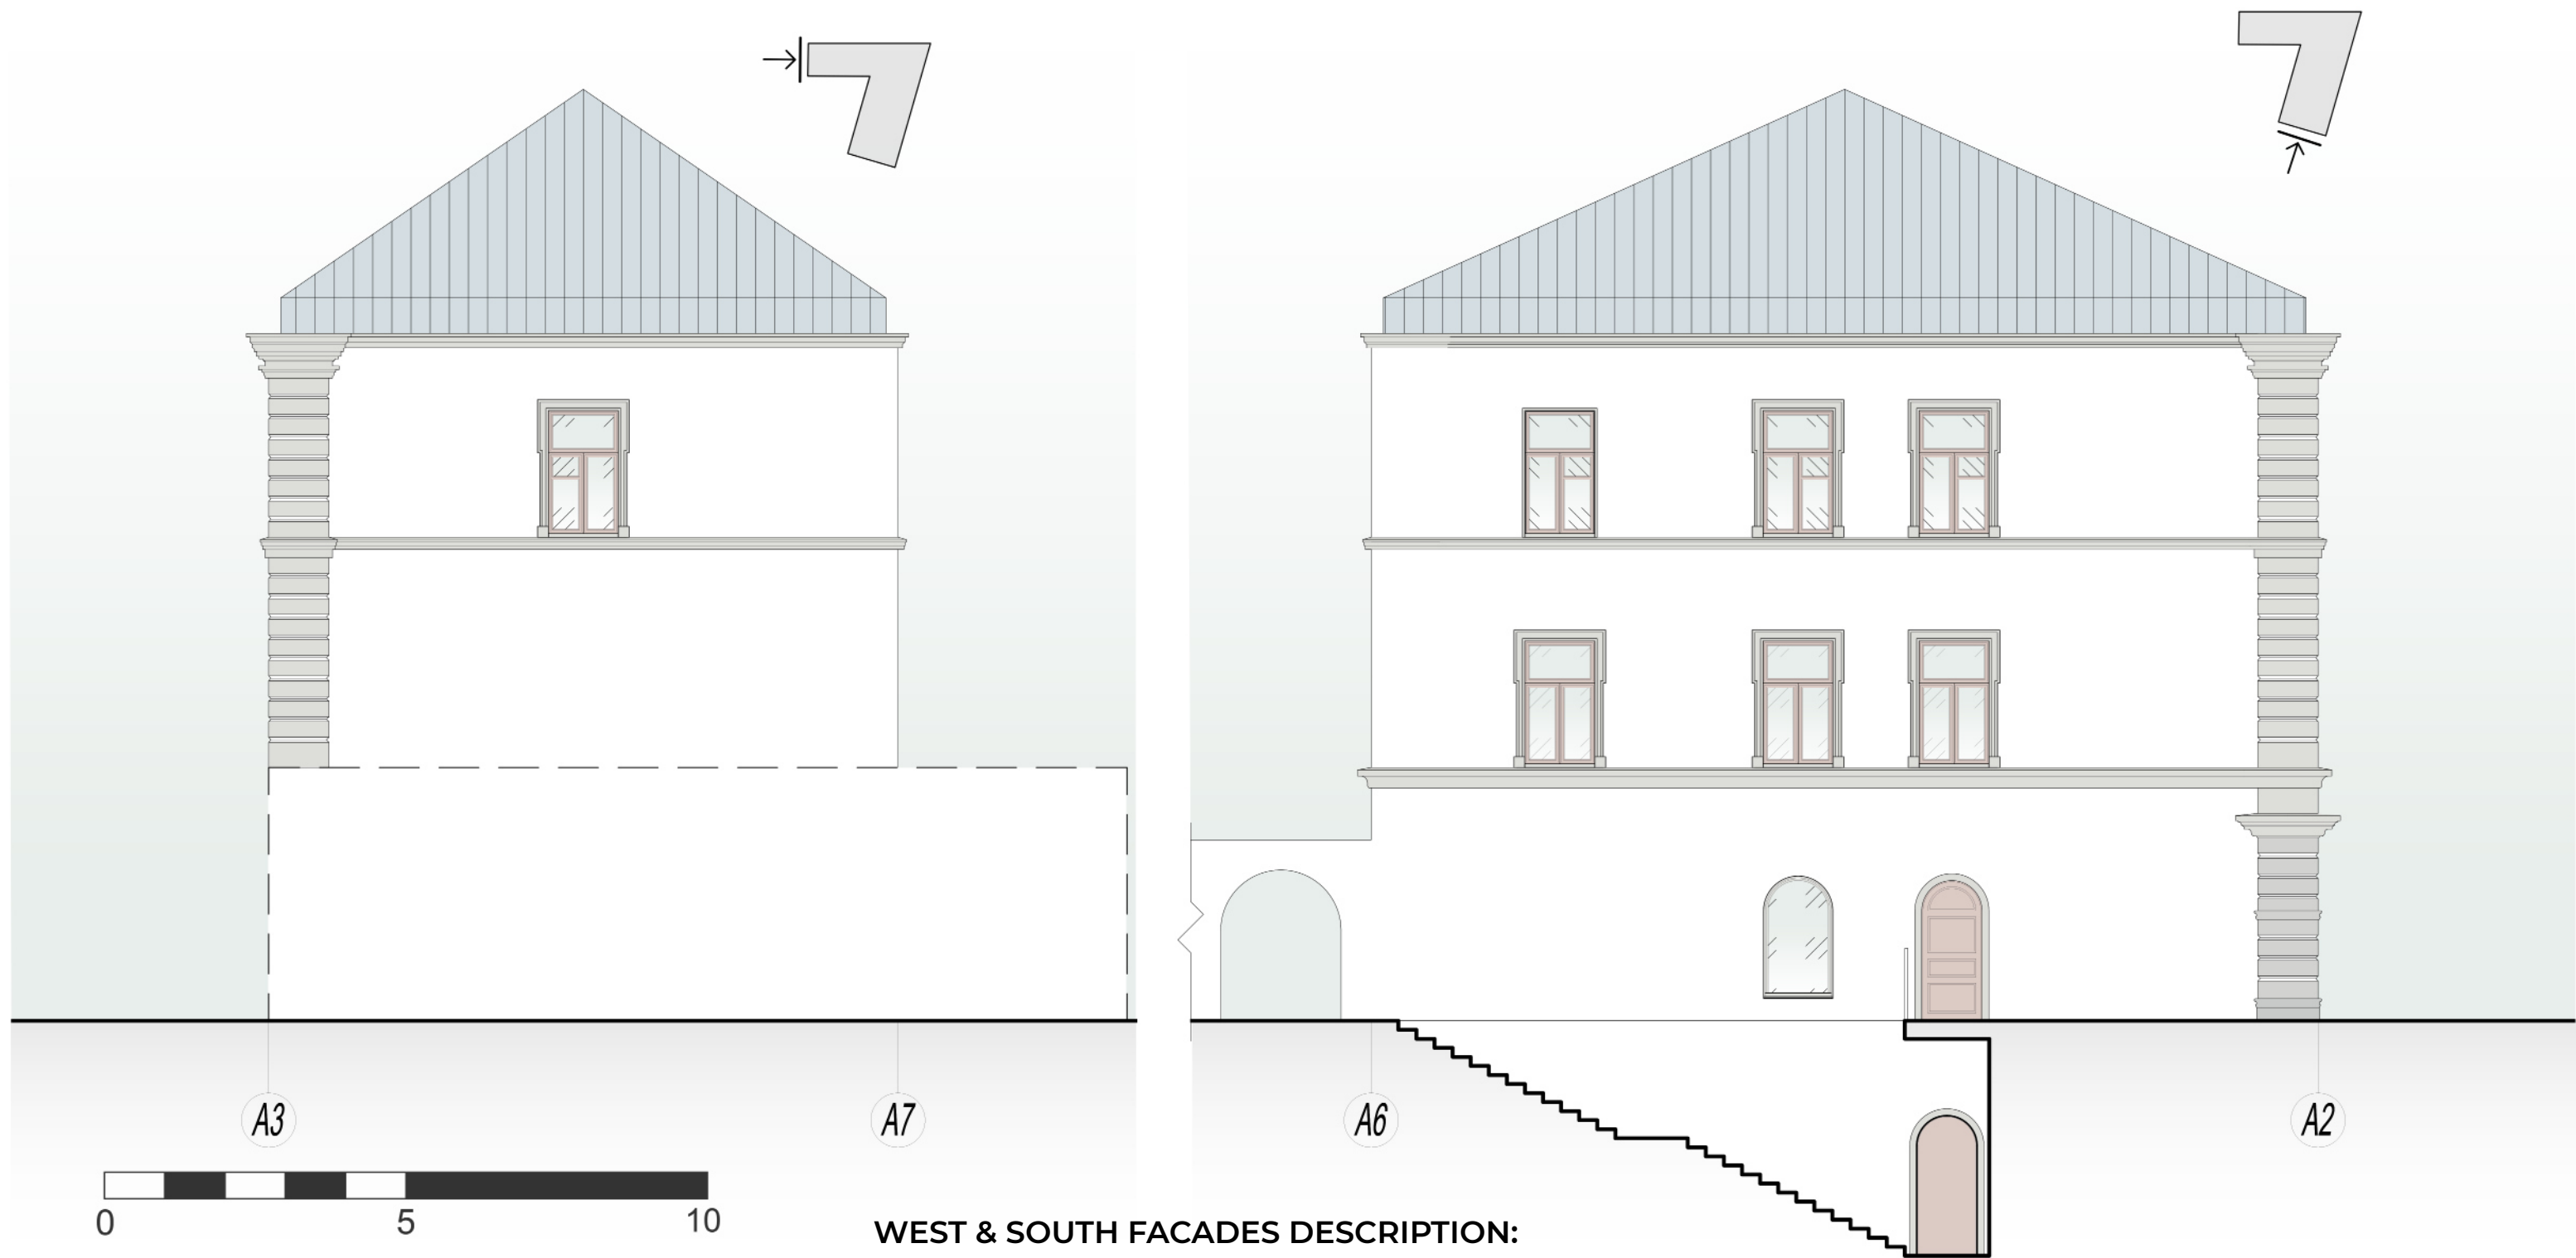
The color scheme of the facade is made by a coloristic design project. These recommendations indicate the required contrast of the hue of the tone (within the same color). \*Corresponds to archival records and historical documents.

**WEST & SOUTH FACADES DESCRIPTION:**

1. The color scheme indicated on the facade is a guideline for a coloristic project.
2. Designed staircase to the underground floor (it is a separate entrance to the kitchen area, under the restaurant).
3. The classical view of the facade has been preserved and restored, as it was conceived by the architect during a major reconstruction in 1885.
4. The roofing material is metal, as in the historical original. This (metal) roofing was a classic for the buildings of those times (17th century) and is largely preserved to this day.
5. Window frames restored from preserved original wooden frames. Without the possibility of opening after reconstruction. (The building is fully provided with centralized ventilation, air intakes through the roof).
6. New street entrance to the courtyard area.
7. New windows were arranged, using overhead light to partially illuminate the basement.

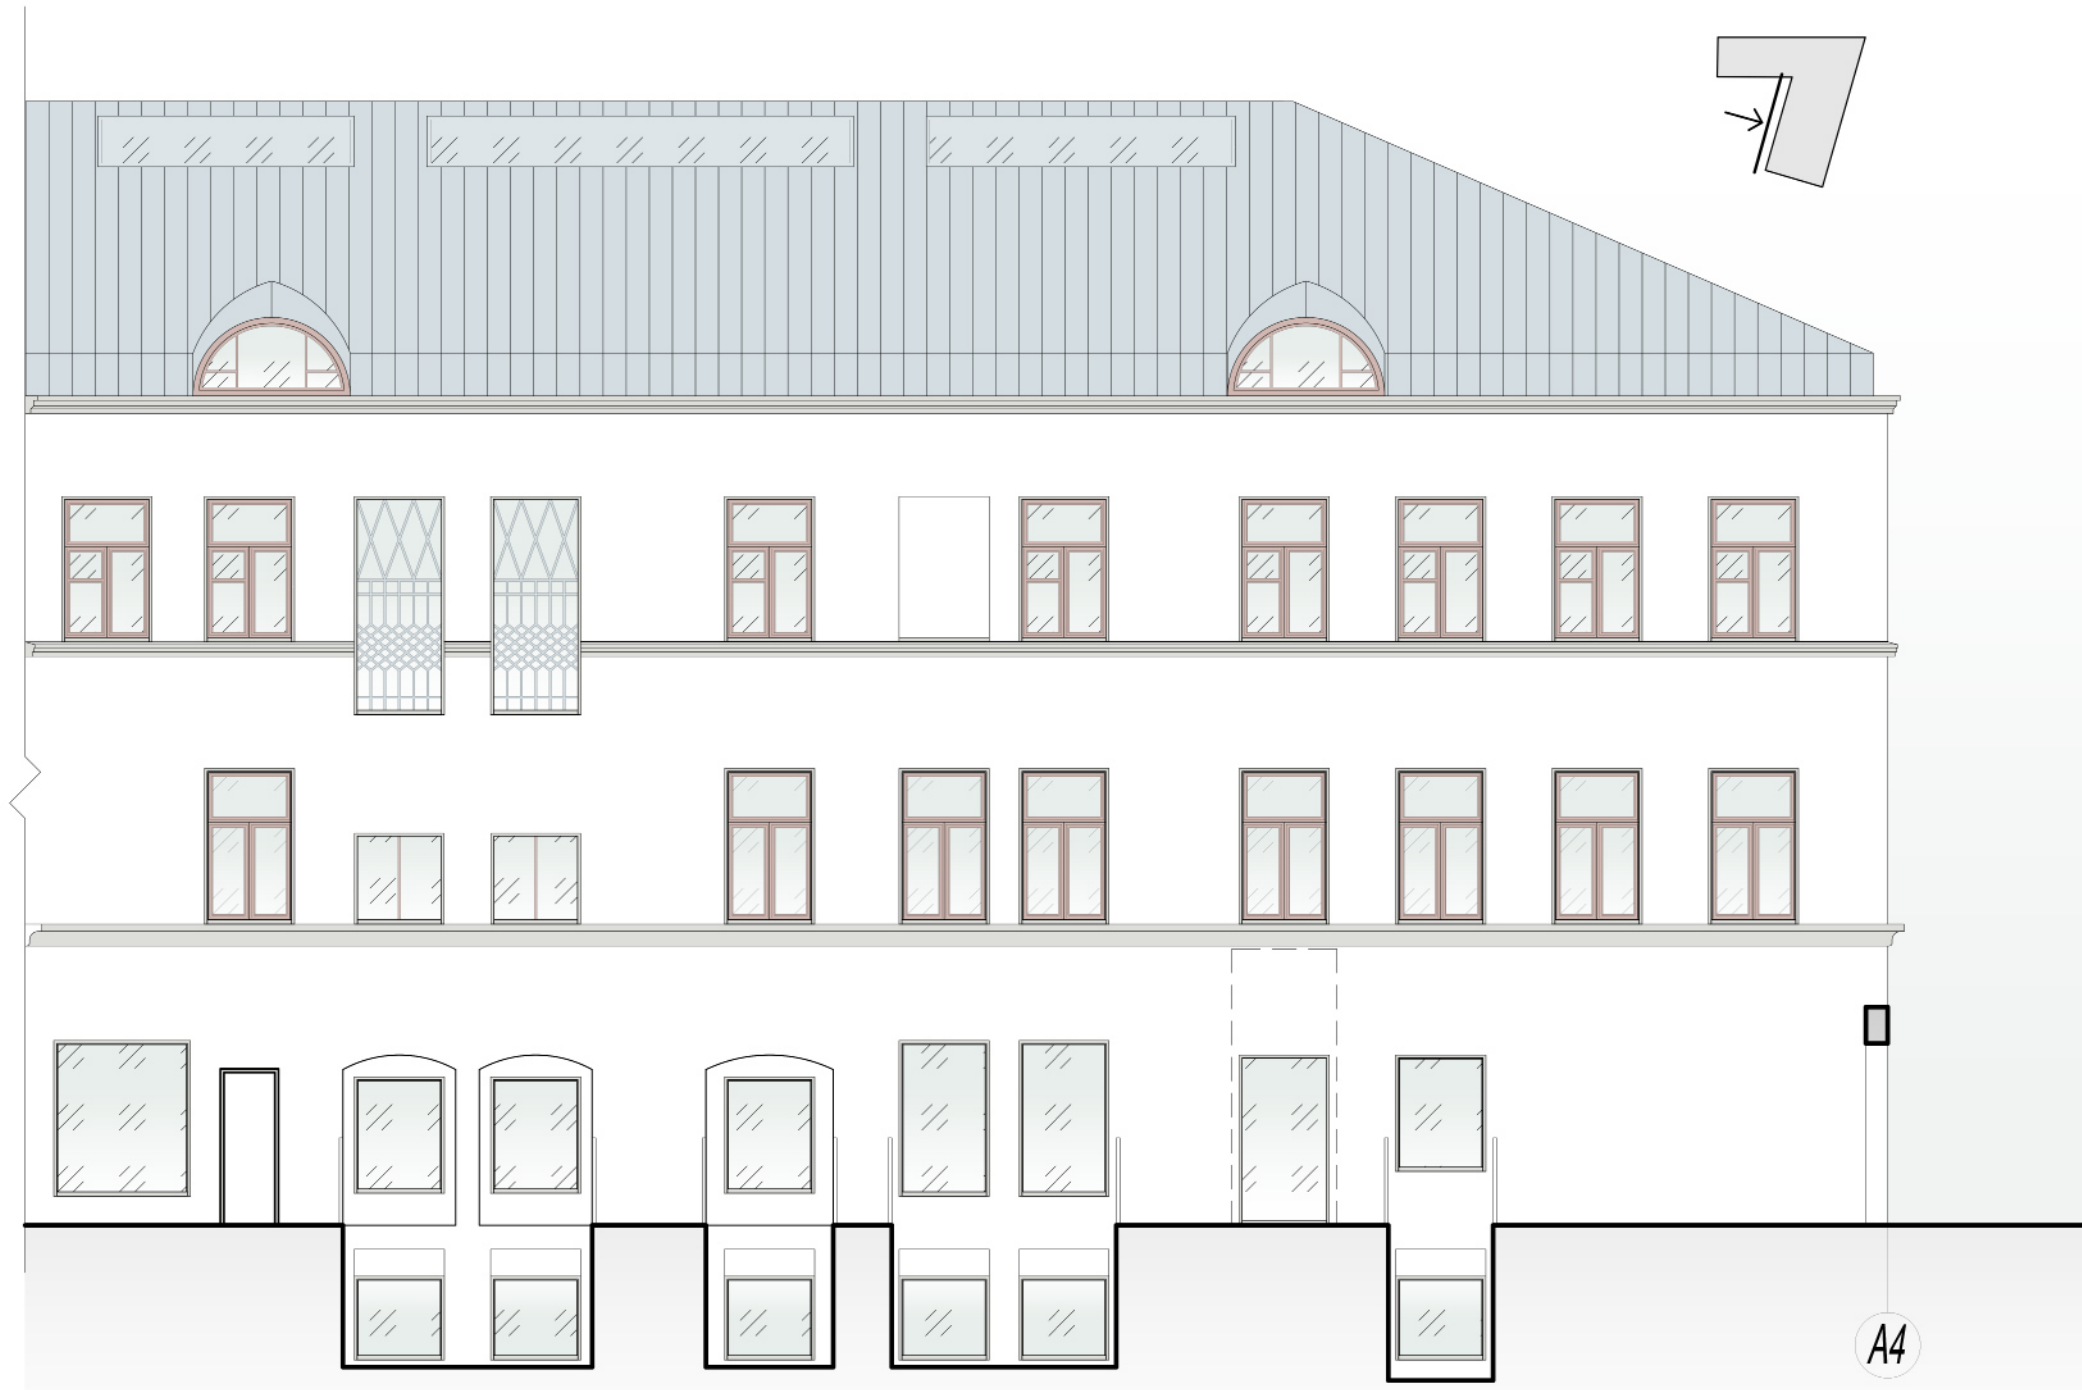
The color scheme of the facade is made by a coloristic design project. These recommendations indicate the required contrast of the hue of the tone (within the same color). \*Corresponds to archival records and historical documents.

6. Existing doorways and roght window frames have been retained to maintain the historical influence on the architecture and life of the building. The windows in the roof have been preserved in their original location and style.

7. New windows were arranged, using overhead light to partially illuminate the basement.
