Department of Architecture:  
«Sustainable Architecture and Landscape Design»  
2022

*«Applying Sustainable Methods in Renovation of the Historical building in Tver, Russia.»*

*«How to apply sustainable renovation technique to a protected historical building?»*

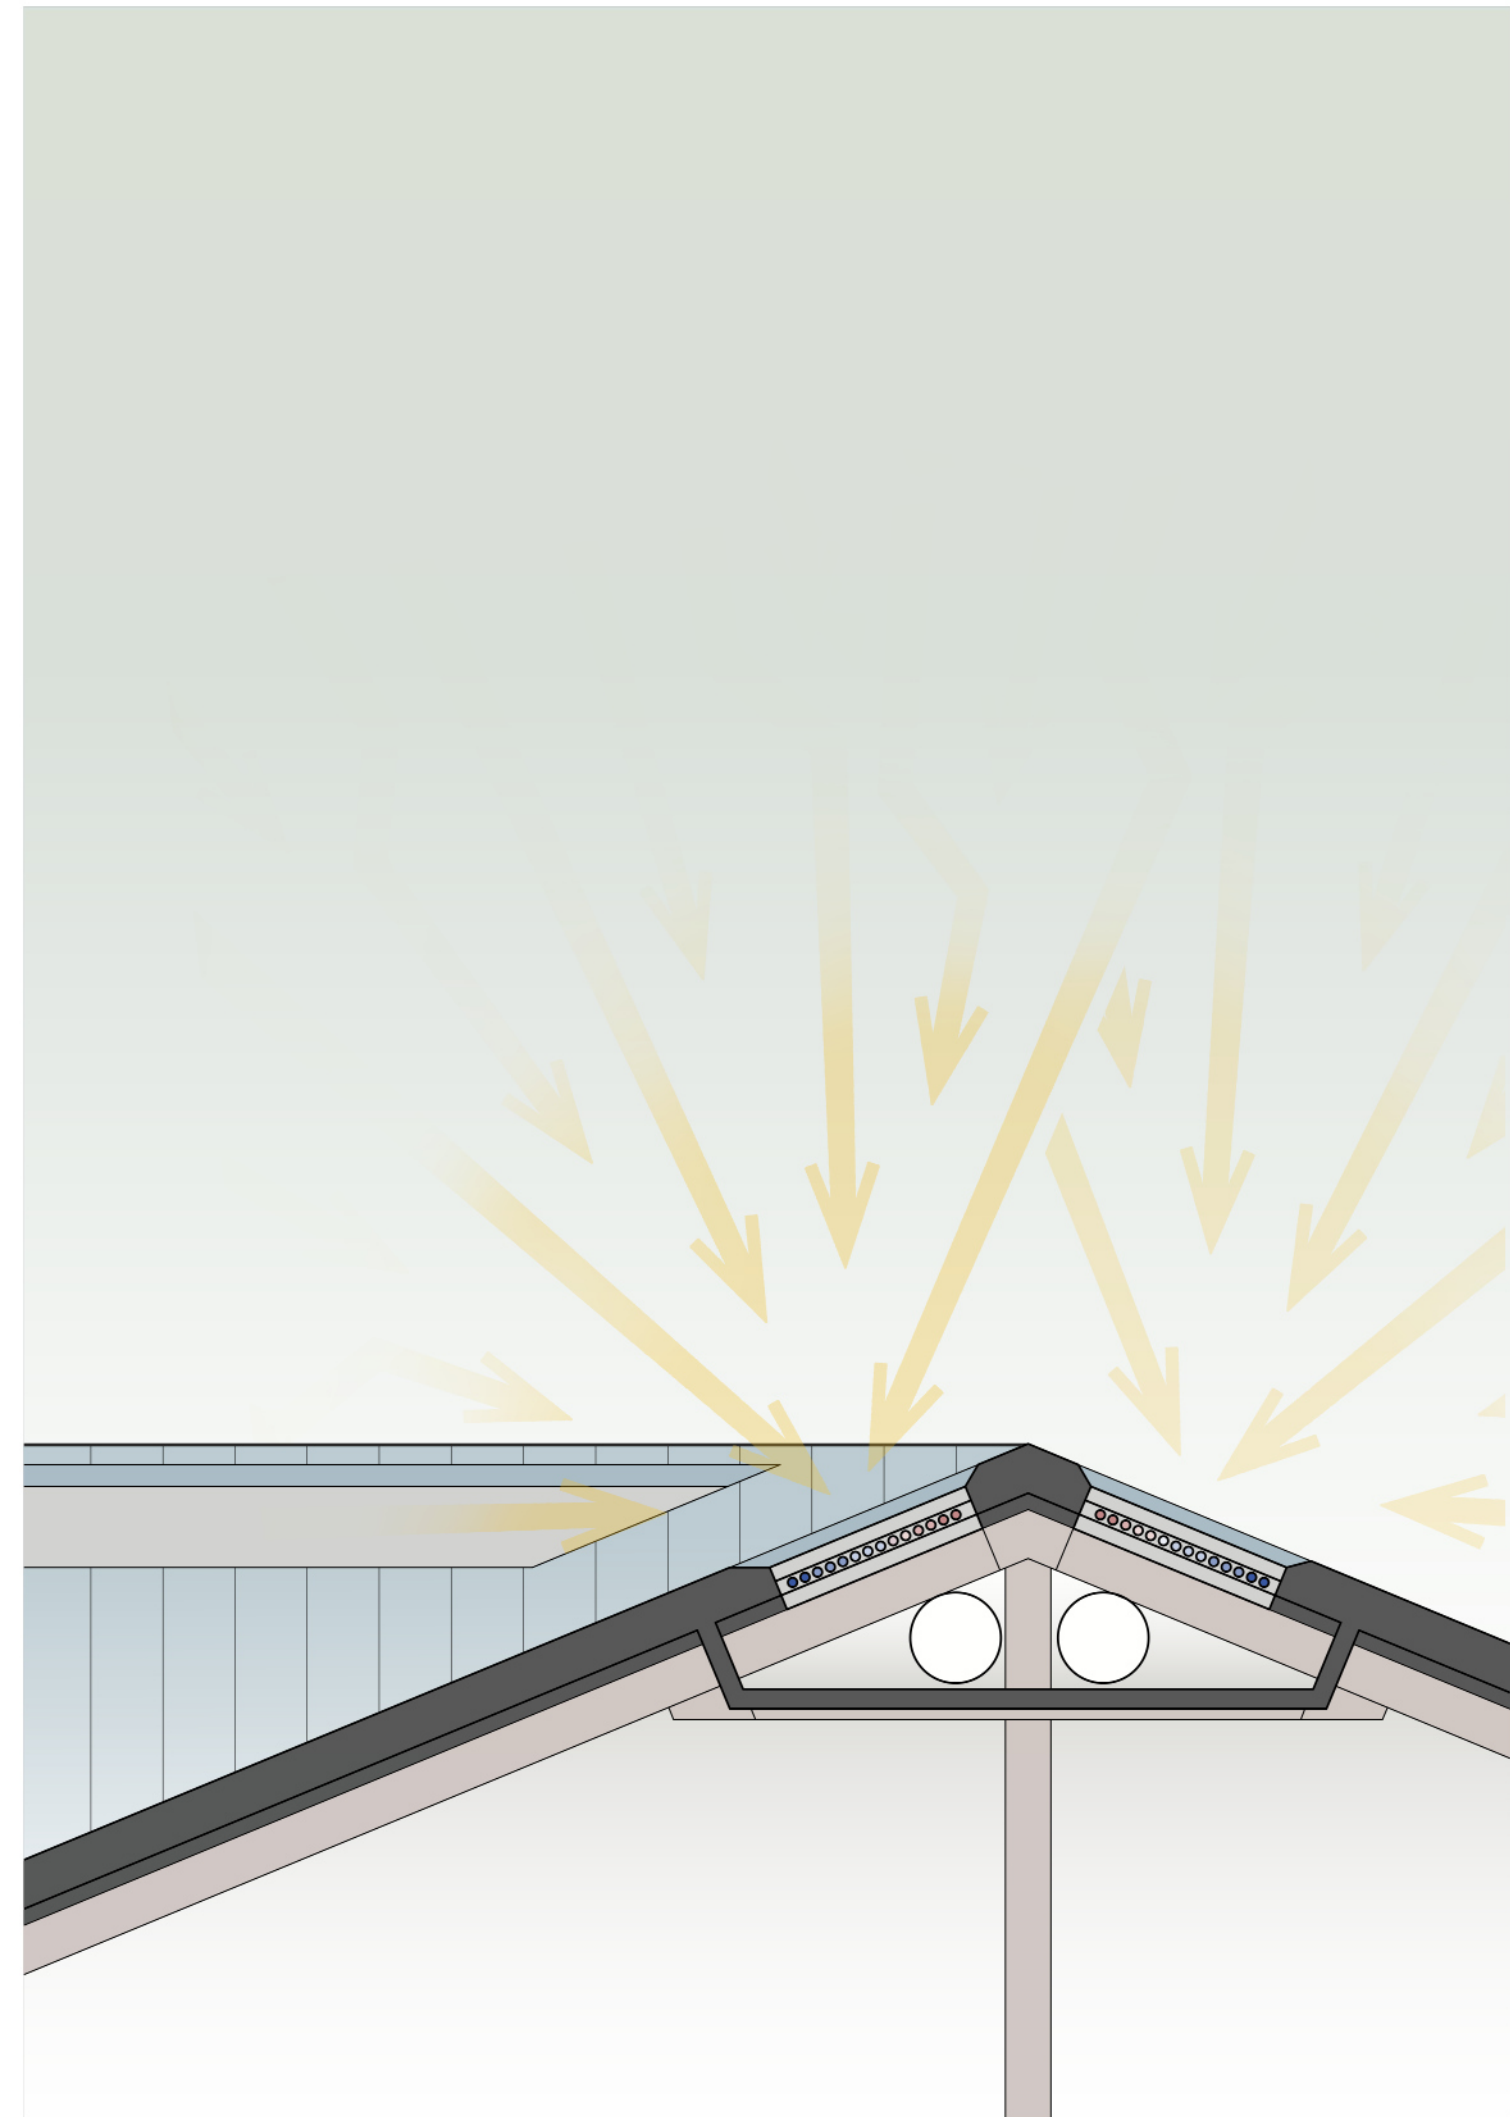
#### \*Solar heater tubes parametrs:

Length - 1800±5mm. The outer diameter of the tube - 58±0.7mm. The thickness of the outer glass tube is 1.8±0.15mm. Tube inner diameter - 47±0.7mm. The thickness of the inner glass tube is 1.6±0.15mm. Glass material - borosilicate glass 3.3mm. Vacuum level - between the walls of the tube  $P 5 \times 10^{-3}$ Pa. Absorption rate > 91%. Loss of solar radiation < 8% (80C±1.5C). Max. temperature 270C - 300C. Rated pressure - 0.6MPa. Average heat loss coefficient - 0.6W/(m<sup>2</sup>). Three Layer Vacuum Tube Coating - Advanced Selective Absorption Coating: Composite - Copper, Stainless Steel, Aluminum (CU/SS-ALN(H)SS/ALN(L)/ALN). Application method - DS reactive spraying.

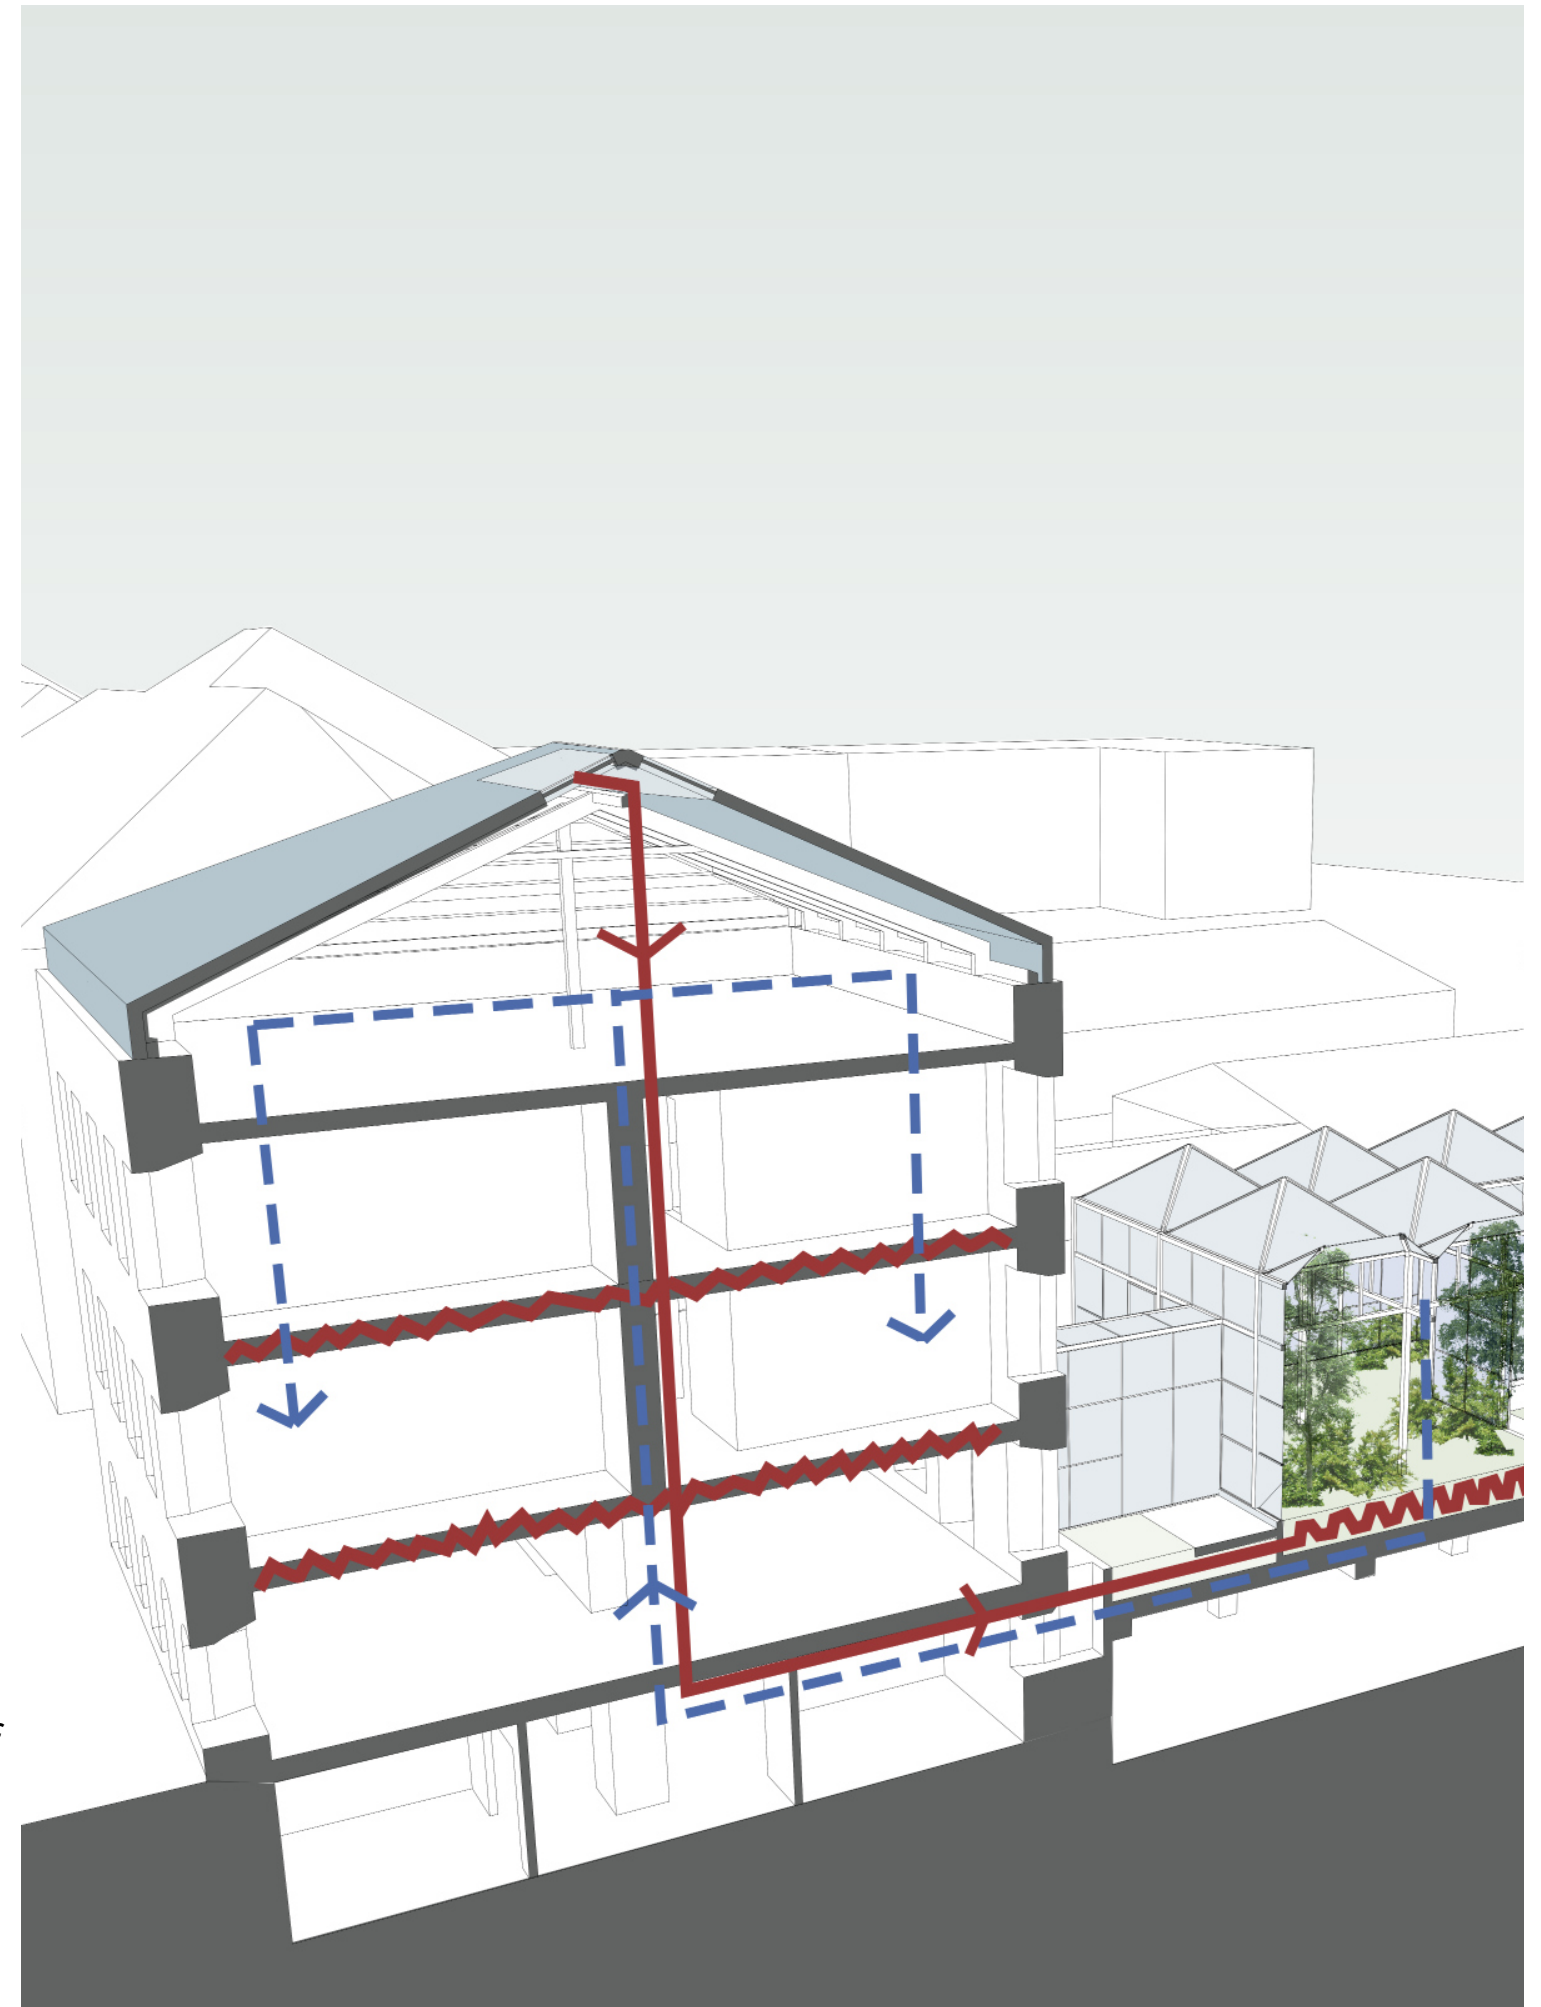
## CALCULATION OF THE THERMAL POWER OF A VACUUM SOLAR HEATER

3. The total outside heated soil surface (inside glass structure) ~ **90 m<sup>2</sup>**. Lets take double consumption for soil inside the glass structure (greenhouse) as **300 watts** for 1 m<sup>2</sup>. Then 90 m<sup>2</sup> x 300 watts = 27000 watts (**27 KW/h**).

4. Checking - **27 KW/h** + **48 KW/h** + **10.5 KW/h** (~12% loses of overall heating system) = **85.5 KW/h** < **87.68 KW/h**.
