Project Site and Historical Building (Convitto)

Site Plan

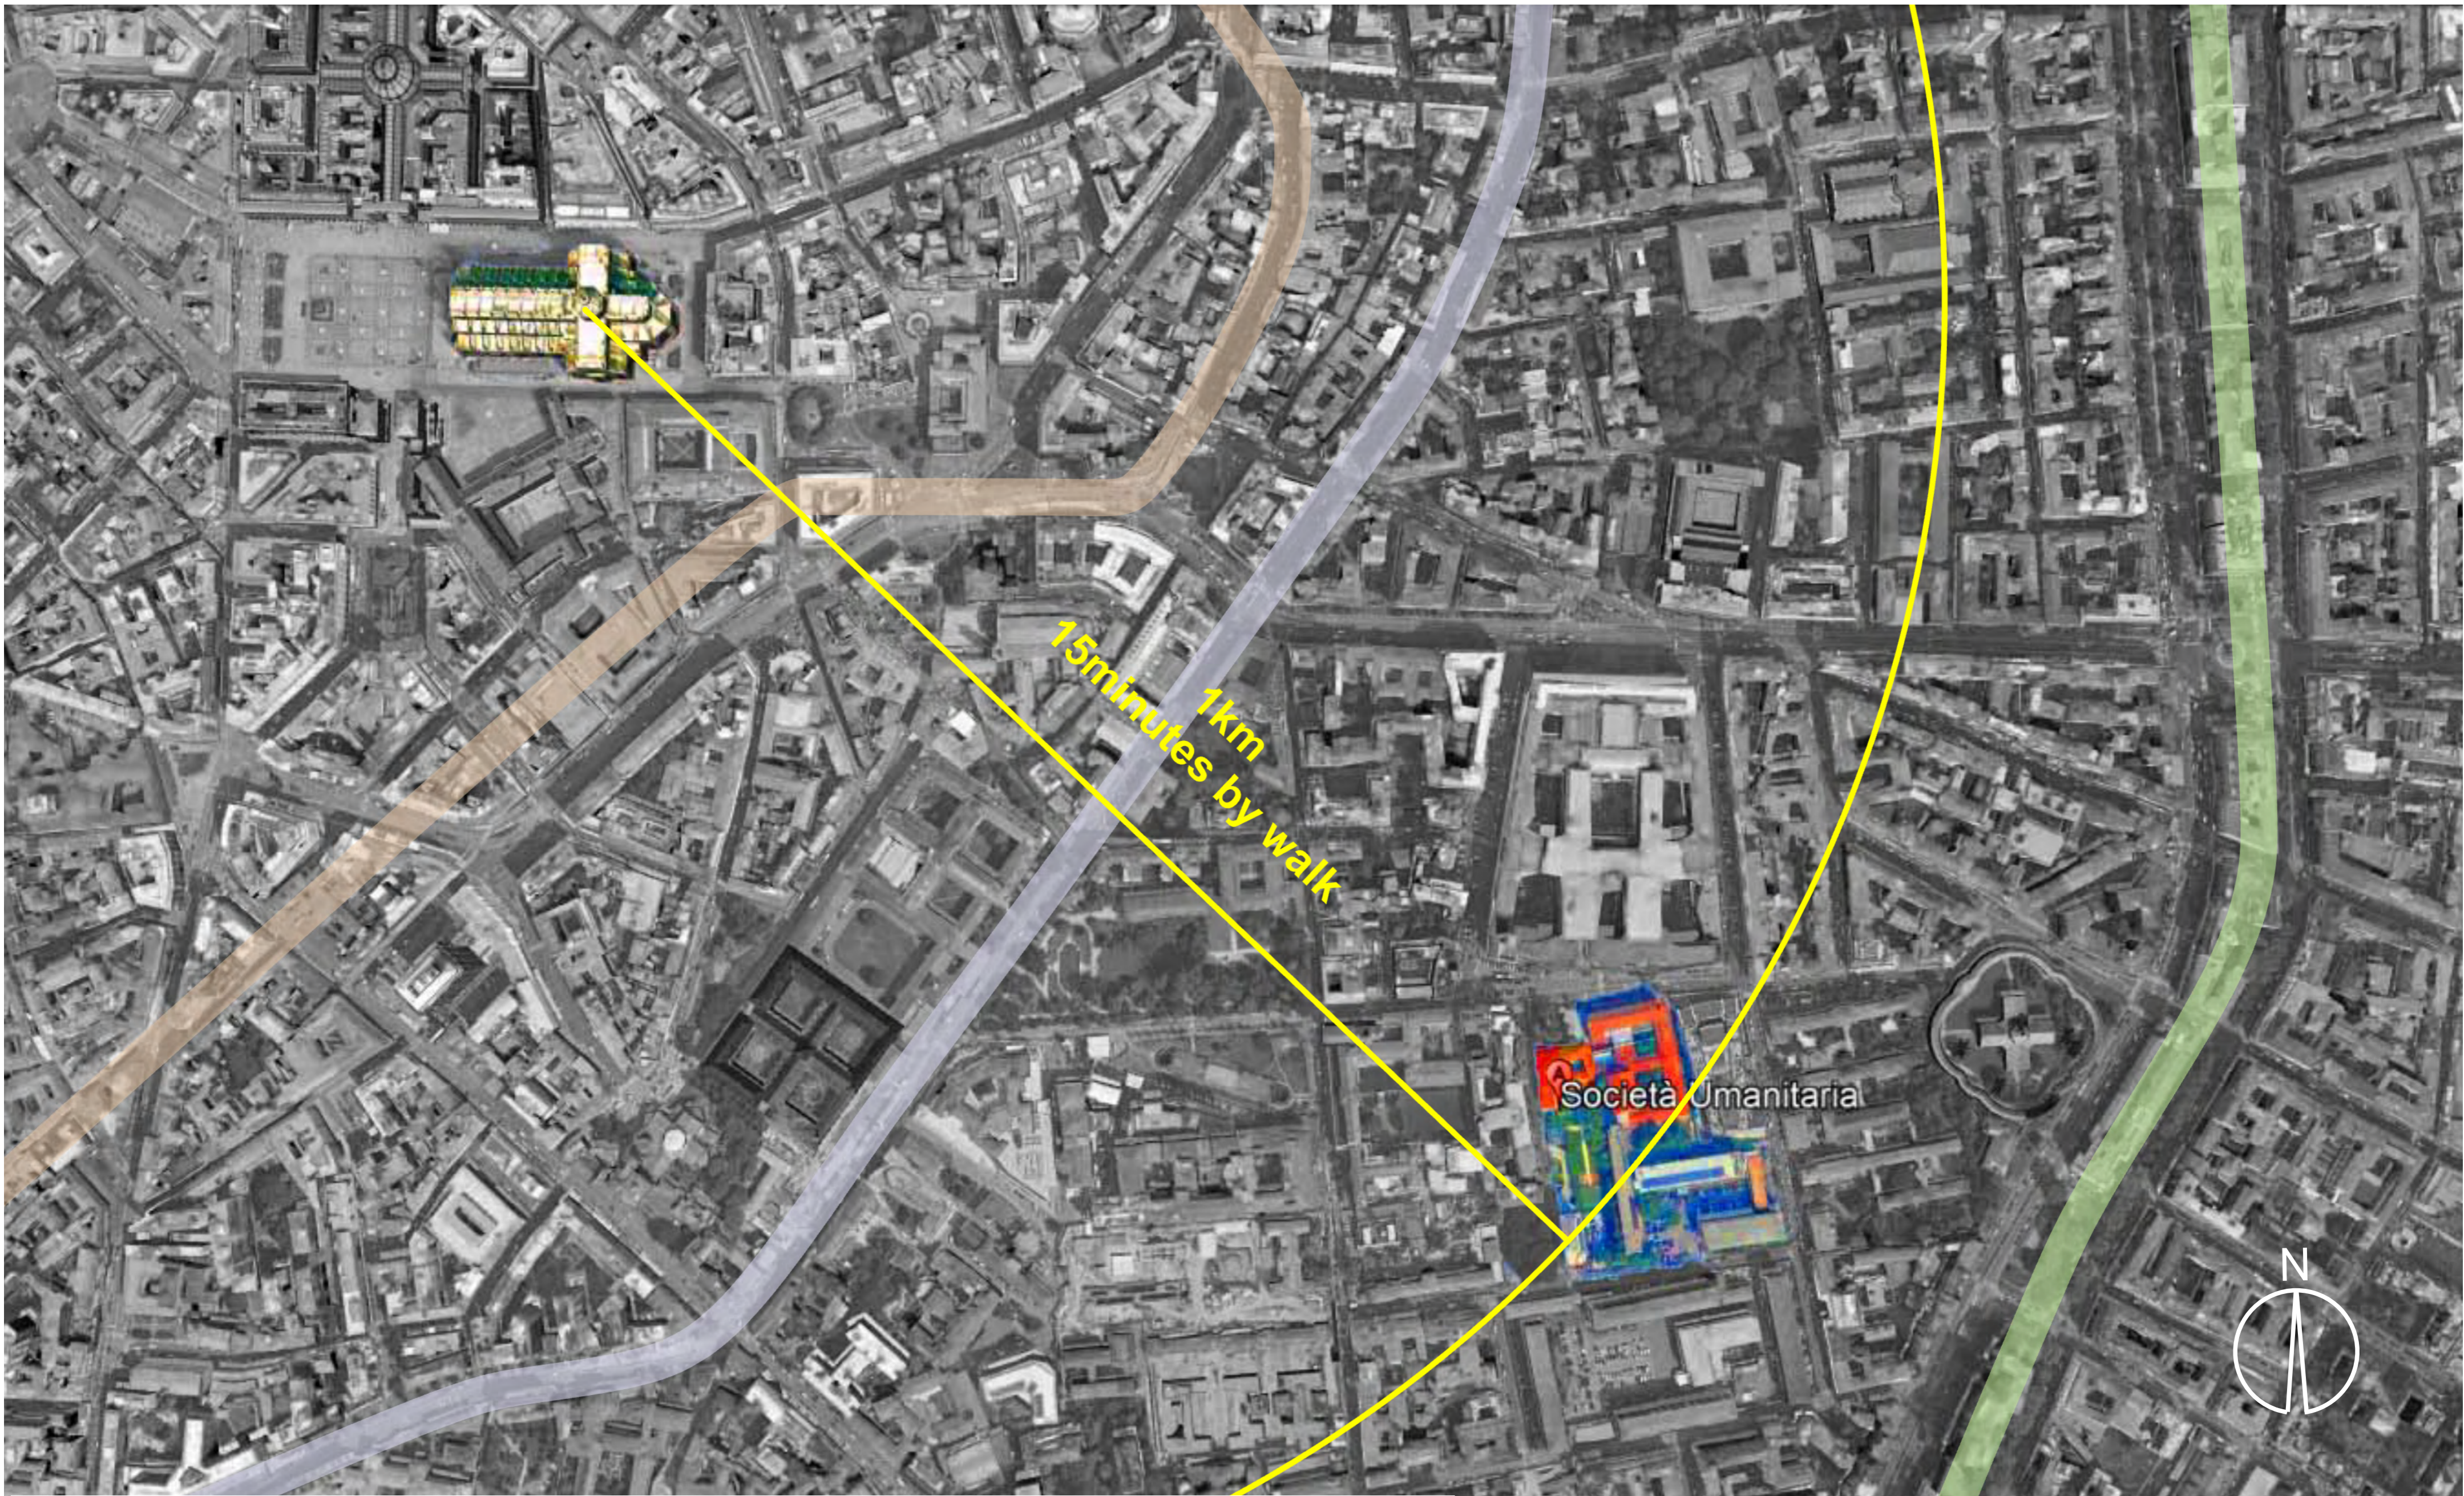
Roman Wall Medieval Wall (12c) Spanish Wall (16c)  
Duomo and Umanitaria

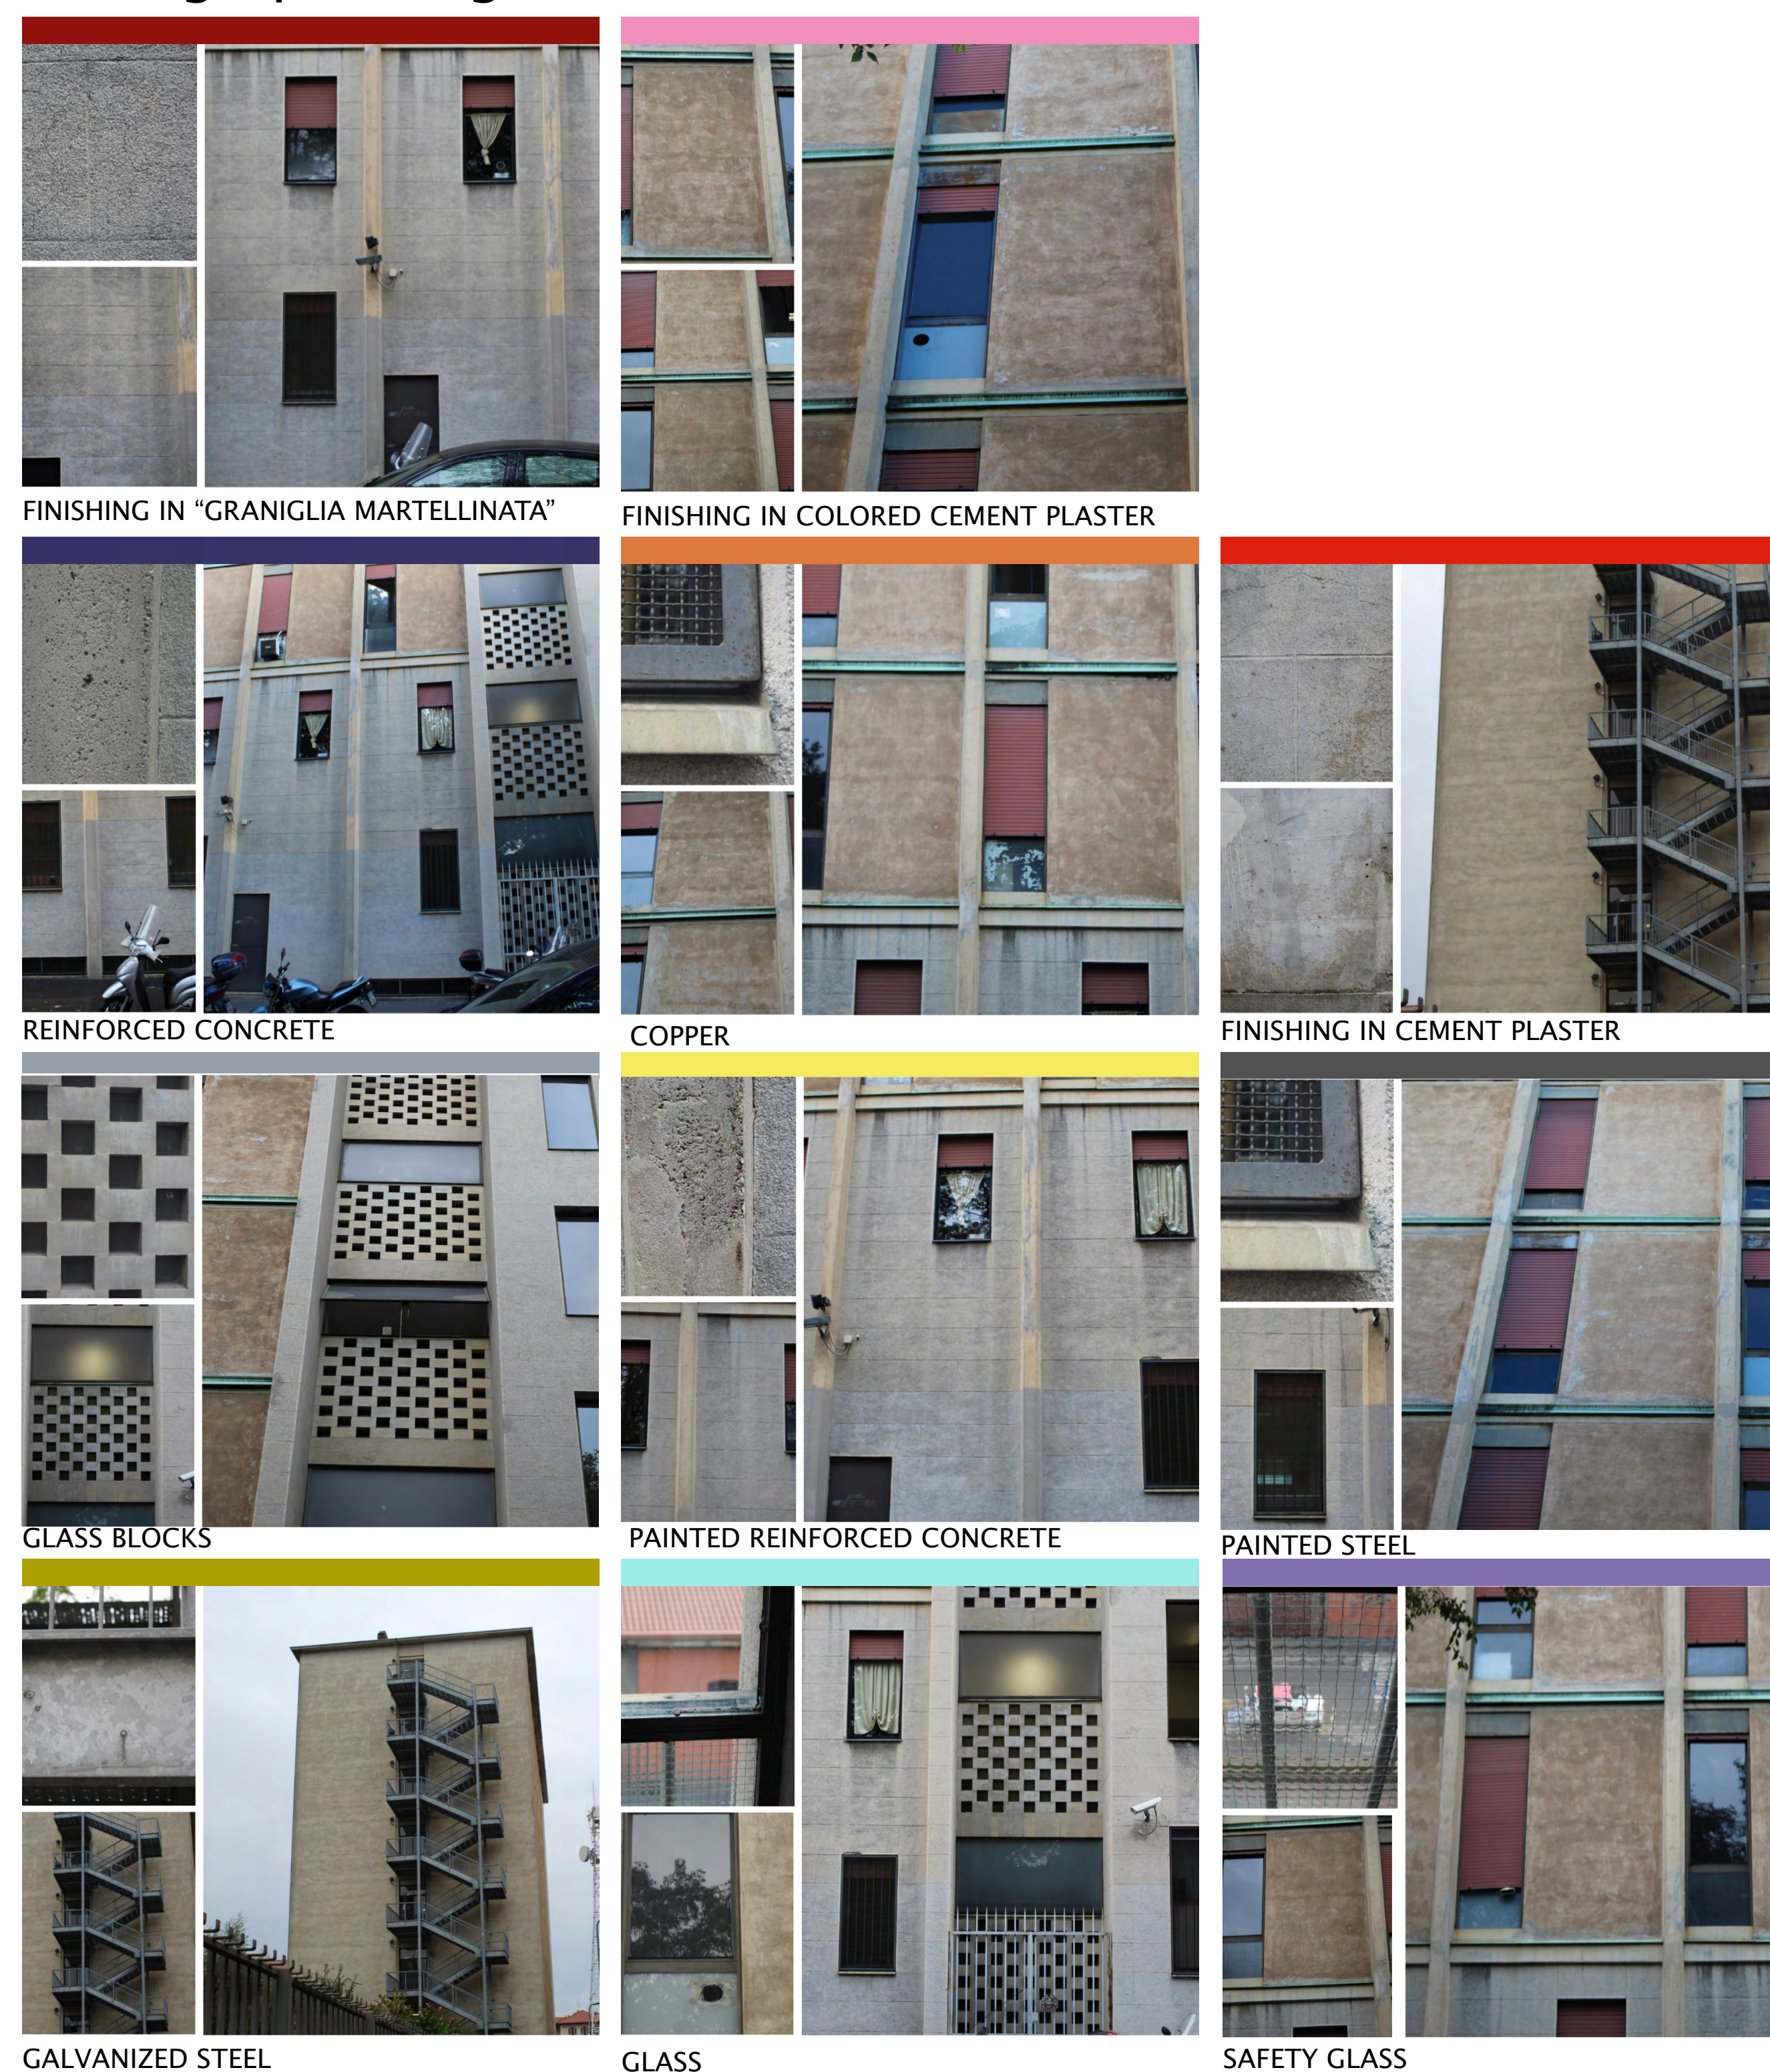
Photographic Legend: Material

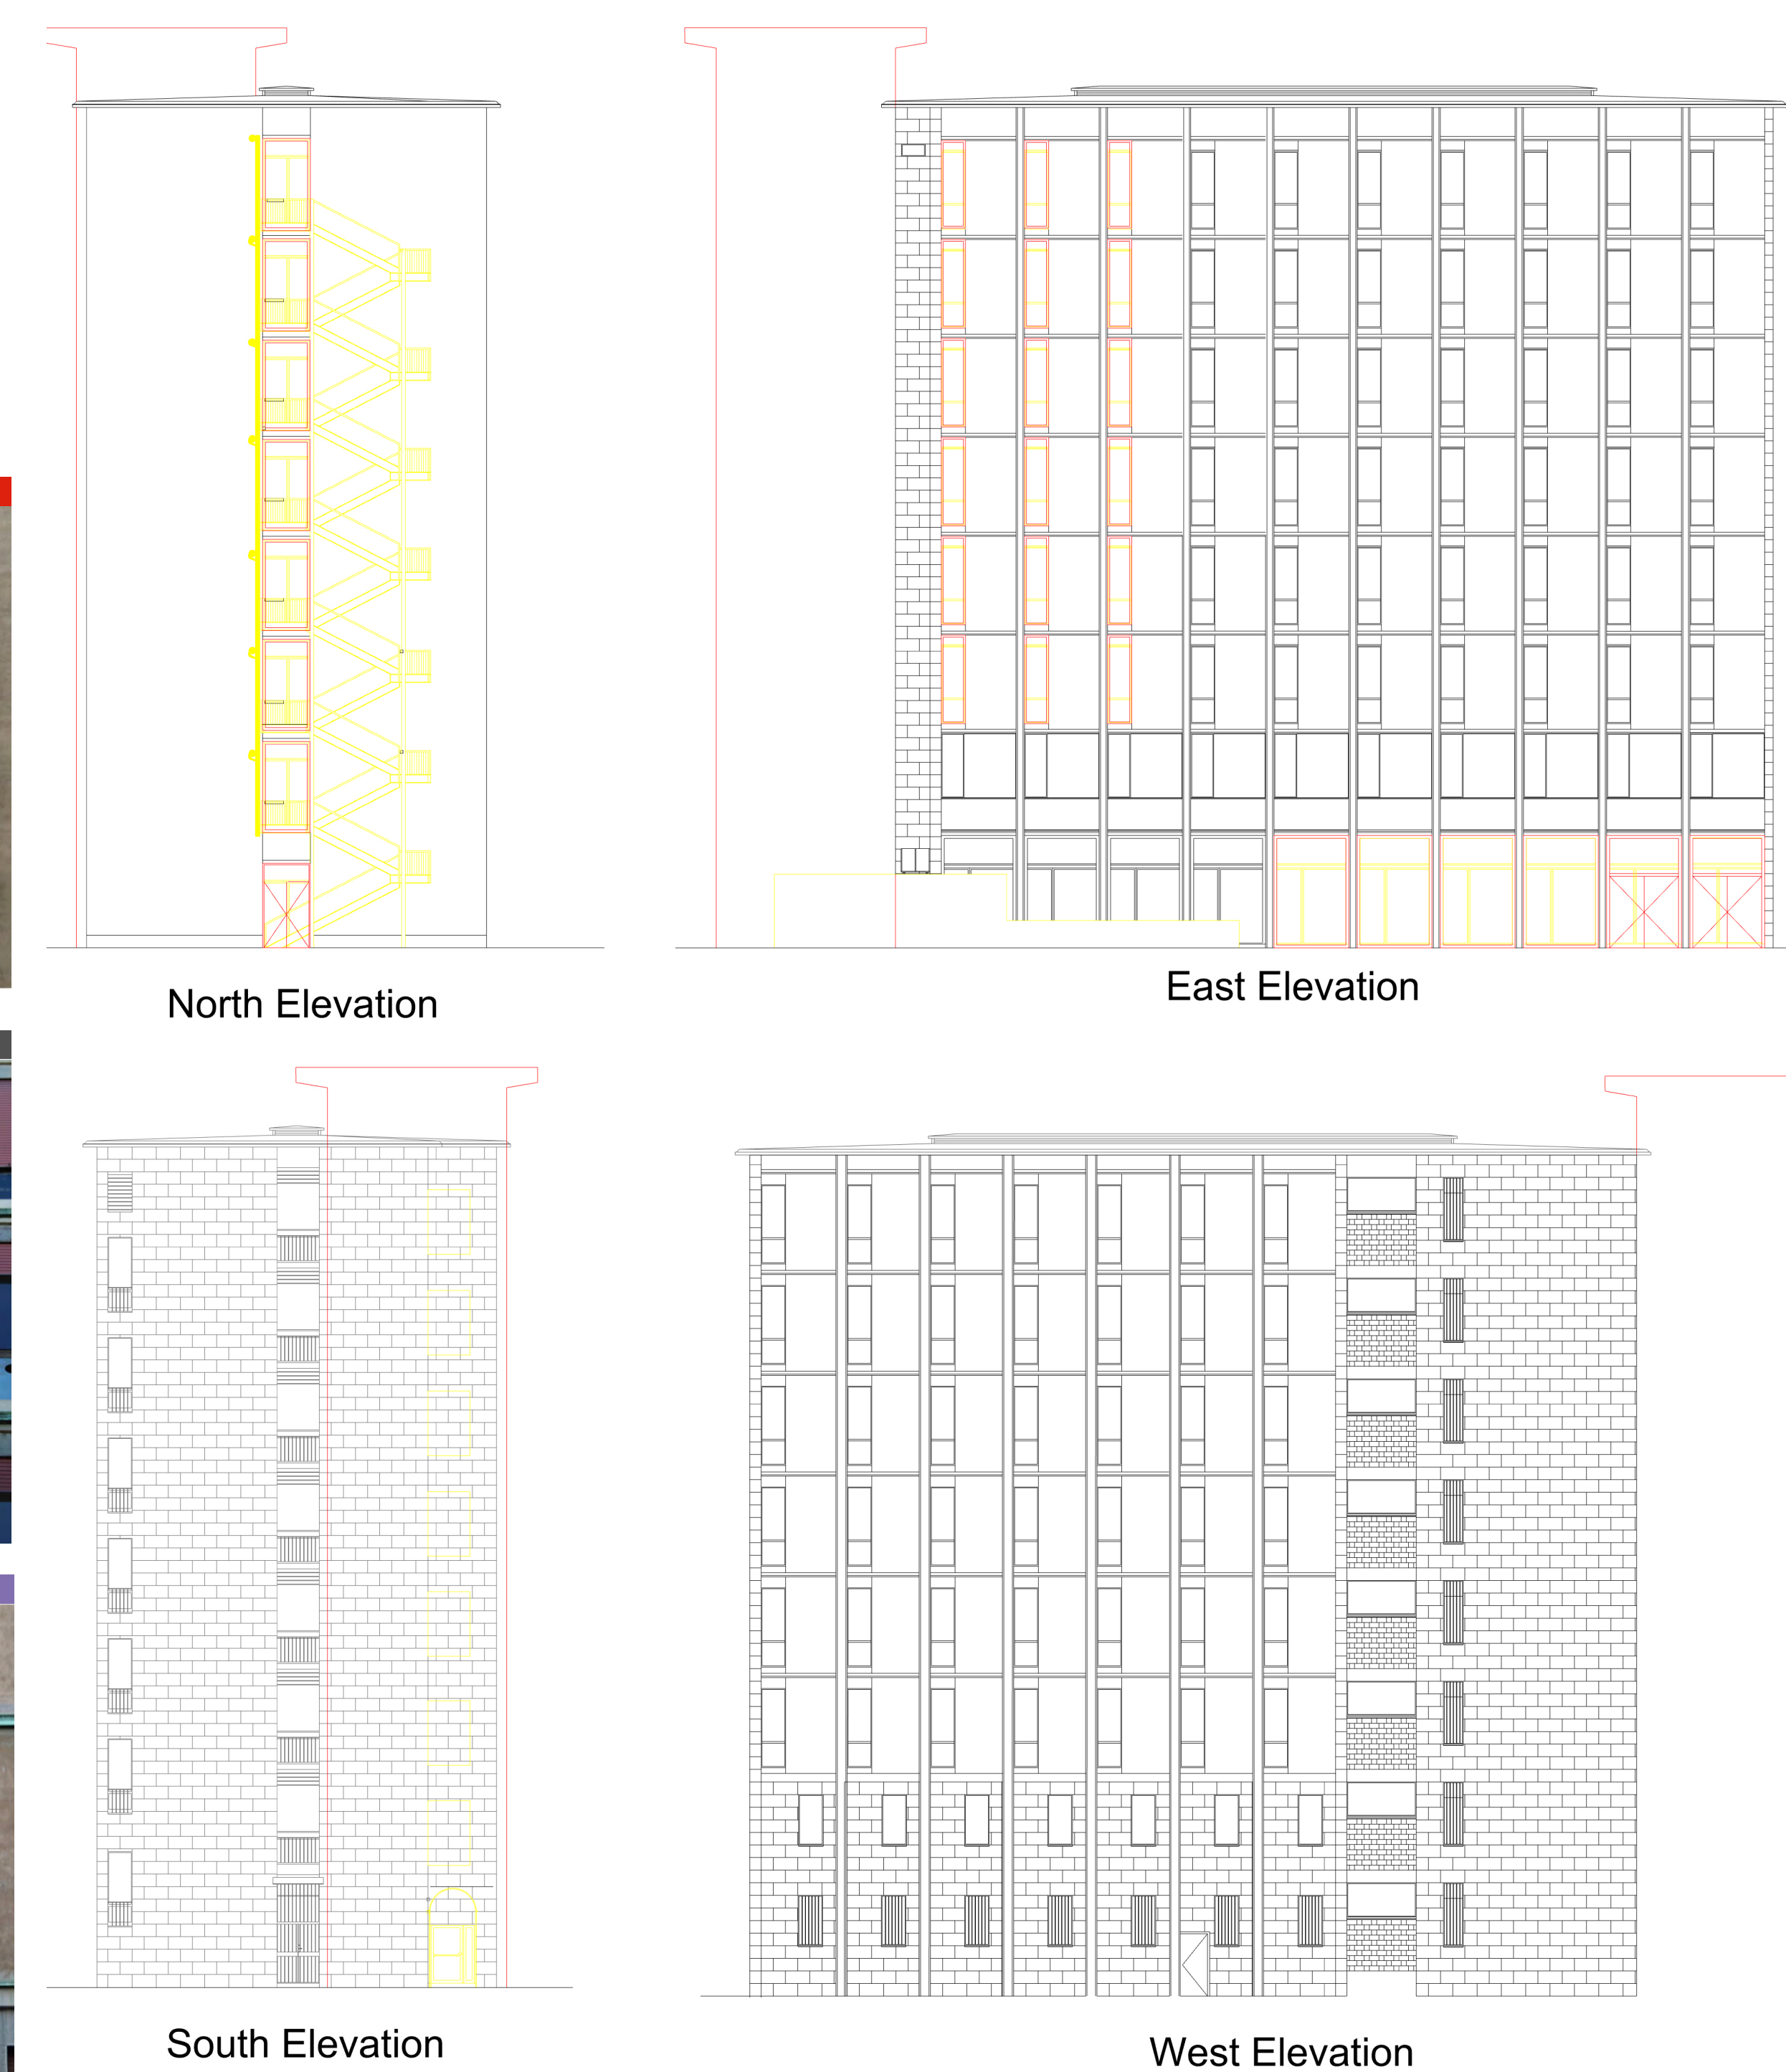
Elevation: Demolition and Construction

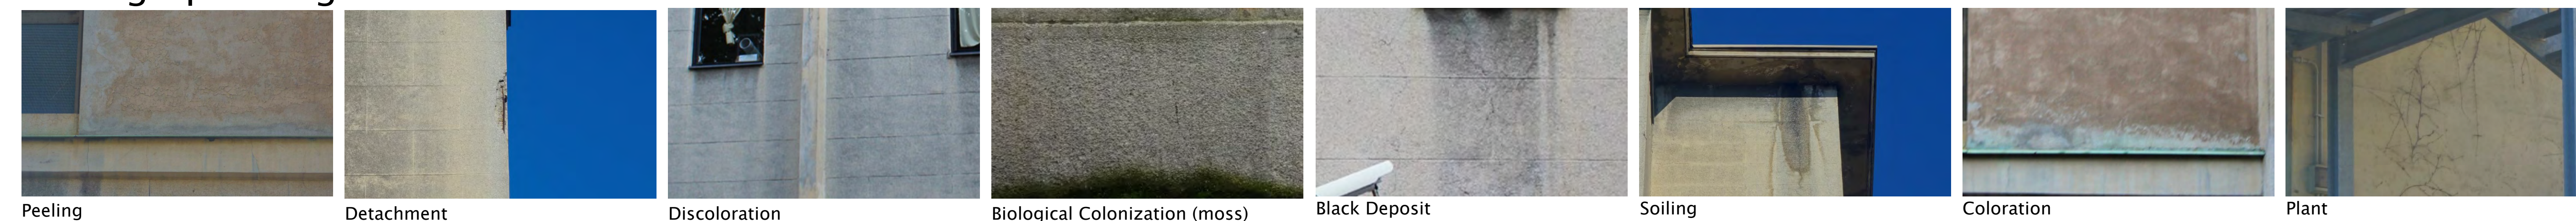
Photographic Legend: Deterioration

**Problem**  
 1. Visible Facade But Spoiling The Value By Staircase  
 2. Biological colonization  
 3. Discoloration  
 4. Black Deposit

**Problem**  
 1. Peeling of Plaster  
 2. Difficult to observe the situation correctly  
 3. Facing new volume  
 4. Micro Climate might change

**Problem**  
 1. Black Deposit  
 2. Rebar is exposed to outside air

**Problem**  
 In East Part, most parts are 1. Peeling of Plaster Cleaned with Nebulized Water 2. Discoloration and Soiling (not at low pressure), and only limited parts of them are Cleaned Intervention at Low Pressure carefully in 1. Clean carefully at low pressure order to underline the importance 2. Attach the detached plaster with compatible one 3. Coating with silica  
 However in this side, most of parts are Cleaned at low 4. Painting Pillar (not only discolored part) 5. Painting Wall (not only discolored part)

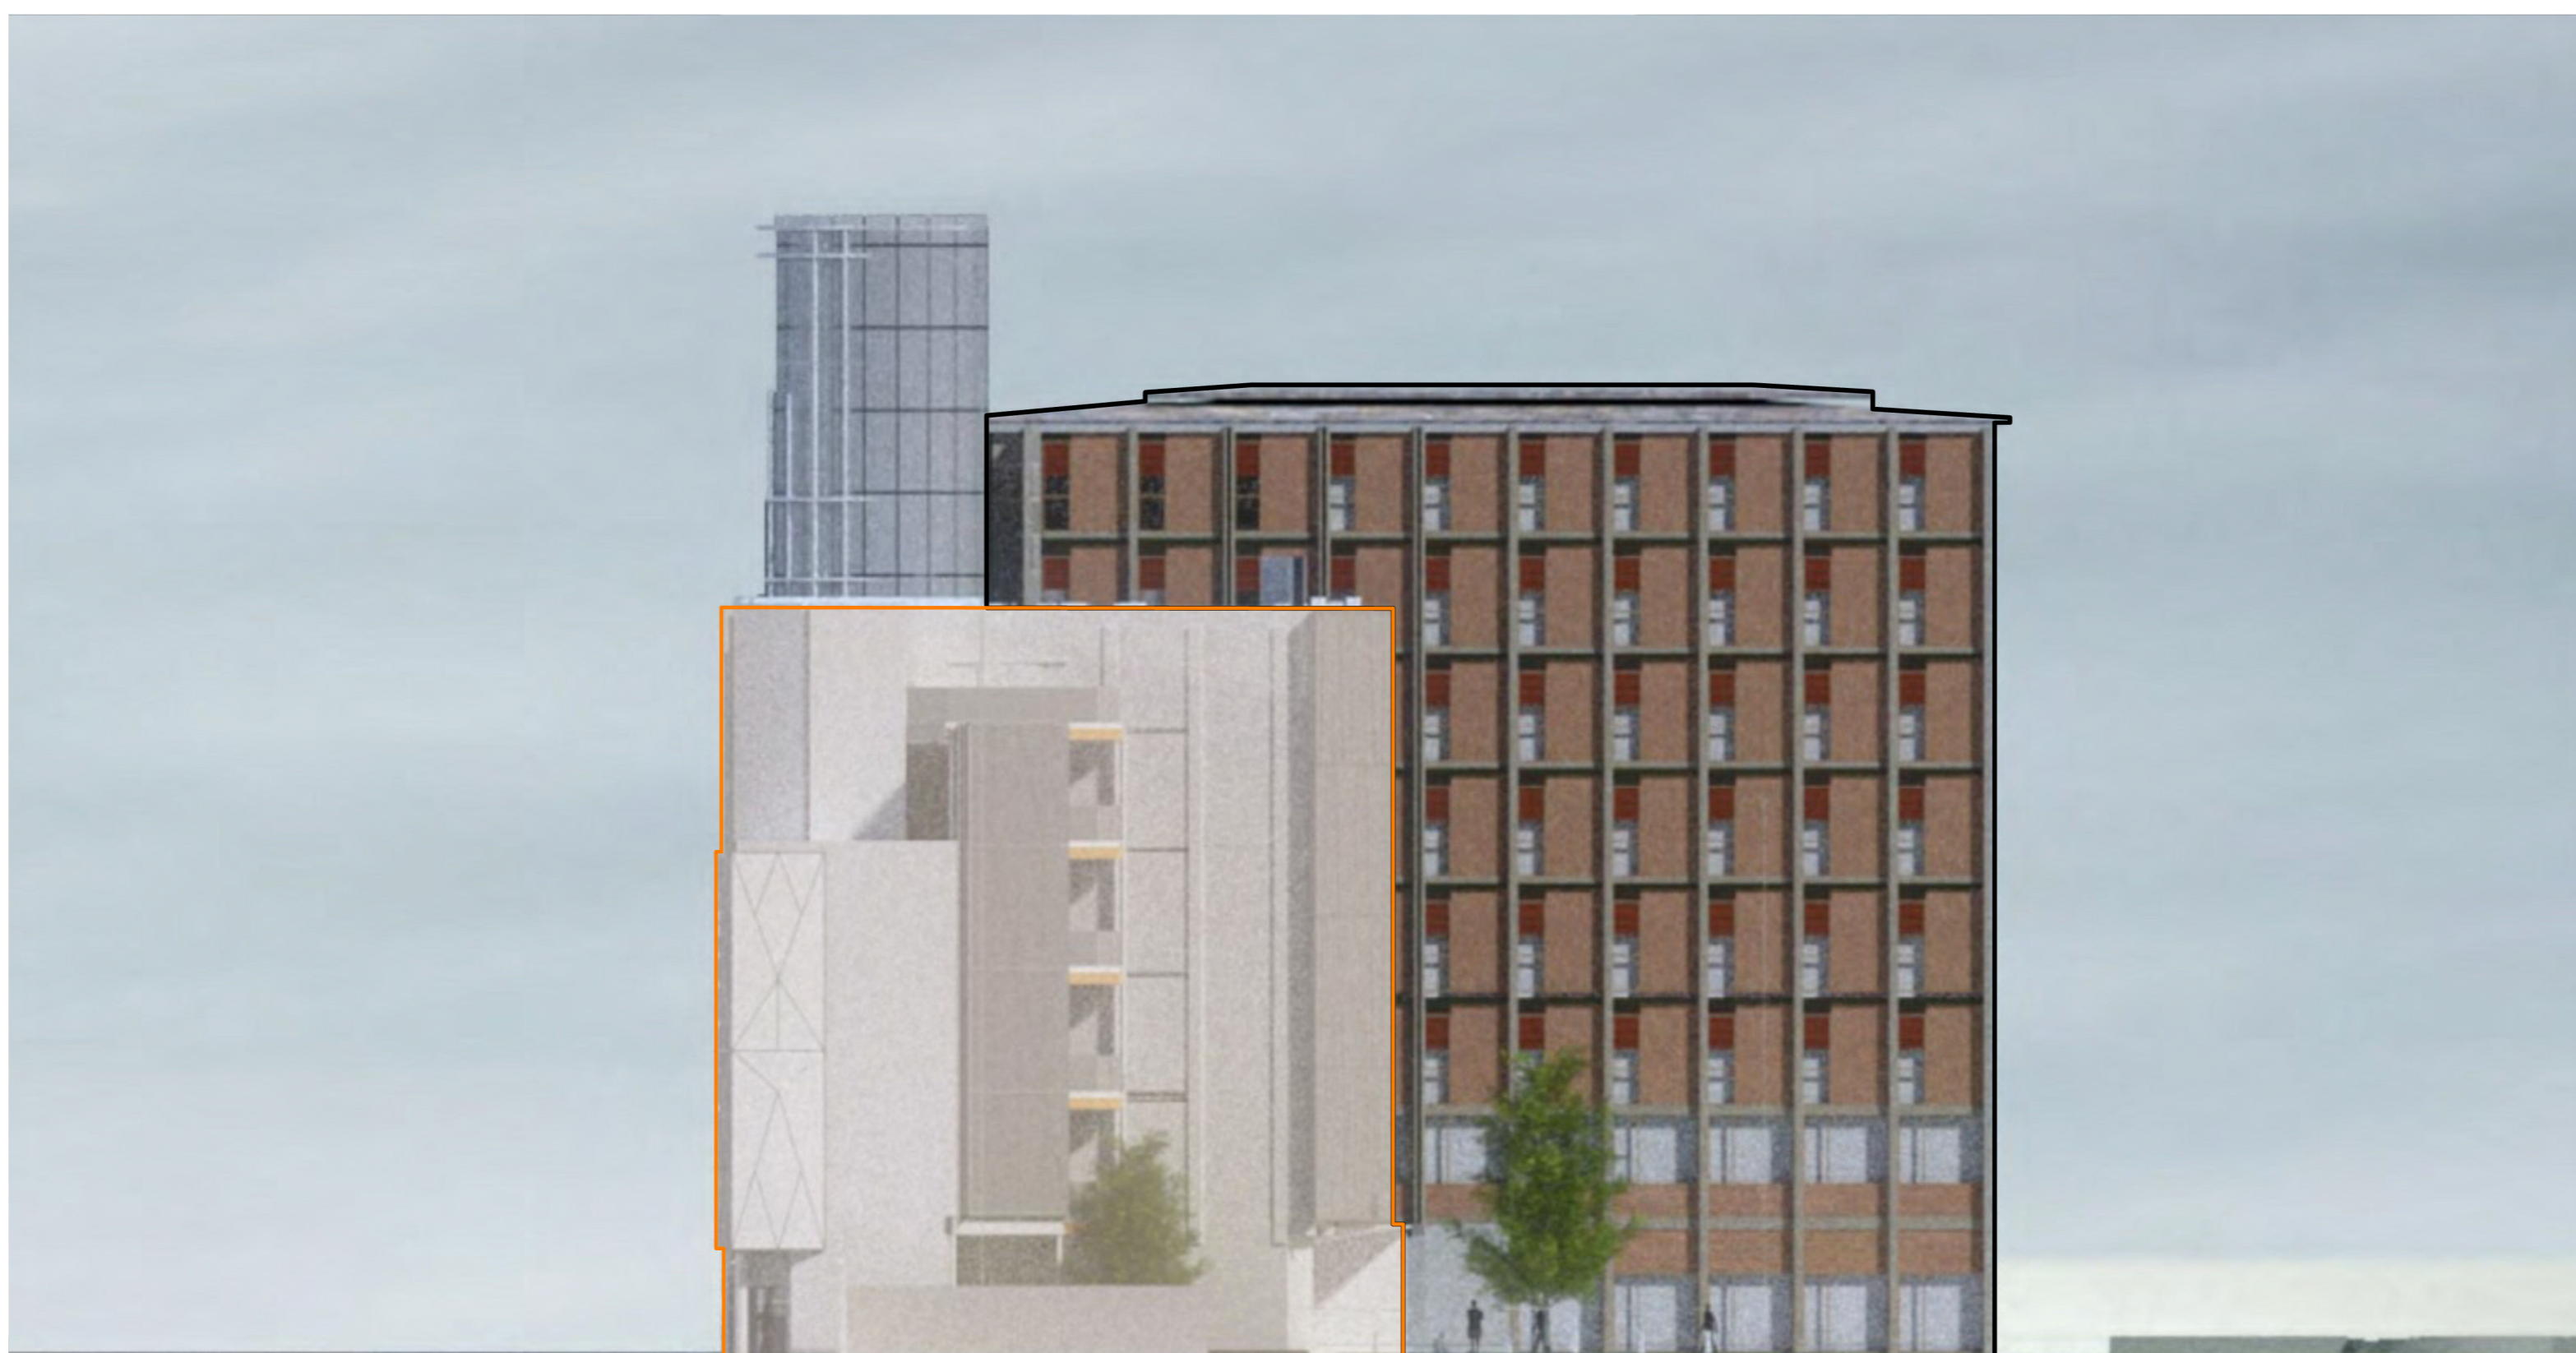
New and Historical : New Volume Covers a Part of Historical Building
