CAFETERIA

In the continuity of improving Società Umanitaria, a cafeteria as a gathering space, available for all users, is created.

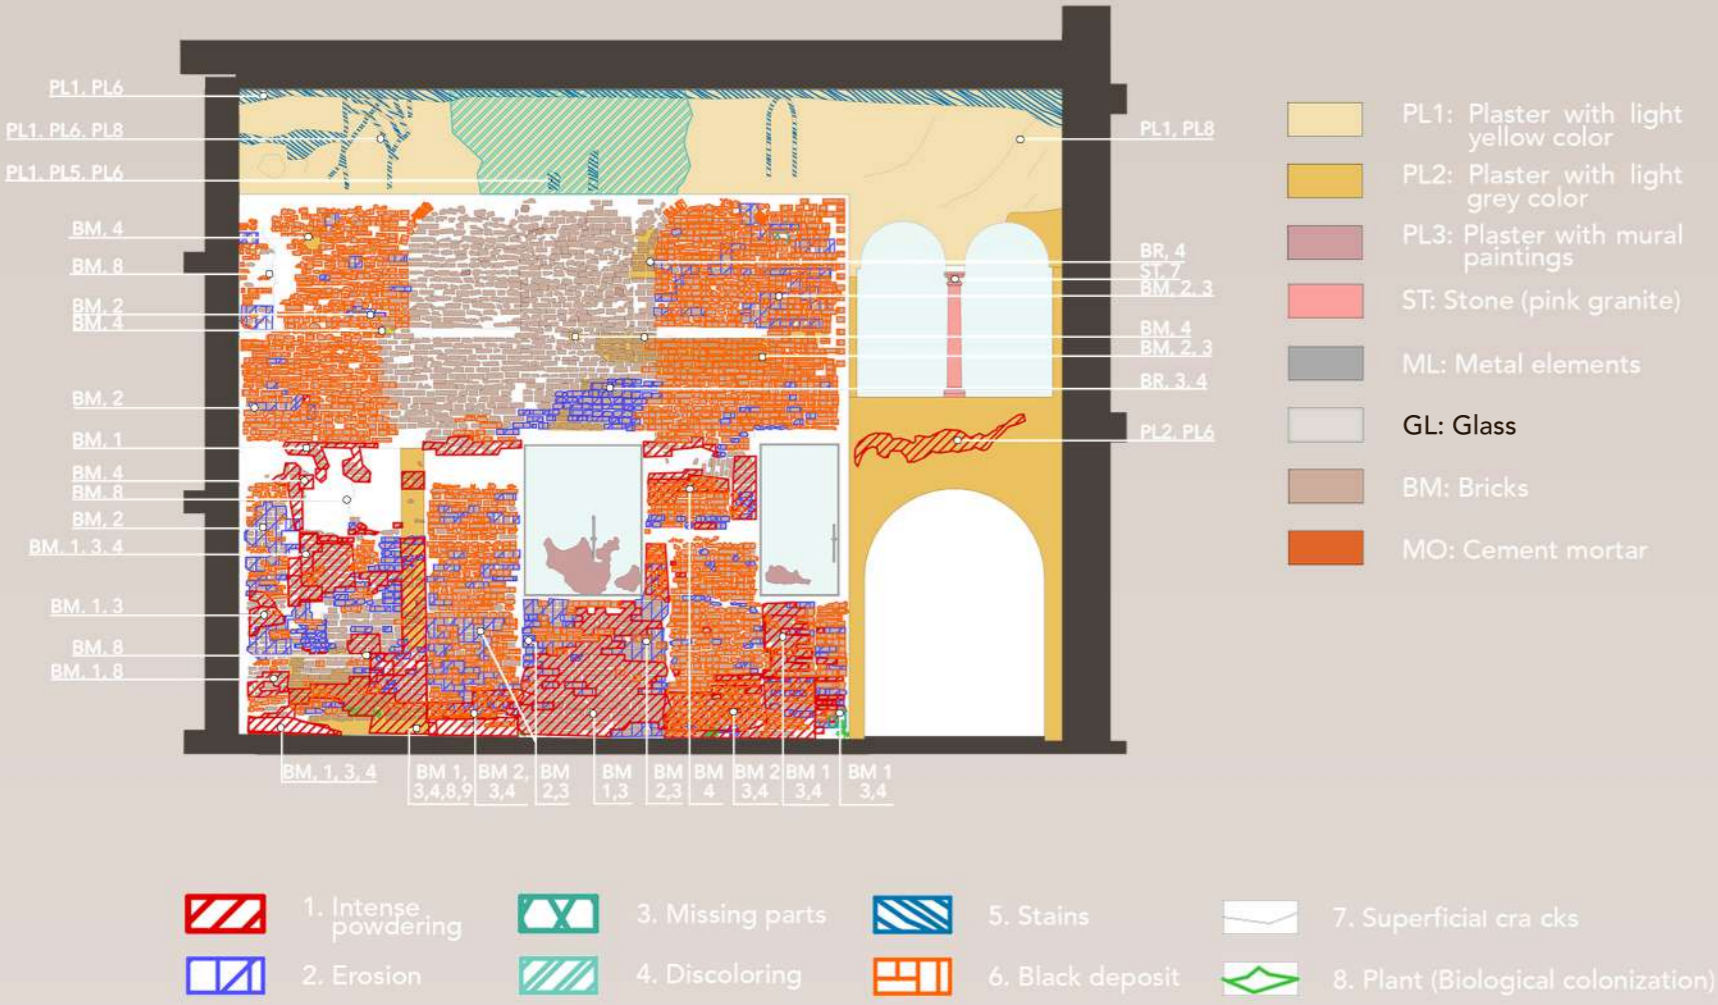
MATERIAL AND DECAY MAPPING made by GR05
1/100

An analysis of this wall was made for its preservation and the rising damp has been detected as the main problem. To overcome this decay for the future, an air drain is created to let the water from the soil to evaporate. This intervention will prevent efflorescence and salts aggregation to happen on the bricks.
