6.2. Bilecik “Belekoma” City

CHAPTER 6: CITIES AND LOCATIONS

6.2.2. Architectural values

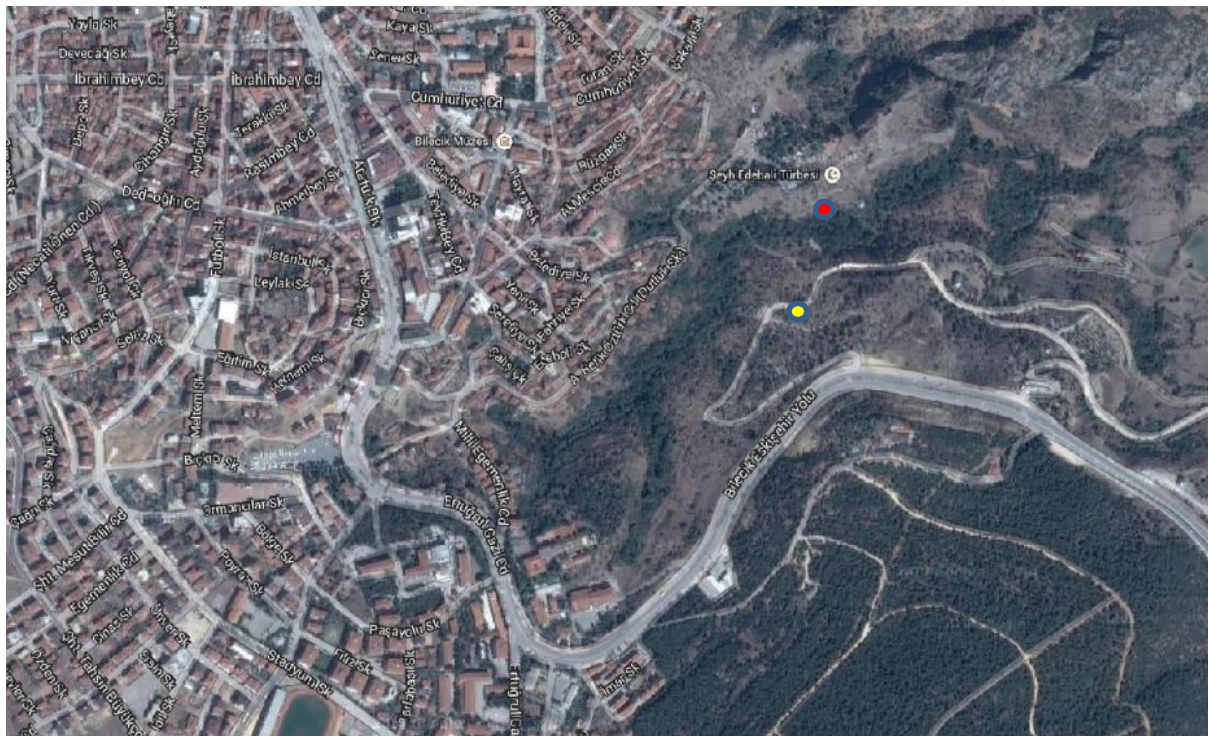
Fig 6.21: Bilecik city focus on Seyh Edebali tomb, Süleymanpaşa bath (red point) and Emirlers bath (yellow point). (Google maps, 2014).

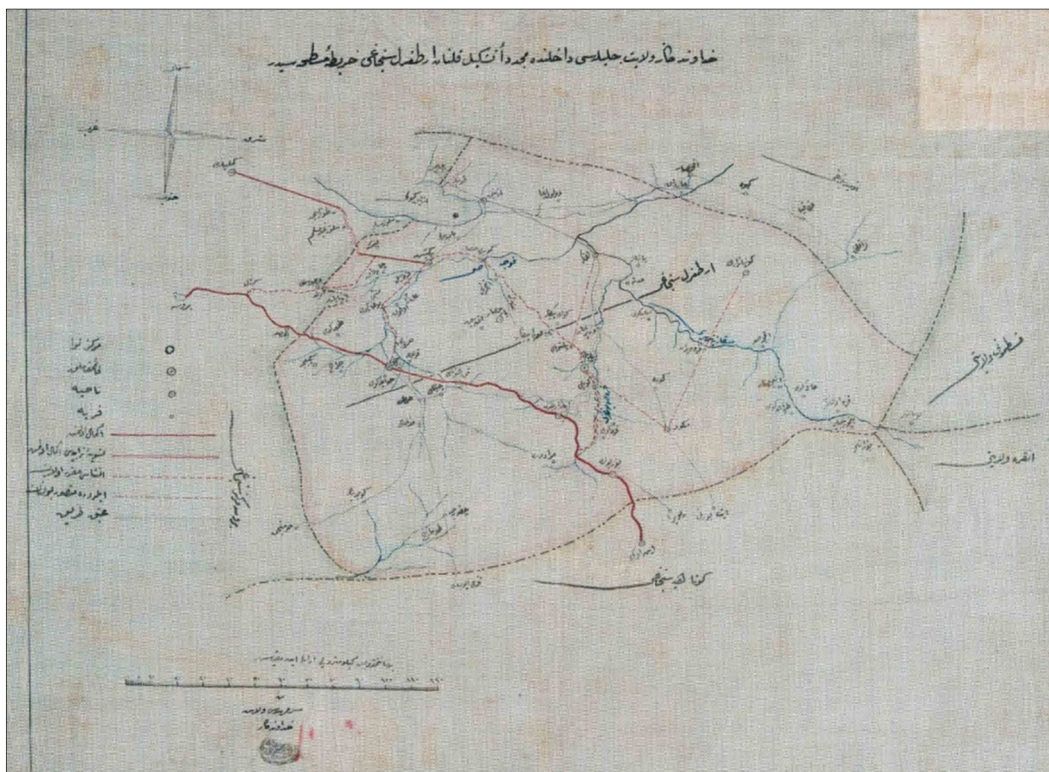
Fig 6.23: Hüdevendigar vilayeti, Erturul Sanca ı hand drawn map in 1885, scale: 1/500.000 (Historical names of Bilecik City in Ottoman Empire) (Özcan,, Sarnay, 2012).

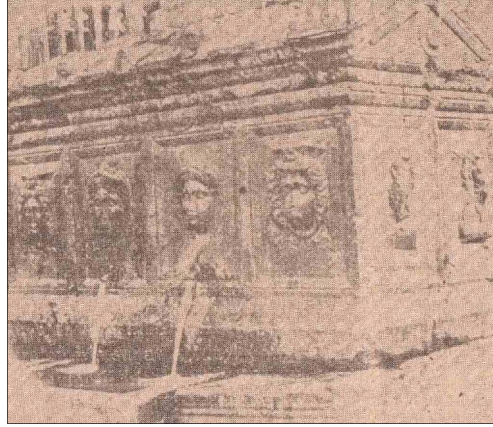
Fig 6.26: “Kulaklı ta ” tomb (Güney, 1938).

The heads of “Gorgon Medüz” were existed on this Roman tomb. The starting age of the tomb was around A.C. 3rd century. The dimensions were 2,5m to 1,5m. (Güney, 1938).

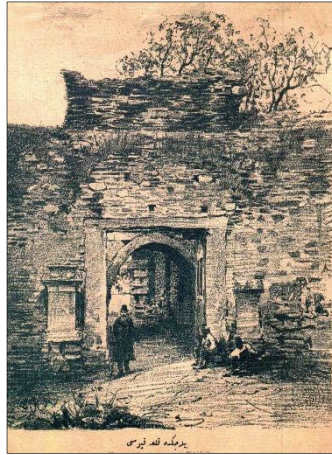
Fig 6.27: One of the gate of the castle in Bilecik, 8 Sep. 1892 (Özcan, Sarnay, 2012).

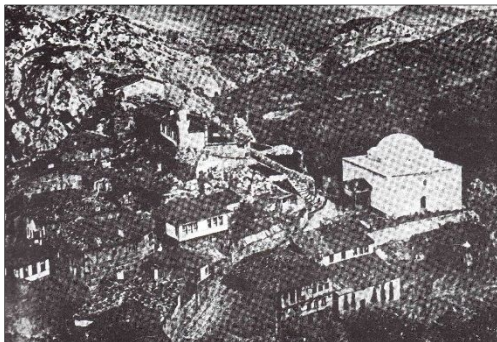
Fig 6.28: The castle of Bilecik and Orhan Mosque, (1882) (Ayverdi, 1989).

Bilecik Orhan Gazi mosque was located on the steep slope (Ayverdi I, 1989). It was built in 14th century with domed closure structure (Güney, 1938). This structure was built up by Murat Hüdavendigâr after the capture of Biga settlement. From the past till now the originality of the mosque was changed dramatically due to the wrong repairment techniques. The building was constructed with “alma ık” masonry bounding technique. The outer look of the building is one domed squared plan. The weight of the dome is transferred to the pointed arches. The entrance of the building was given from the north elevation. The pointed arches and oval arches were used on the elevations of the mosque. The brick material was used on the arches. The eaves of the roof were surrounded the building. The lead material was used on the roof of the mosque. The cylindrical minaret of the mosque was attached later to the adjacent of the structure (Ünal, 2008).

Rectangular shape of the mosque was covered with single dome which supported with octagonal tabouret. The weight of the dome transferred to the pointed arches. The width of the arch in south is 1.42m. On the other walls the width of the arch is 2.40m. The minarets of the mosque were constructed in later period of time and they were located on the west and on the east side. General repairment of the mosque and two minarets were constructed in 1889 behalf of brahim Bin Abdüsselim. The original minaret of the mosque was located 30m away in north direction from the structure. This minaret was constructed after 50-60 years from the construction of the mosque (Ünal, 2008).

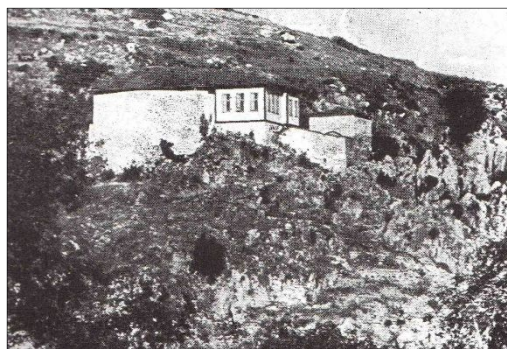
Fig 6.30: eyh Edebali and Mal Hatun tombs in Bilecik (Ayverdi, 1989).

The entrance of the tomb was located ten steps down forward according to the topographic structure of the land. The tomb was constructed in square plan with folded roof. Inside of the tomb there was a dome closure. The wall structure was built up of stone. The construction was very simple and rough. The eaves of the roof surrounded the tomb (Ünal, 2008).

This tomb was located in the city center of Bilecik at Cumhuriyet district. It was built adjacent to the east wall of “ eyh Edabali” tomb. It was built at the same date with the masjid of “ eyh Edebali”. The plan type of the masjid was rectangular with the dimensions of 4.90mx9.60m. Inside of the space the arches could be perceived. The closure of the space was folded roof outside and domes inside with tile covering (Ünal, 2008).

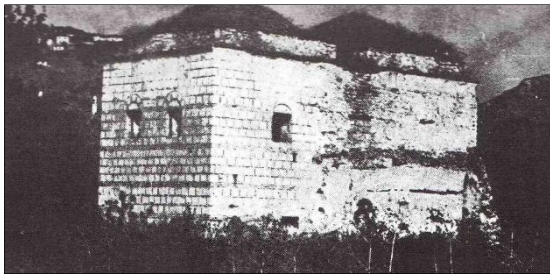
Fig 6.31: Orhan Imaret in Bilecik (Ayverdi, 1989).

“Orhan Gazi” imaret was located in the center of the Bilecik city, stiklal district. It was located on the hillside and south-west direction of the “Orhan Gazi” mosque. The building was constructed in the period of Orhan Gazi (1324-1362) (Güney, 1938). The building technique and the dimensions were similar to buildings which were built in the same period of Orhan Gazi (Ayverdi, 1989). Today, the existing building was highly devastated. The middle of the building was approximately square plan in 6.75mx14.50m dimensions with a closure of two domed structure. However these two domes could not survive until today, they were collapsed. As well the side parts of the “Orhan Gazi” imaret were collapsed (Ünal, 2008).

The construction materials of the building were stone, brick, timber and picking materials. The elevations of the building were constructed stone and brick materials. The dome and the arches were made up of brick materials. The surface of the dome and arches were plastered with gypsum. There was ornamentation on the surface of the building with hand-drawn figures with colorful paints (Ünal, 2008).

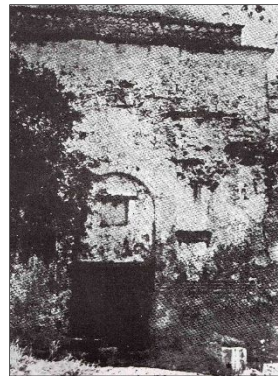
Fig 6.32: The entrance gate of Orhan Imaret (Ayverdi, 1989).

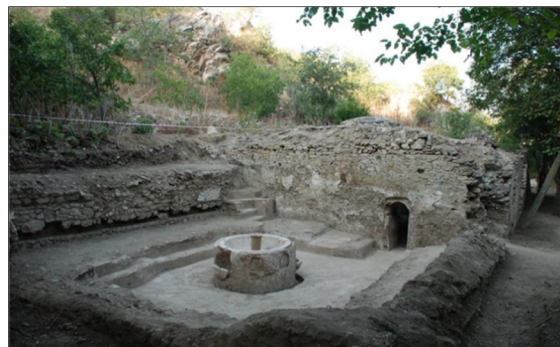
Fig 6.33: Süleymanpa a bath (Mülayim, Öztürk, 2011).

This building was located in Bilecik city in the middle of the valley near the stream. This building was constructed in early period of Ottoman with “ eyh Edebalı” building complex in (1230-1402). The building separated in to three different sections and two partially enclosed bathing cubicle “halvet”. The general shape of the bath was rectangular. Big part of the bath was collapsed.

In the south-east of the “Süleymanpa a” bath there was a square planed undressing area. On the north of that area there was a worm area. Both of those spaces dome structures were collapsed. The hot area was planned rectangular which was closed with vault and supported with two arches. In the middle of the vault there was dome with lightening openings. In this area there were two enclosed bathing cubicle “halvet”. The heating room of this bath was totally collapsed and the water tank was partially damaged (Ünal, 2008).
