POLITECNICO DI MILANO

School of Architecture, Urban Planning and Building Engineering
MSc Architecture, Built Environment and Interiors

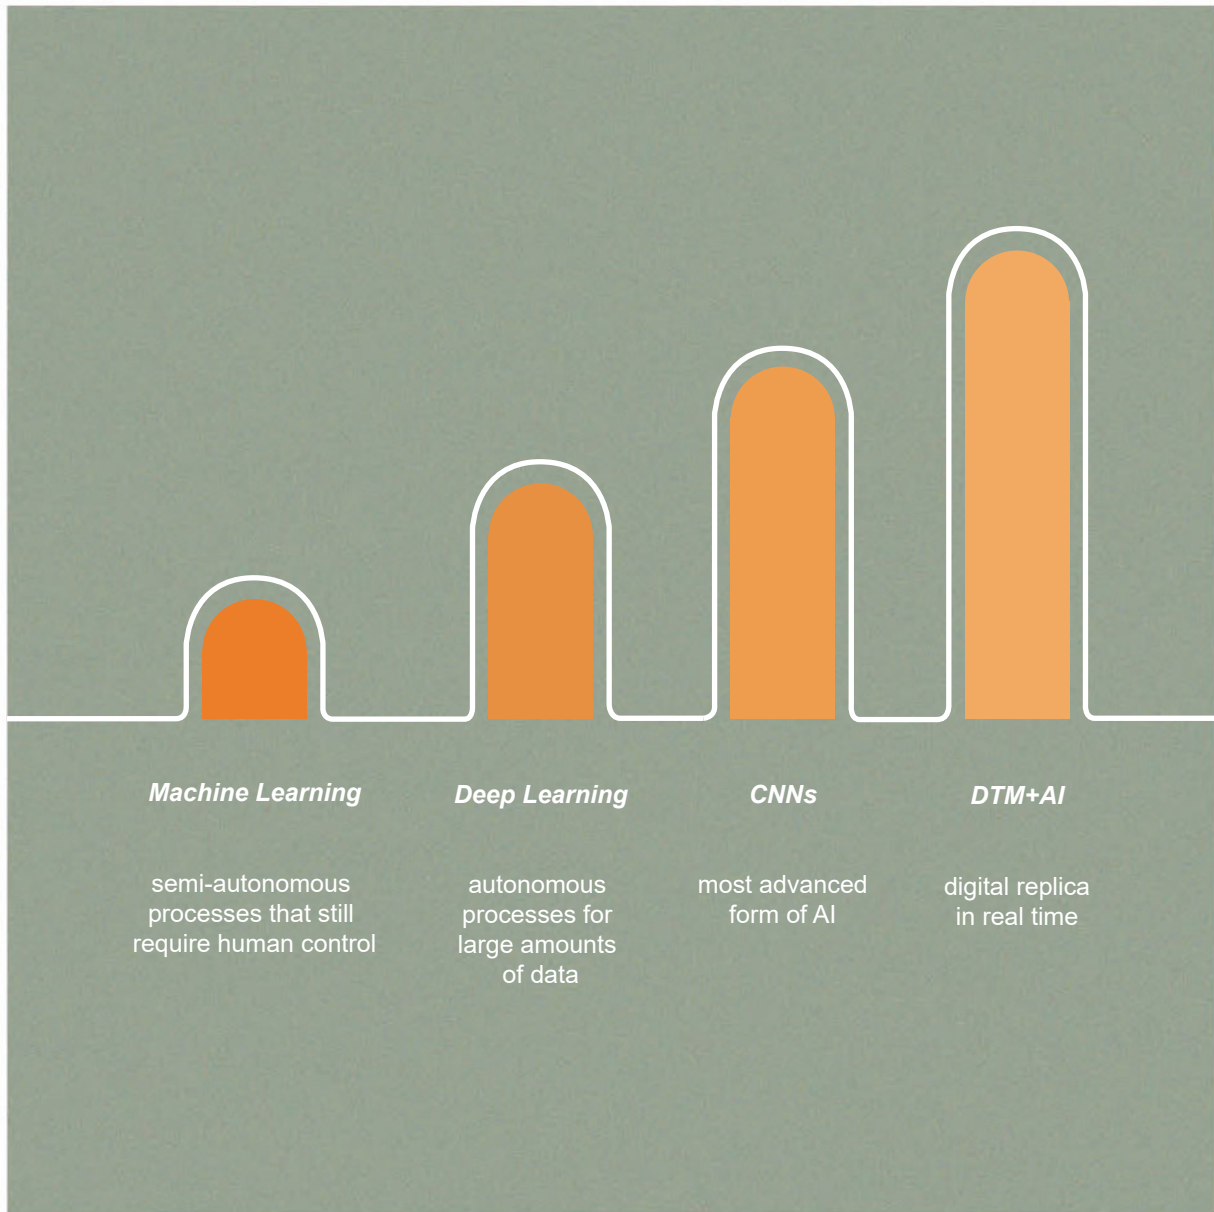
Specifically, it is possible to transfer visual and video images to the machine for automatic inspection to recognise the desired elements and perform analyses of surfaces and their decay. Within the computer vision process, convolutional neural networks (CNNs) represent the most advanced form of intelligent technology. They can fragment the images received into pixels corresponding to tags and labels, which are used to perform convolutions of arithmetic functions and make predictions about what the machine sees.

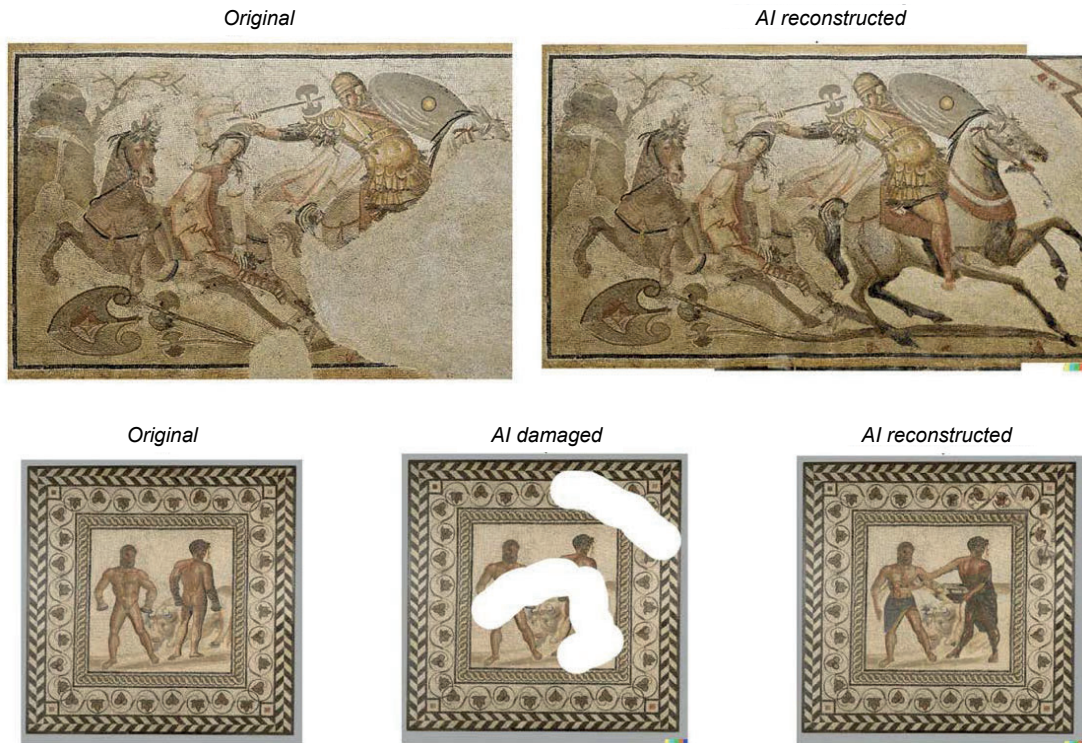
Comparison between the original damaged surface of the Colosseum and its restored version with AI.
source from www.ultralytics.com

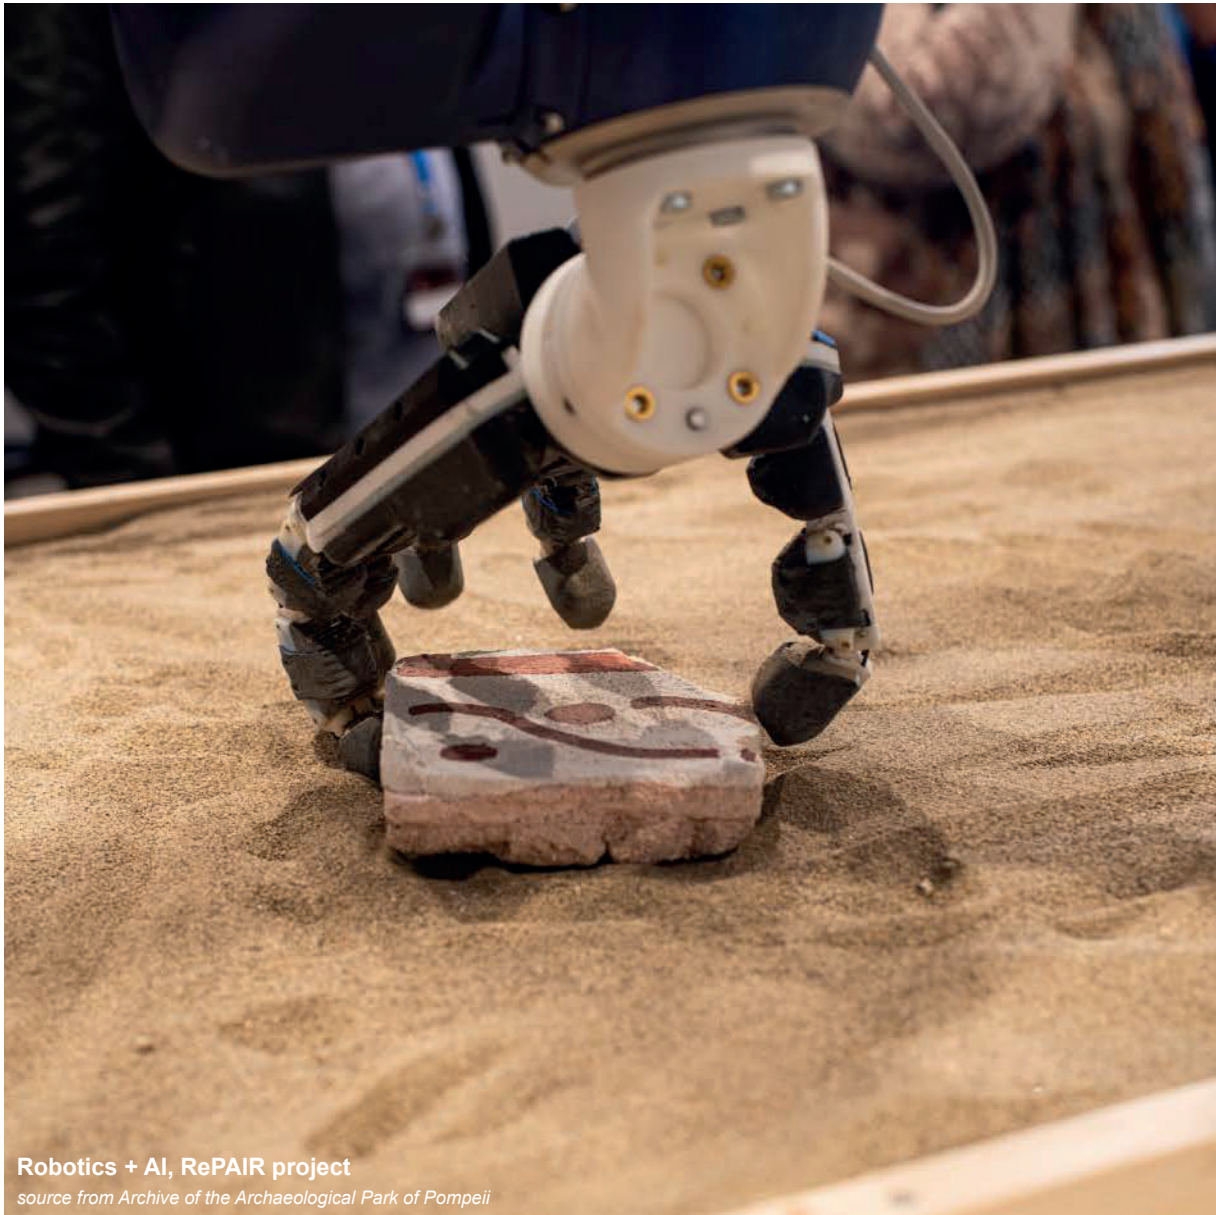
Robotics + AI, RePAIR project

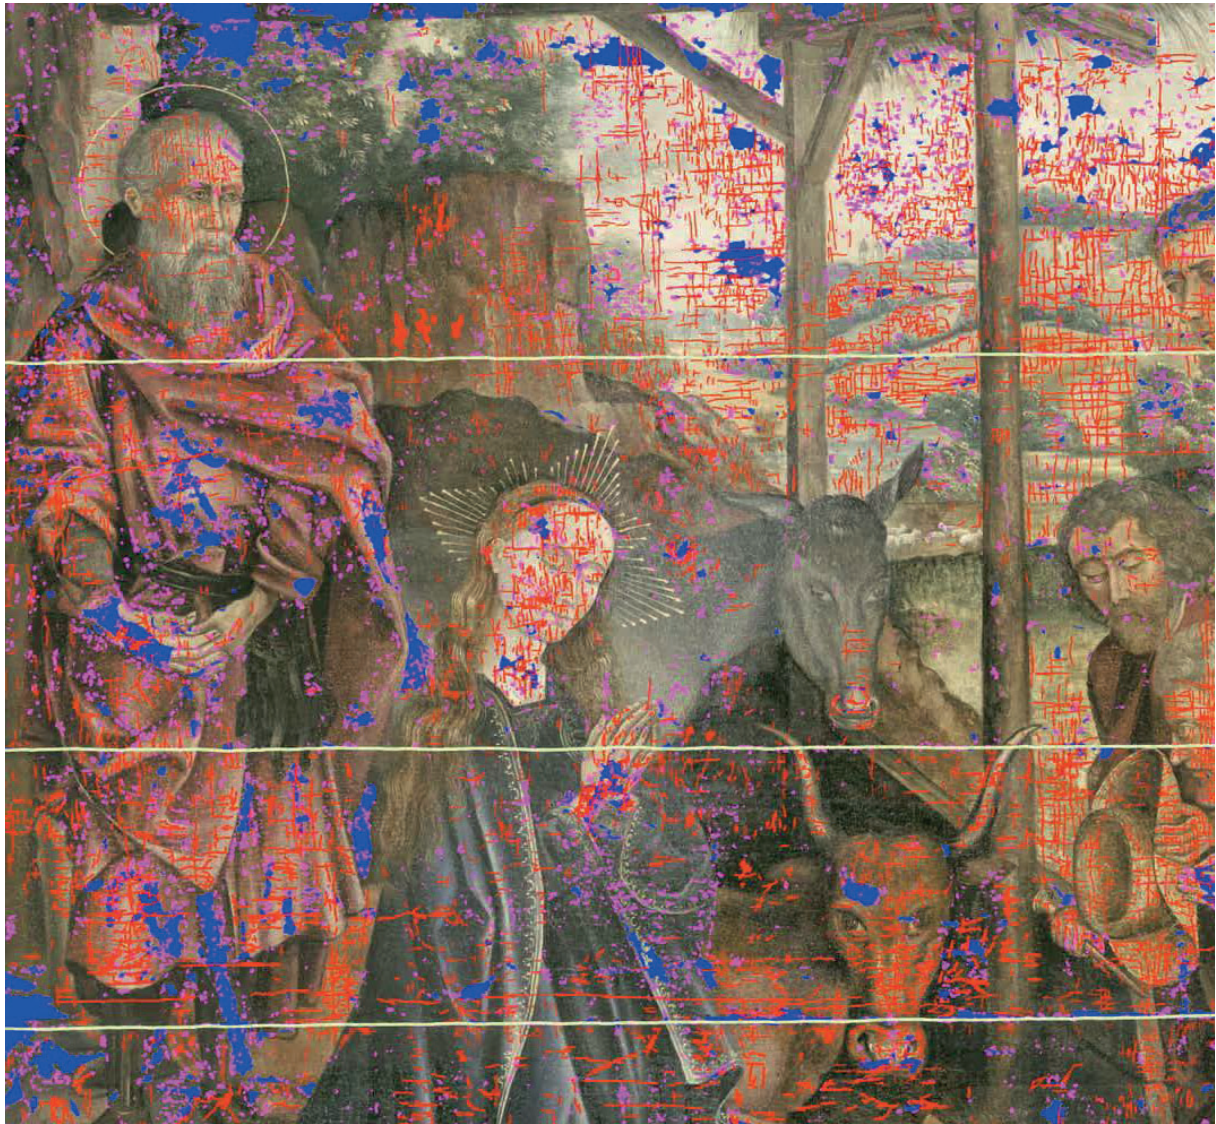
Damage map of the painting

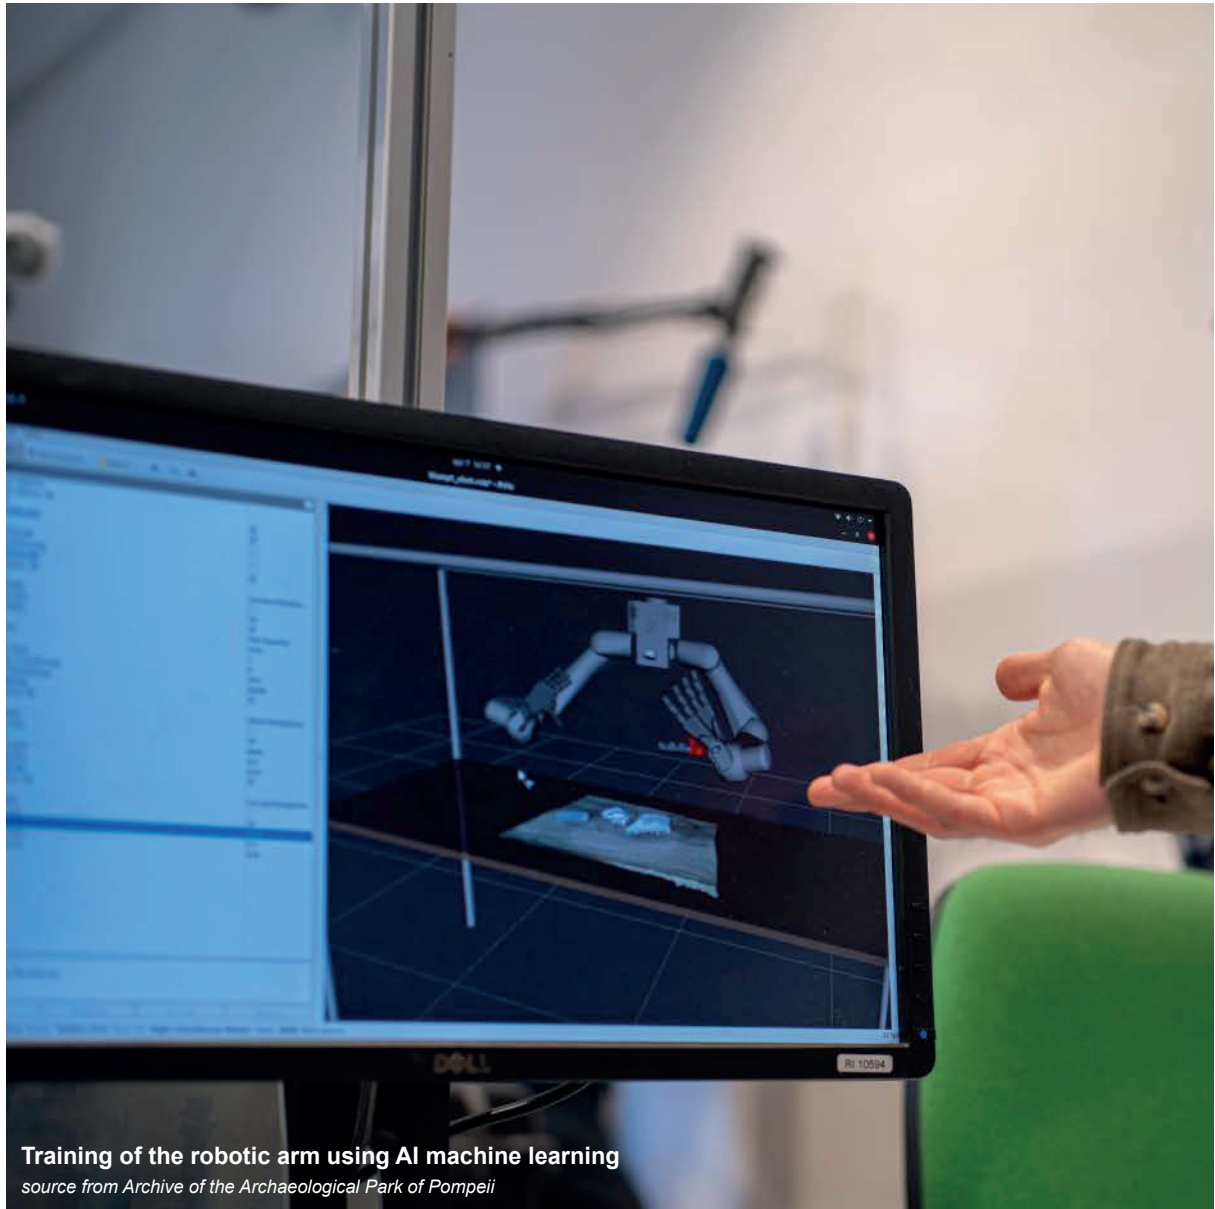
Training of the robotic arm using AI machine learning

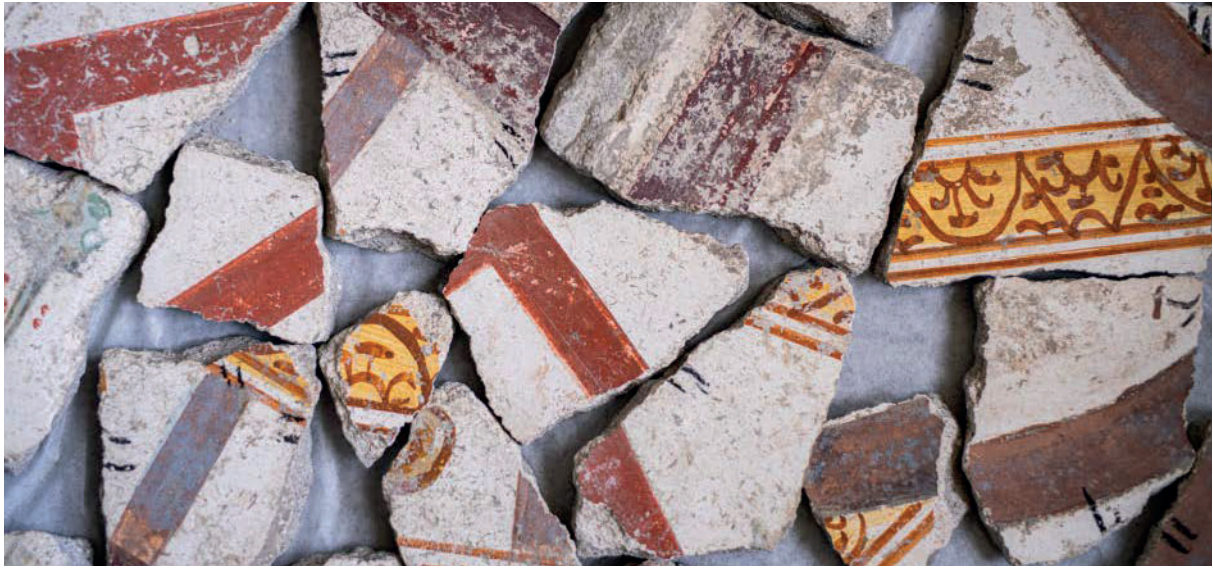
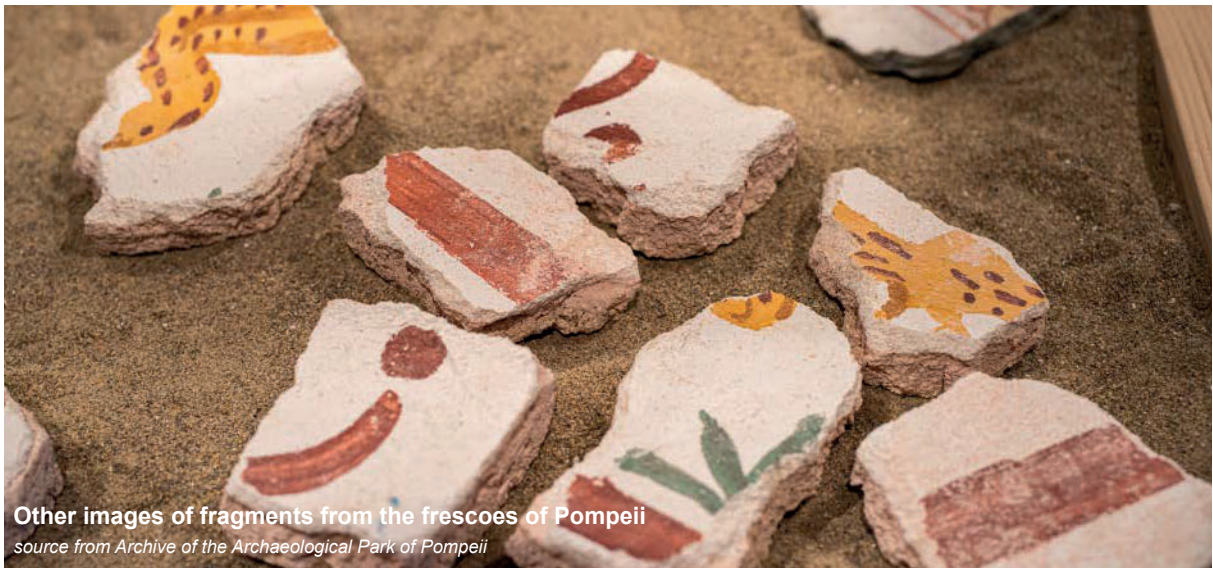
Other images of fragments from the frescoes of Pompeii
source from Archive of the Archaeological Park of Pompeii

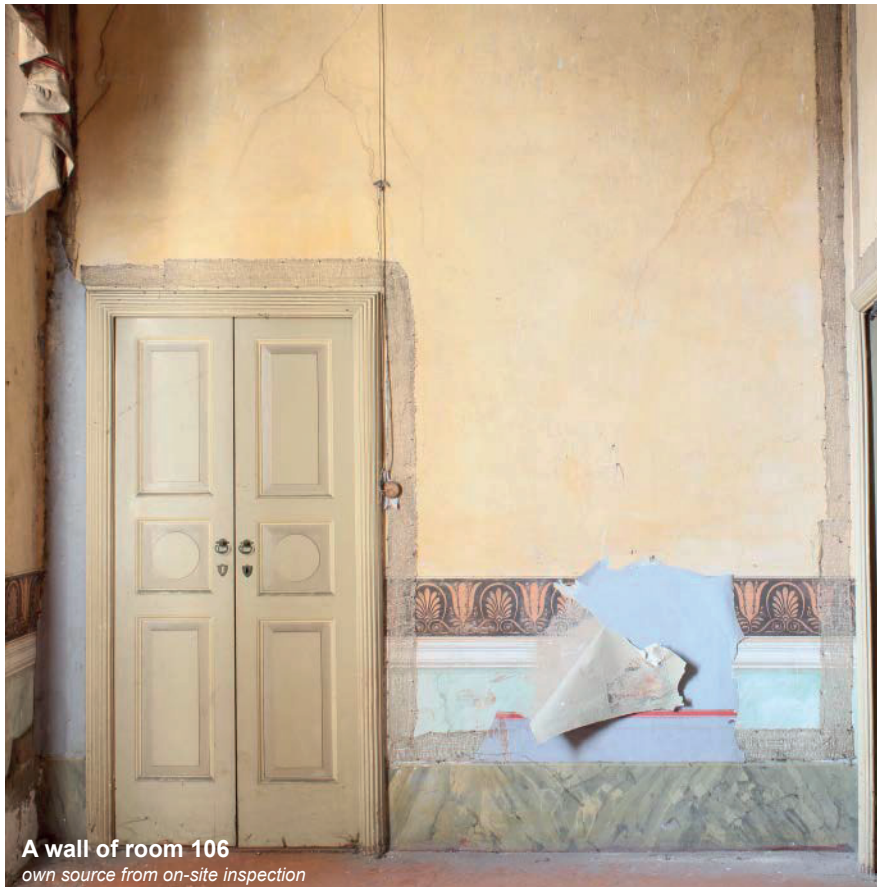
A wall of room 106
own source from on-site inspection

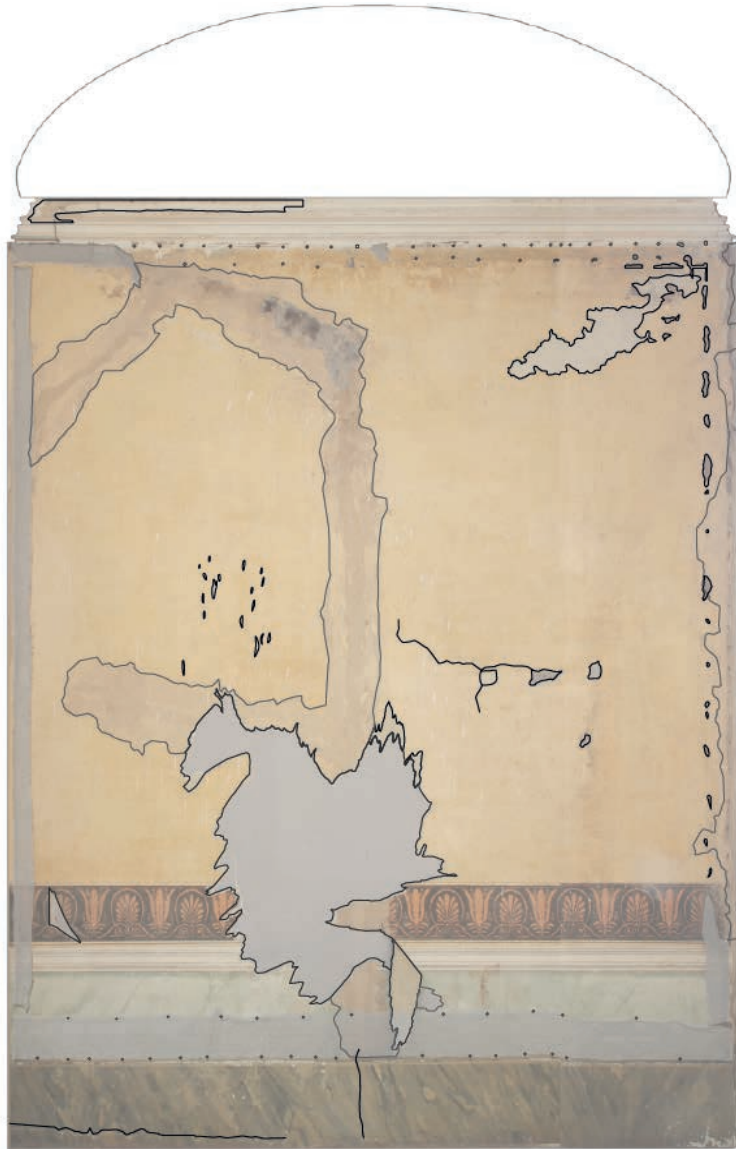
Mapping of decay pathologies
own analysis

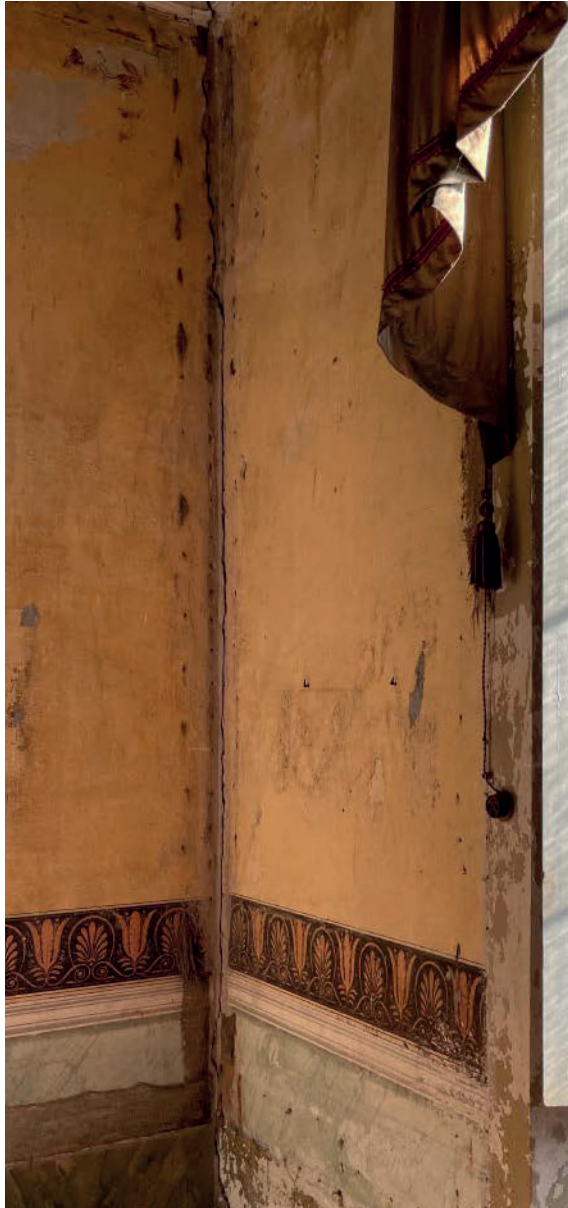
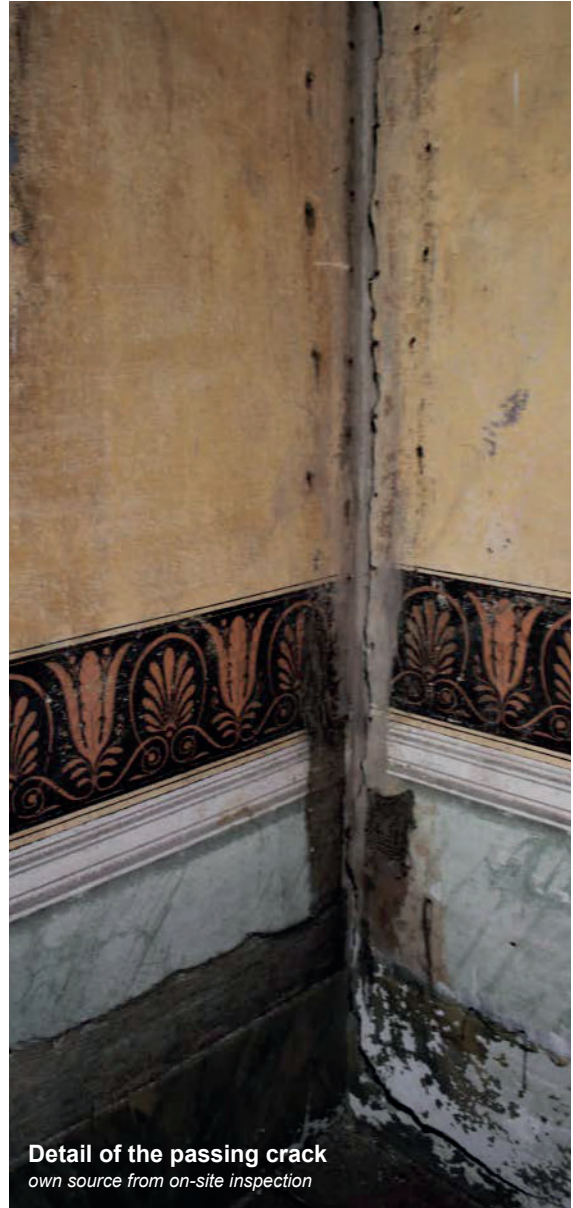
Detail of the passing crack
own source from on-site inspection

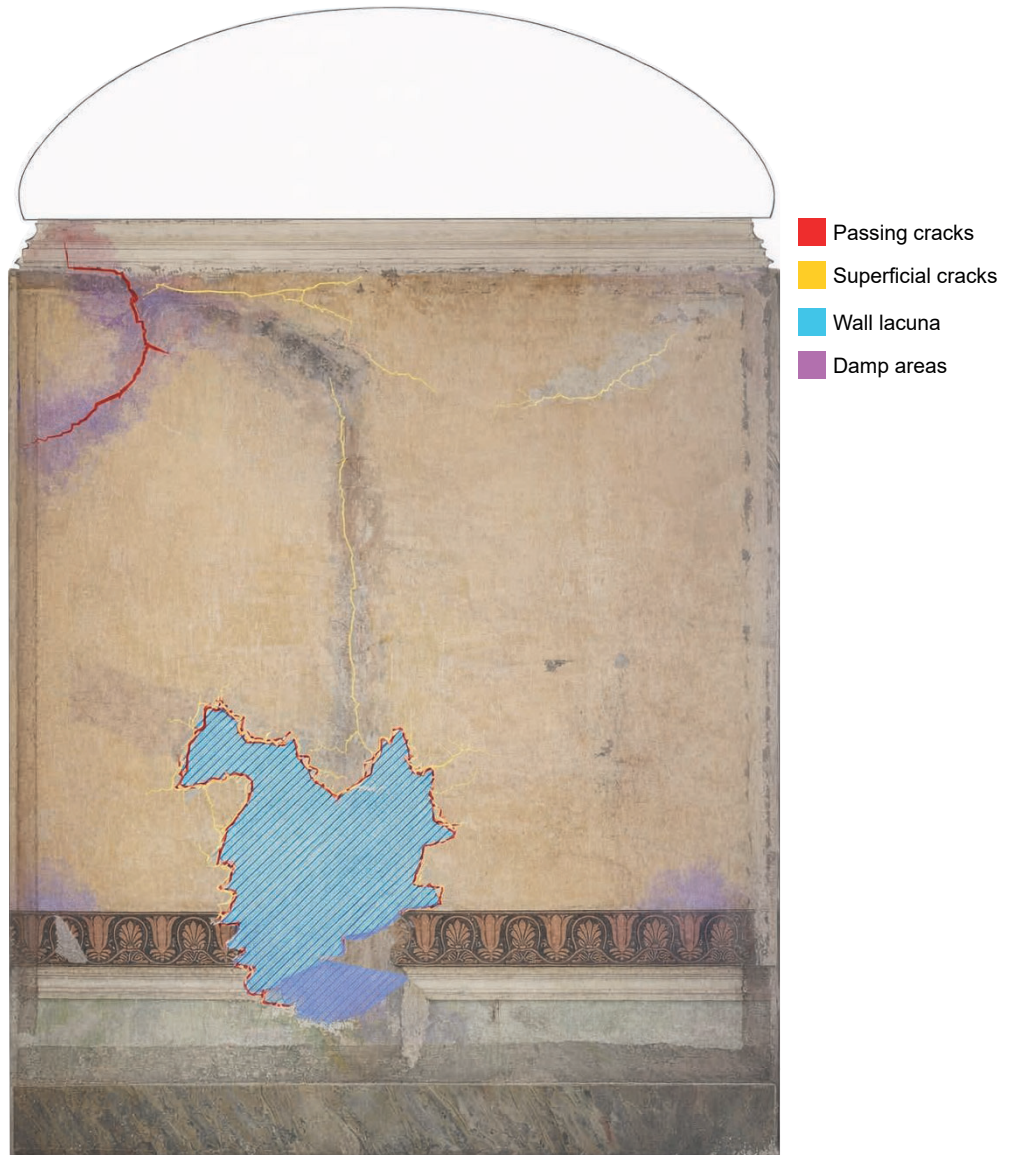
AI mapping of decay pathologies
source from ArchGPT

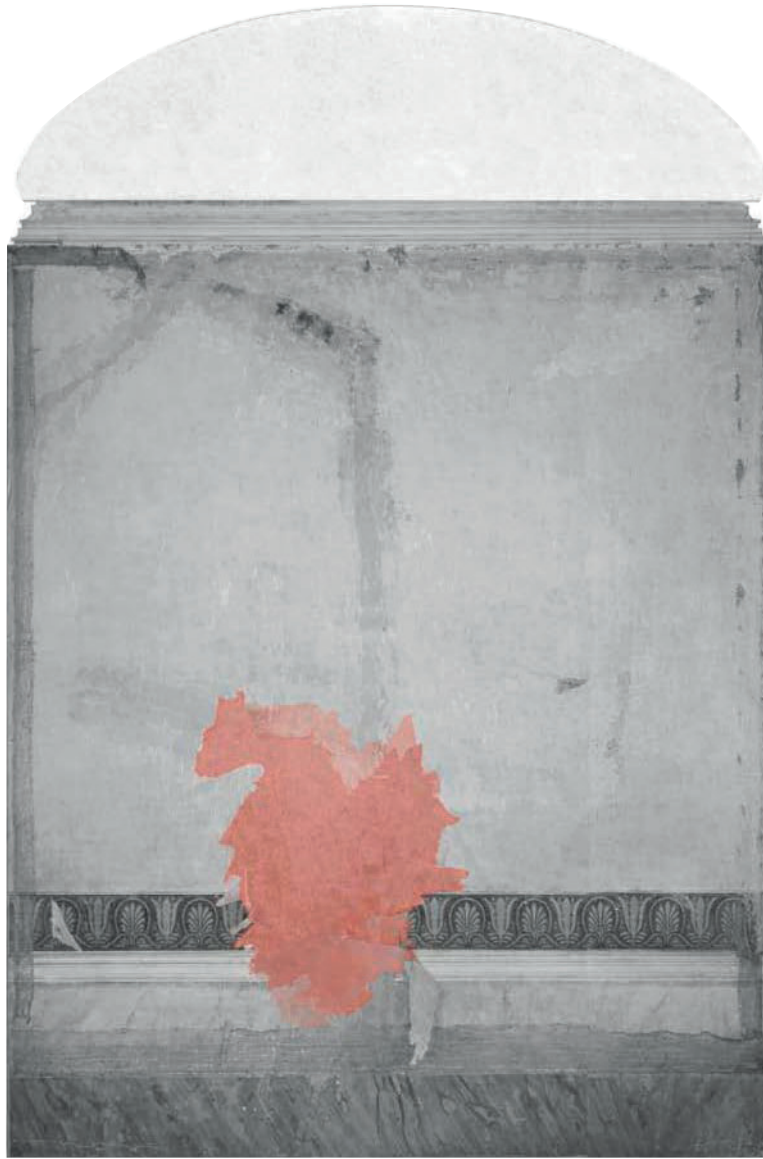
AI mapping of wallpaper area
source from ArchGPT

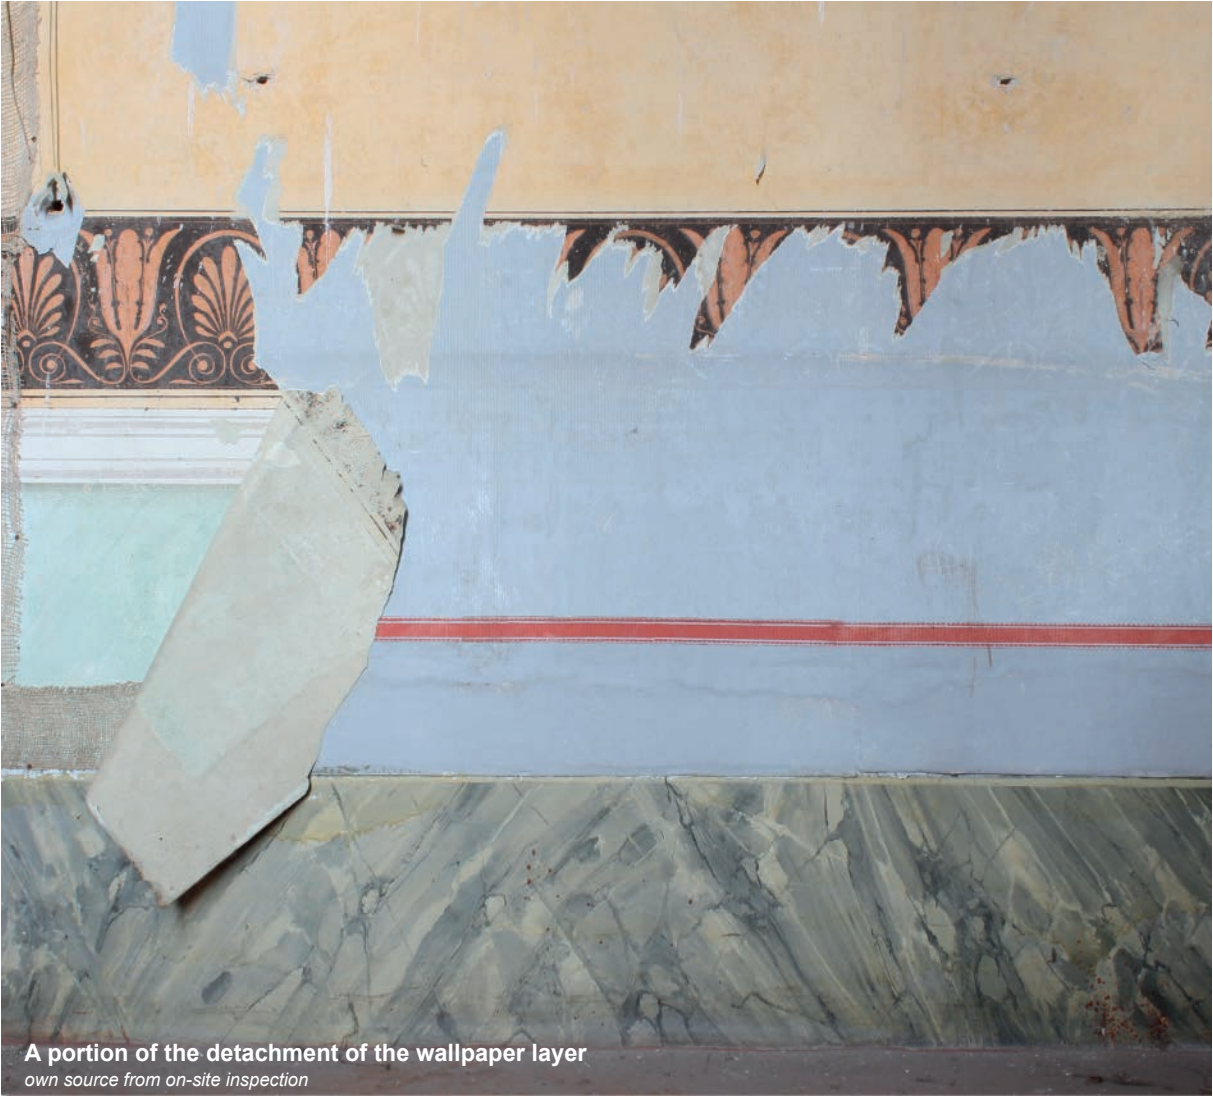
A portion of the detachment of the wallpaper layer
own source from on-site inspection

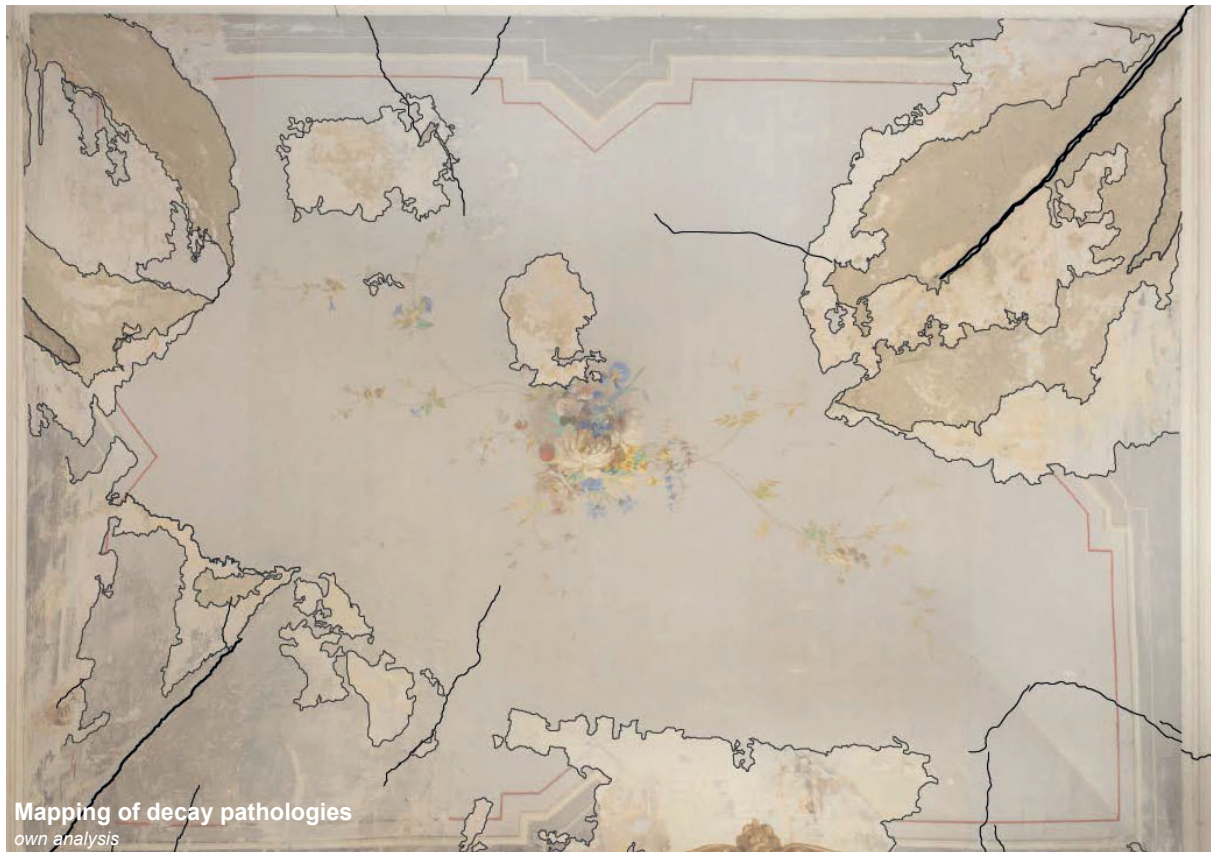
- I. **Passing cracks:** along the lines of intersection of the faces of both vaults, especially in the north-west and south-east corners
- II. **Superficial cracks:** spread across the entire surface of the vault, they do not appear to pose an immediate threat
- III. **Plaster lacuna:** located in the south-east and south-west corners of the vaults, covering approximately 20% of the surface

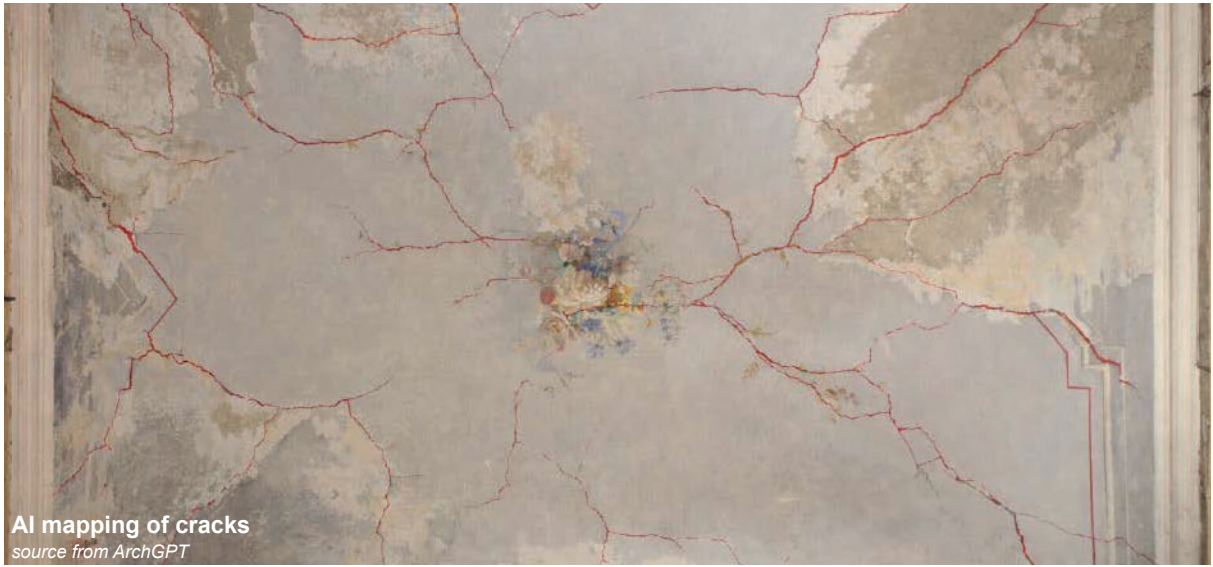
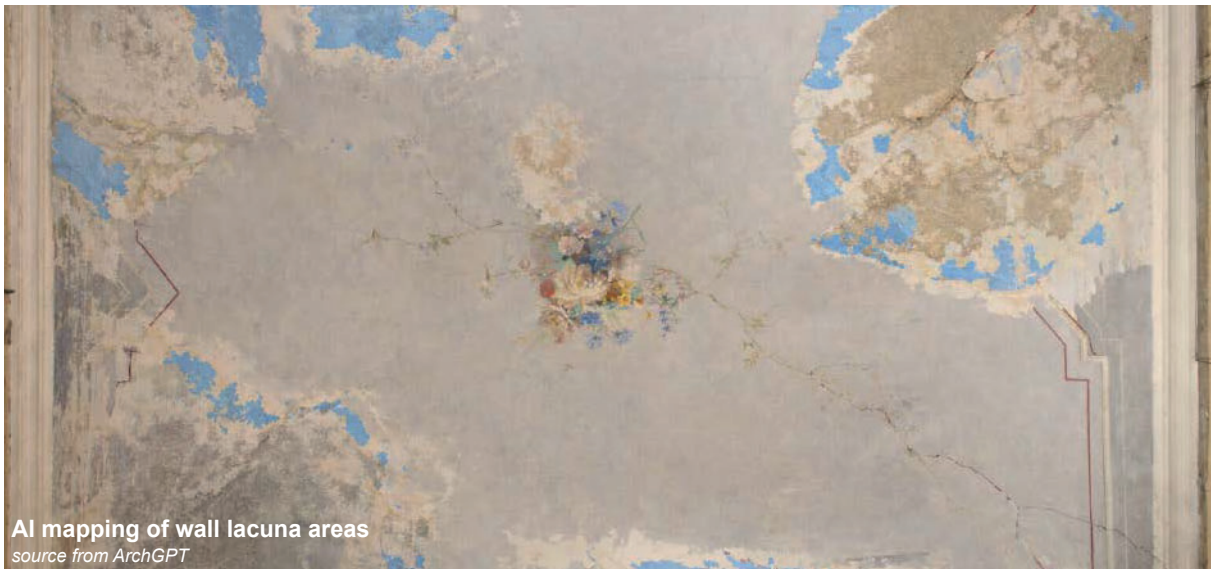
To demonstrate that the AI platform reacts better when the analysis request focuses on a single type of deterioration, we ask it to map the image of the ceiling in two steps, separating the phenomenon of cracks from that of plaster lacuna.

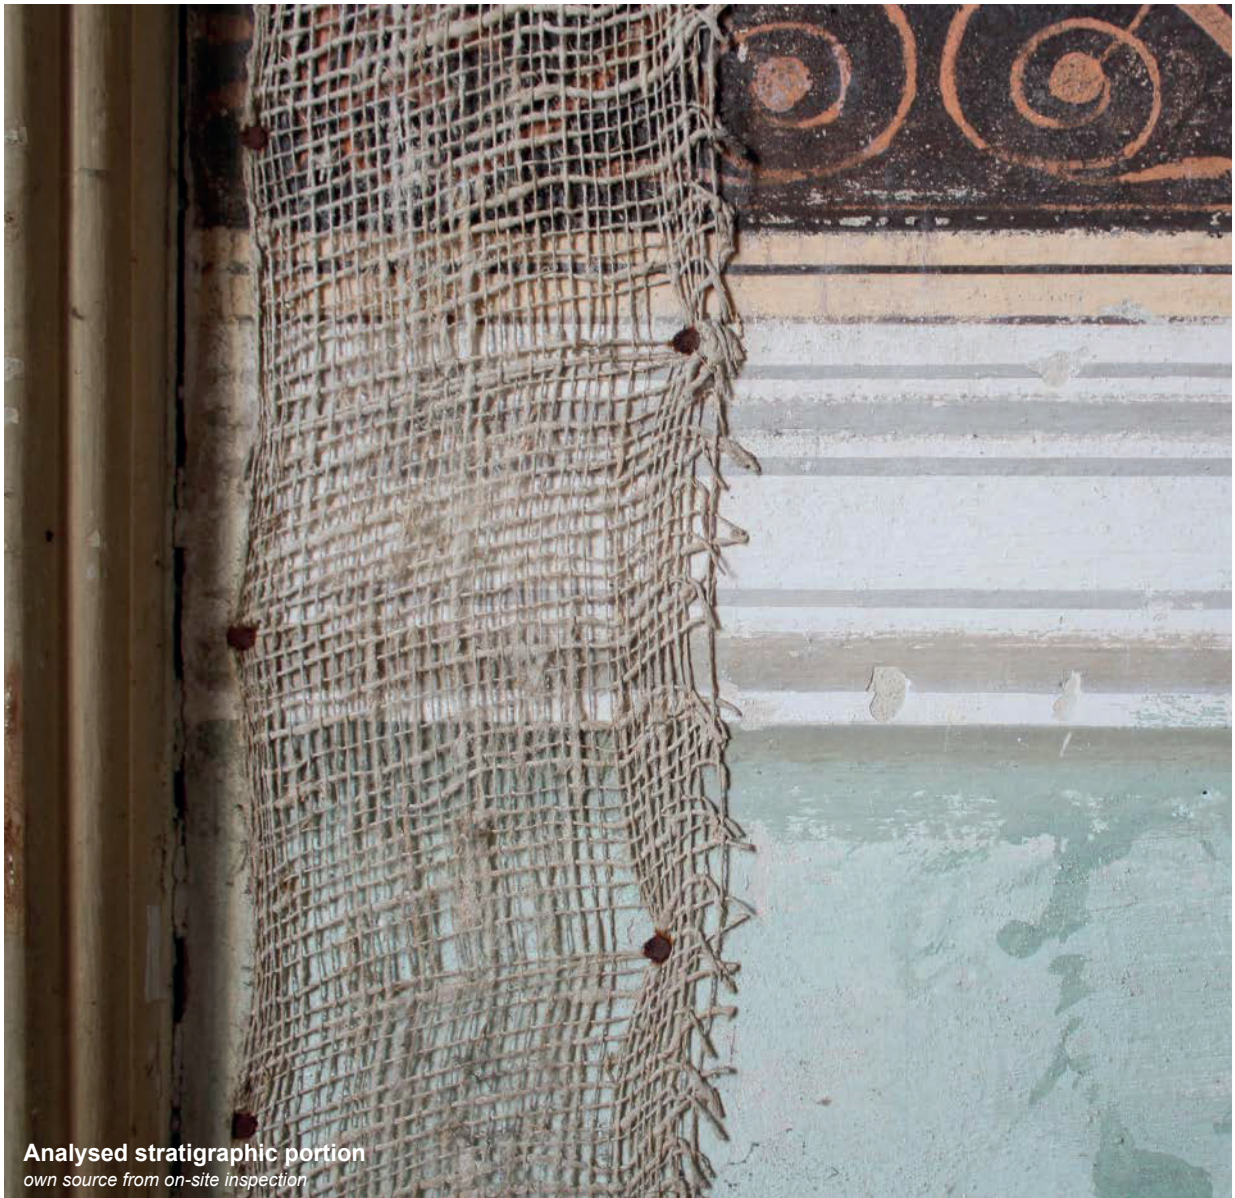
Considering our study of the stratigraphy of the walls, we ask ArchGPT to examine a portion of the wall to identify the possible causes of the detachment analysed.

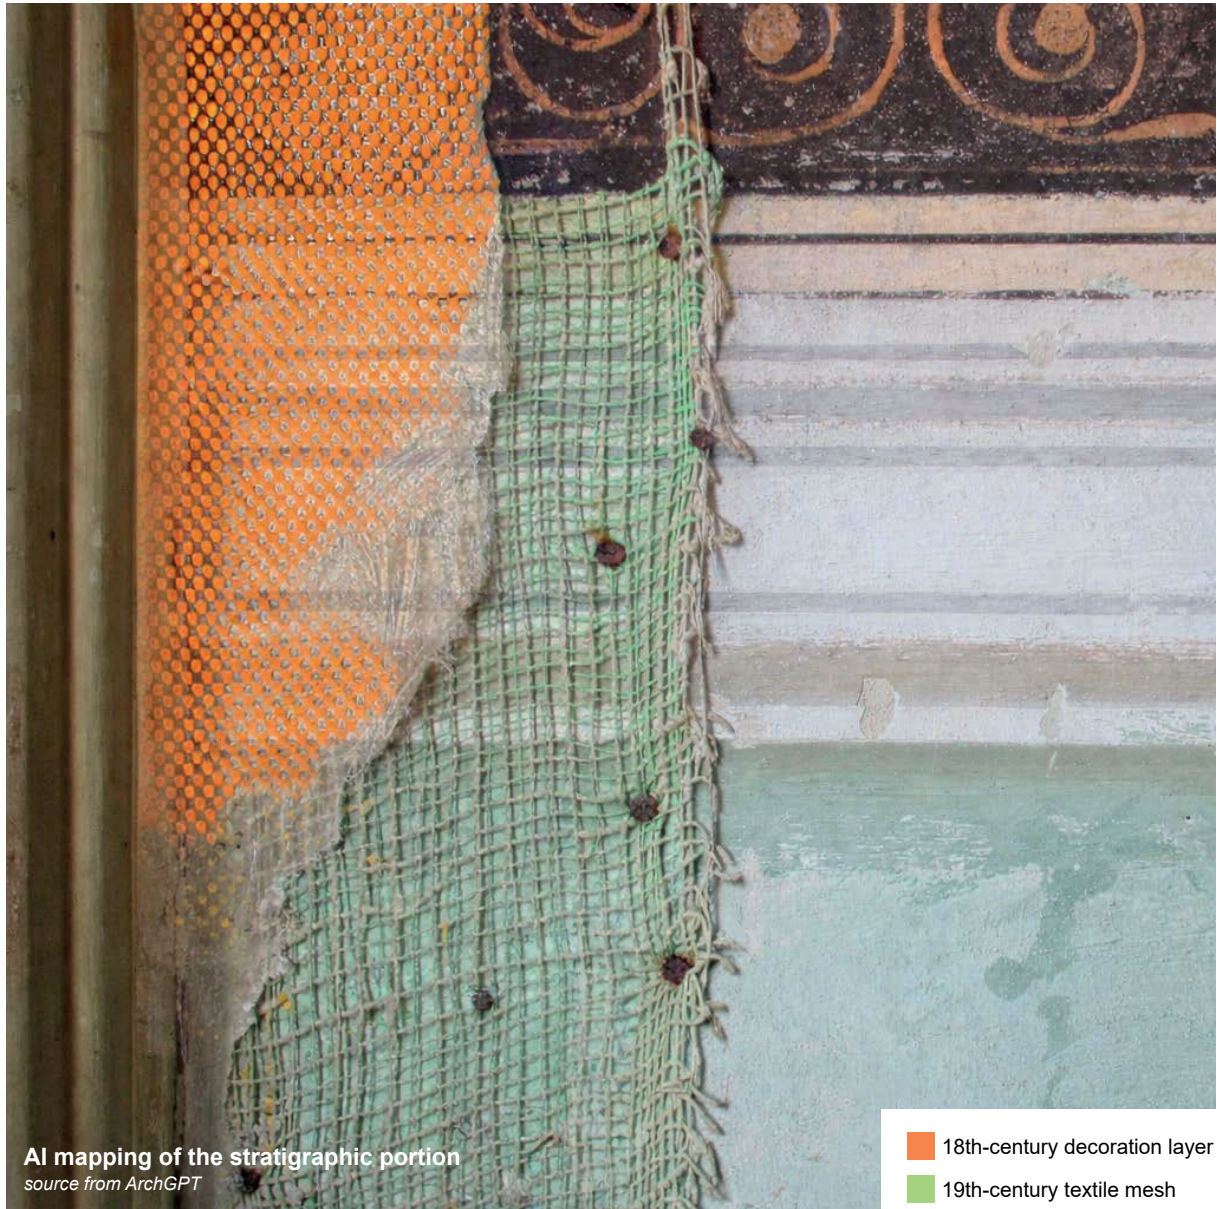
We now ask the AI to create a graphic map, separating the 19th-century decorative layer from the visible portion of the textile mesh.

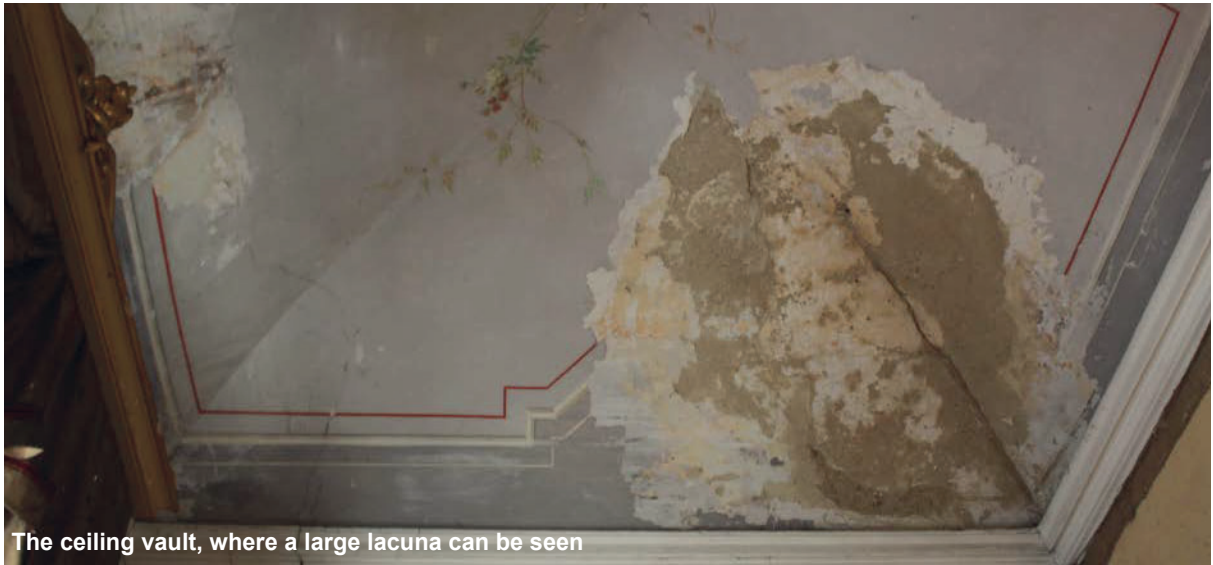
The ceiling vault, where a large lacuna can be seen

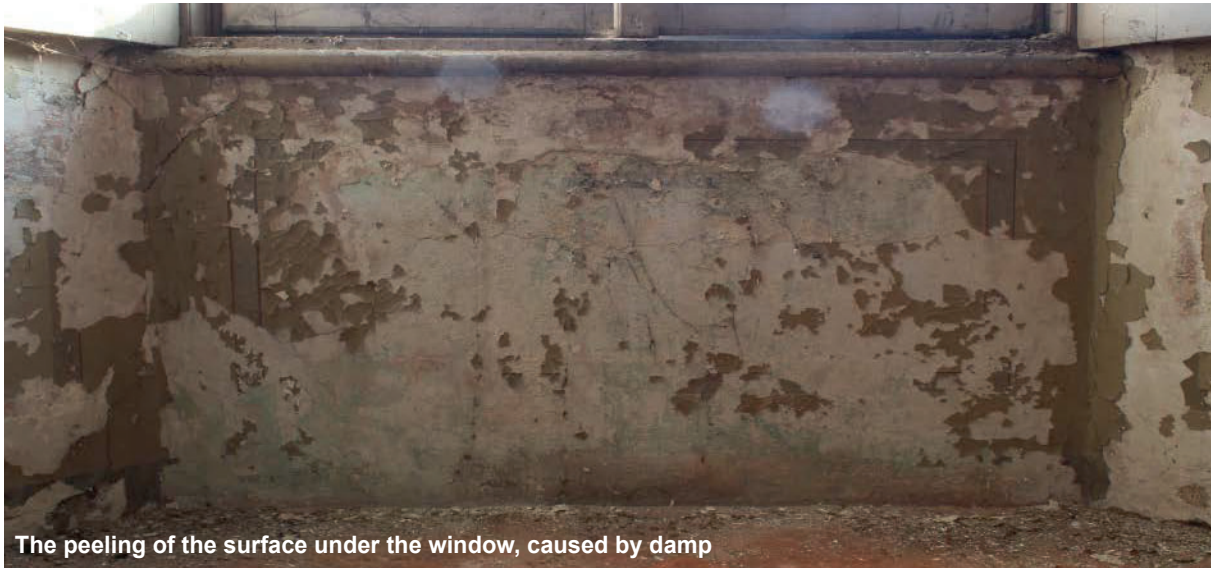
The peeling of the surface under the window, caused by damp

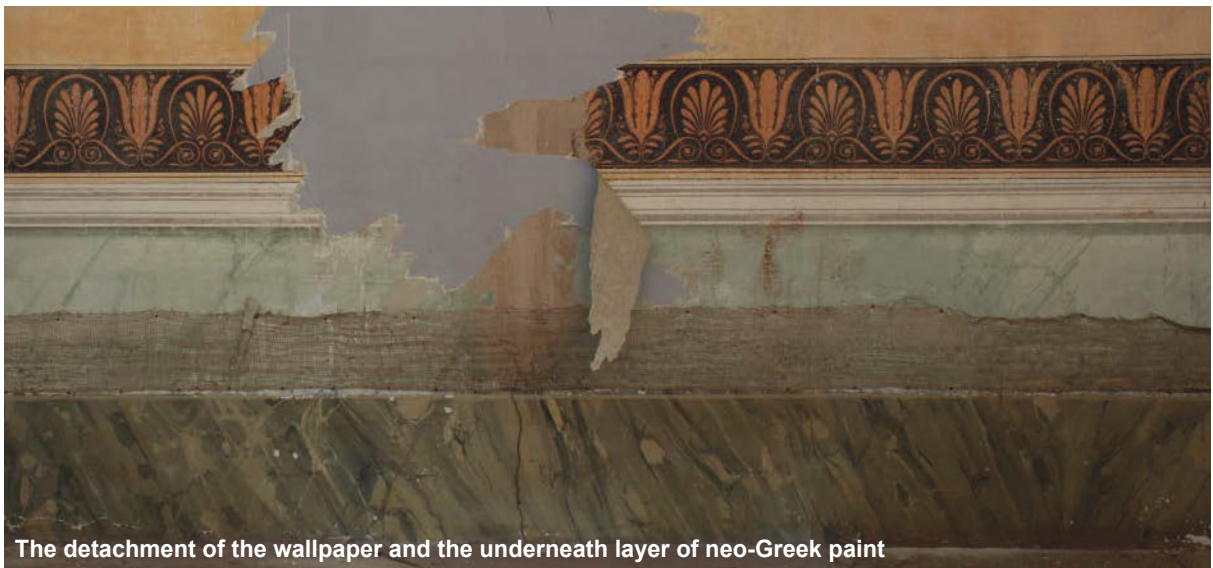
The detachment of the wallpaper and the underneath layer of neo-Greek paint
