POLITECNICO DI MILANO

School of Architecture, Urban Planning and Building Engineering
MSc Architecture, Built Environment and Interiors

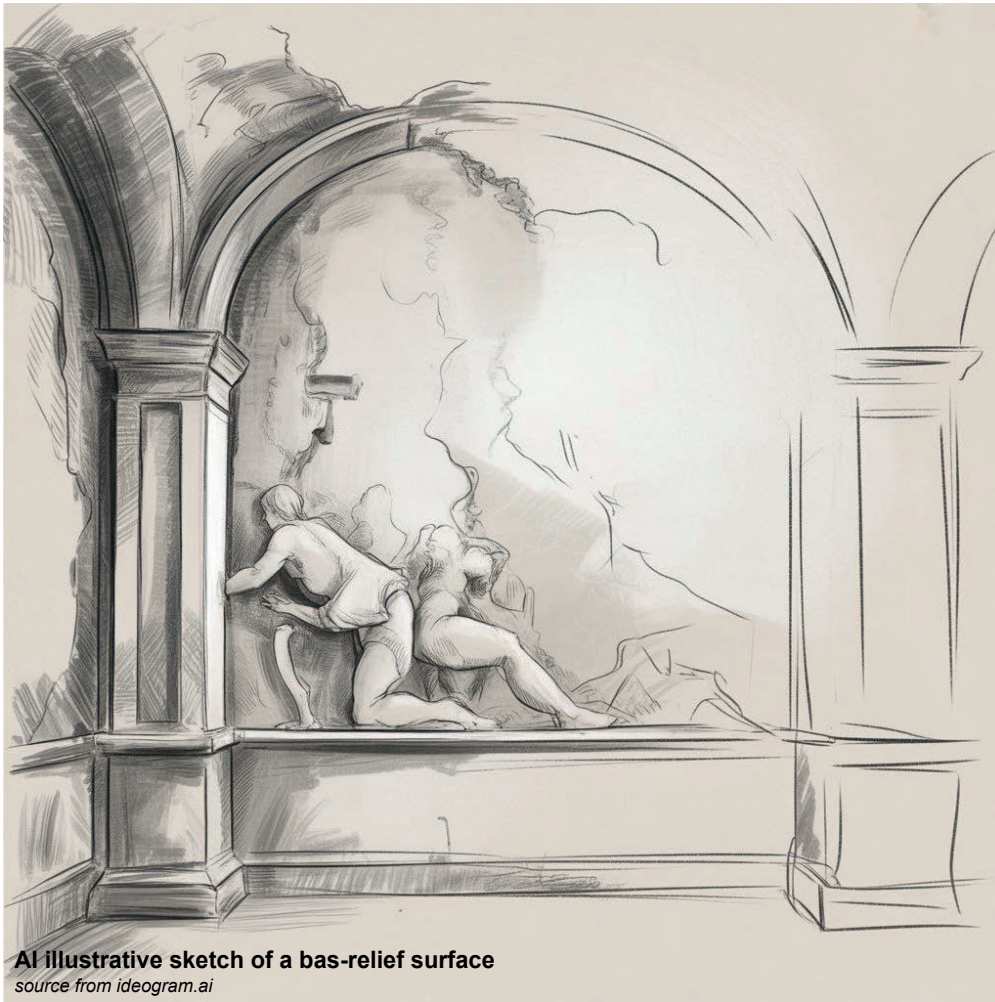
AI illustrative sketch of a bas-relief surface
source from ideogram.ai
